Review of Aurizon Network Review Event 2017 Submission

Tropical Cyclone Debbie

Client: Queensland Competition Authority

AECOM Australia Pty Ltd

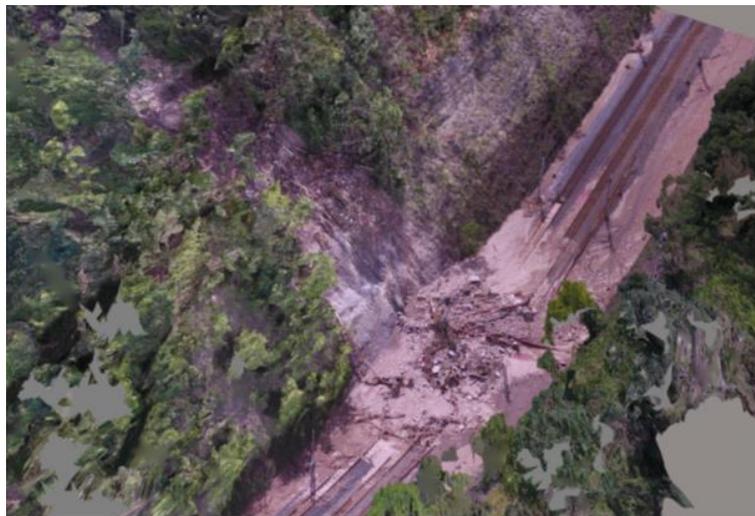
Figure 12 Land slip at Black Mountain

The damage assessment revealed that the Goonyella system was significantly impacted by numerous landslips, access road washouts, and bridge abutment damage. Further, overhead lines and support masts suffered damage, and a signalling equipment room was inundated with water and rock debris. The Goonyella system re-opened for coal traffic on 26 April 2017 with operational restrictions (capacity and speed).

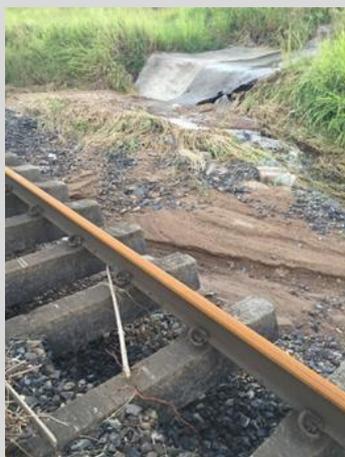
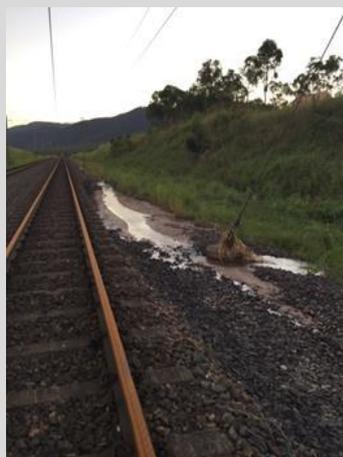
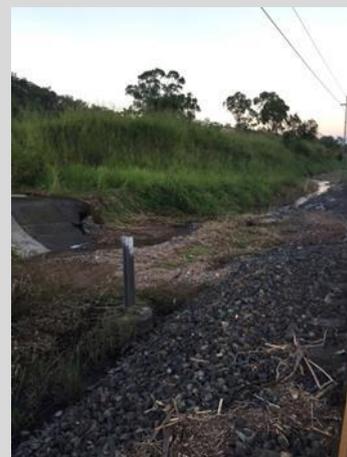
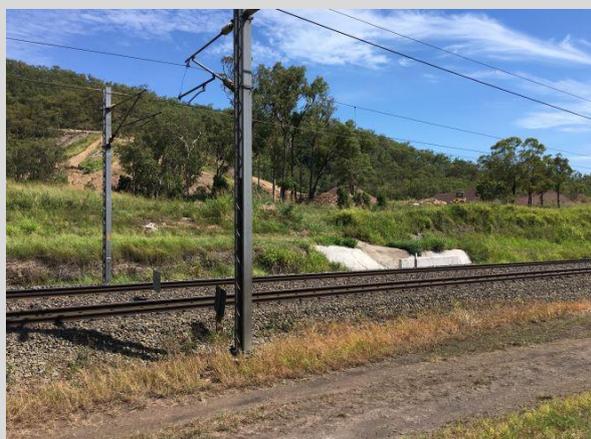
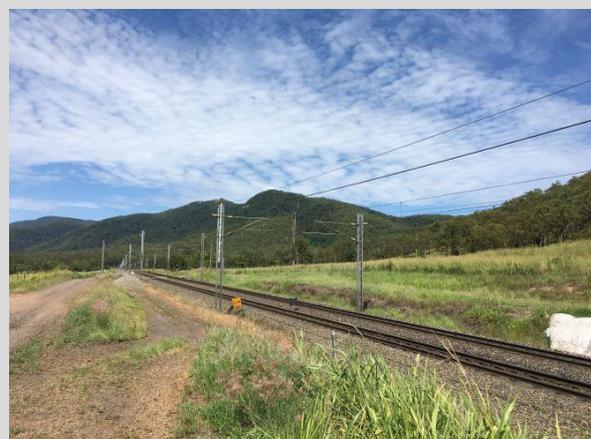
Black Mountain (32.465 - 32.625 km)	Incremental	✓
	Incremental Additional	✓
	Cost Efficient	✓

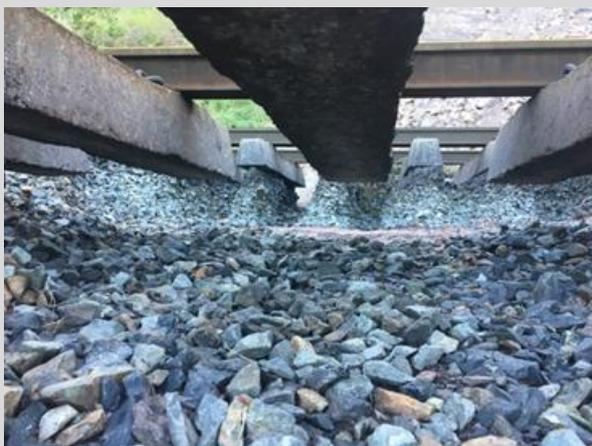
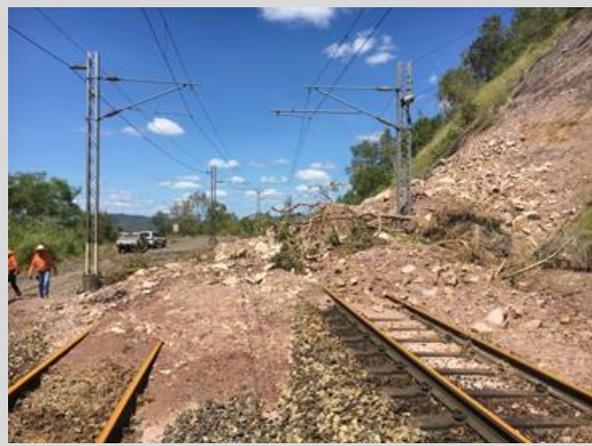
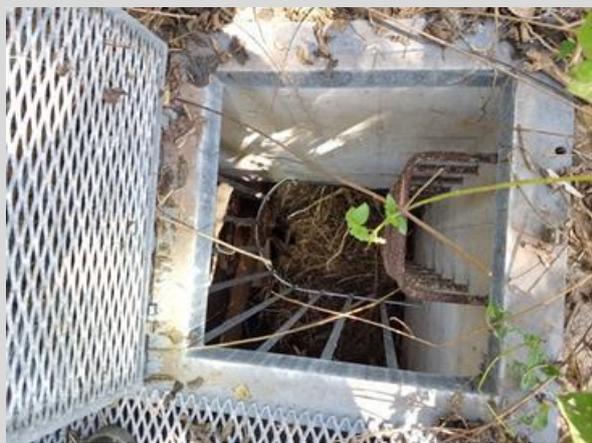
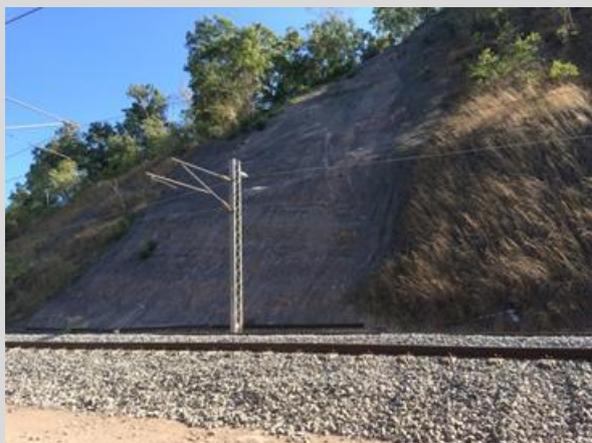
Black Mountain (37.345 - 37.540 km)	Incremental	✓	Flood Claim (\$m)	\$0.83
	Incremental Additional	✓	Impact of findings on Claim (\$m)	\$0.00
	Cost Efficient	✓	Total accepted (\$m)	\$0.83

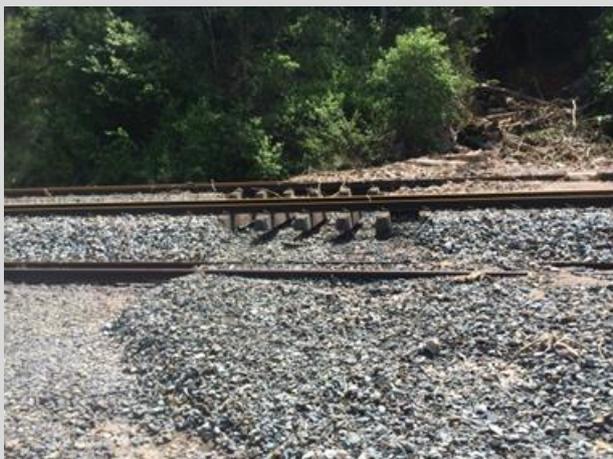
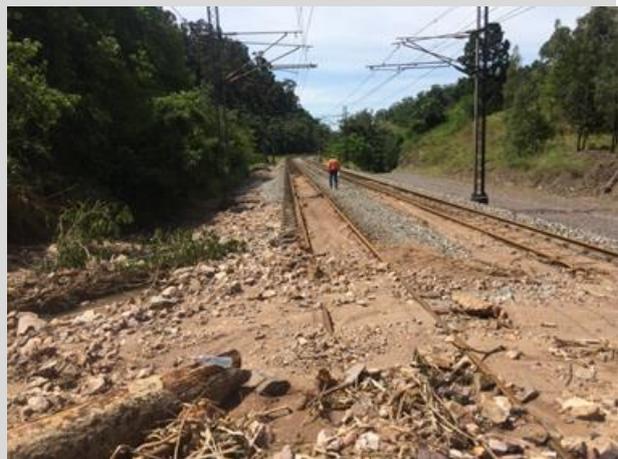
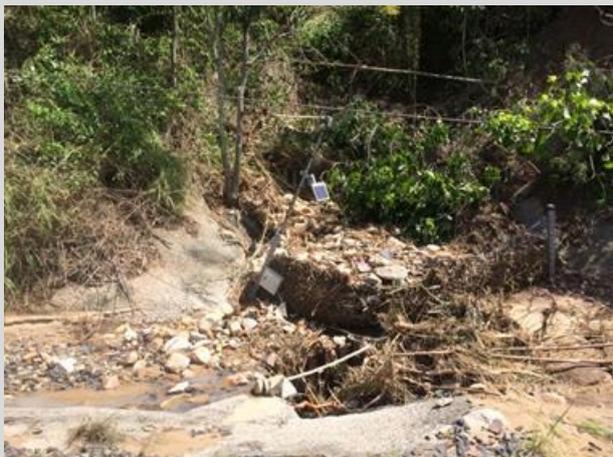
Black Mountain (42.400 - 42.645 km)	Incremental	✓	Flood Claim (\$m)	\$0.80
	Incremental Additional	✓	Impact of findings on Claim (\$m)	\$0.00
	Cost Efficient	✓	Total accepted (\$m)	\$0.80

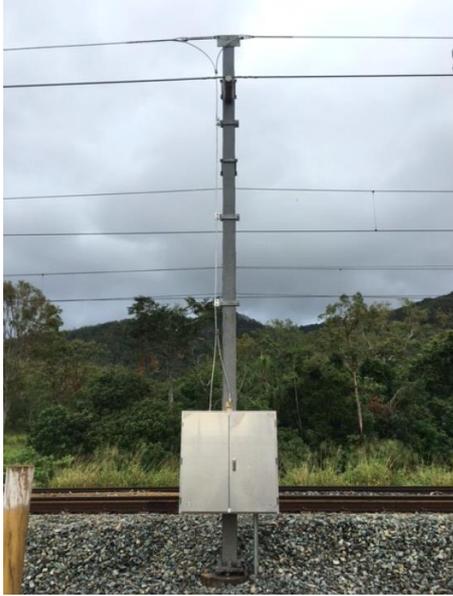
Figure 13 Photo taken following works

The standard to which the cables were manufactured is not known. No data sheet has been sighted for cables or for another materials, however if this cable has been sourced internally from Aurizon Stock then we would expect that it complies to the appropriate standards. Upon review of a final photo at the OPGA termination (GA/35/449/U), we consider the standards followed appropriate.

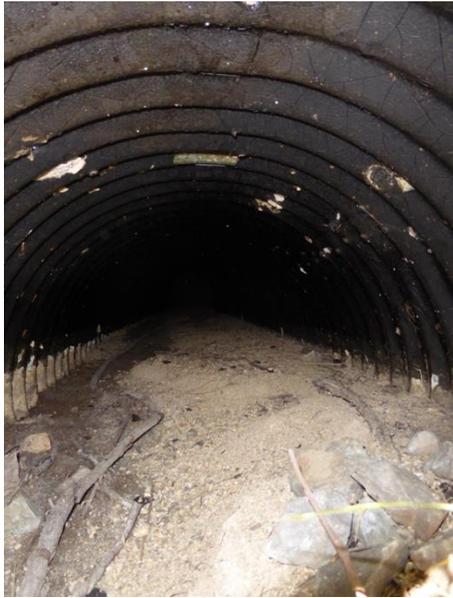
Figure 14 Goonyella Culvert CH42.96, 2016

Chainage (km)	Culvert Length (m)	Level 2 Inspection Report				Last Cleaned
		Date	CS Culvert	CS Water way	Siltation Present	
37.32	50	Jan-16	2	-	No	Dec-15
38.78	51.2	Jan-16	2	1	No	Dec-15
39.61	15	Jan-16	2	1	No	Dec-15
40.95	27	Jan-16	2	1	No	Dec-15
41.23	35	Jan-16	2	1	No	Dec-15
41.32	45	Jan-16	3	1	No	Dec-15
41.88	45	Jan-16	3	1	No	Dec-15
41.95	20	Jan-16	3	1	No	Dec-15
42.96	25	Feb-16	3	1	Yes	Dec-15
43.03	25	Jan-16	3	1	No	Dec-15
43.12	27.2	Jan-16	1	1	No	Dec-15
43.18	30	Jan-16	1	1	No	Unknown
43.3	30	Jan-16	3	1	No	Unknown
43.79	85	Jan-16	2	1	No	Dec-15
43.99	25	Jan-16	1	2	No	Dec-15
44.24	45	Jan-16	1	1	No	Dec-15
44.32	45	Jan-16	45	1	No	Dec-15
44.38	50	Jan-16	2	1	No	Dec-15
44.7	40	Feb-16	2	2	Yes	Dec-15
44.89	30	Jan-16	2	2	No	Dec-15
45.1	40	Jan-16	1	2	No	Dec-15

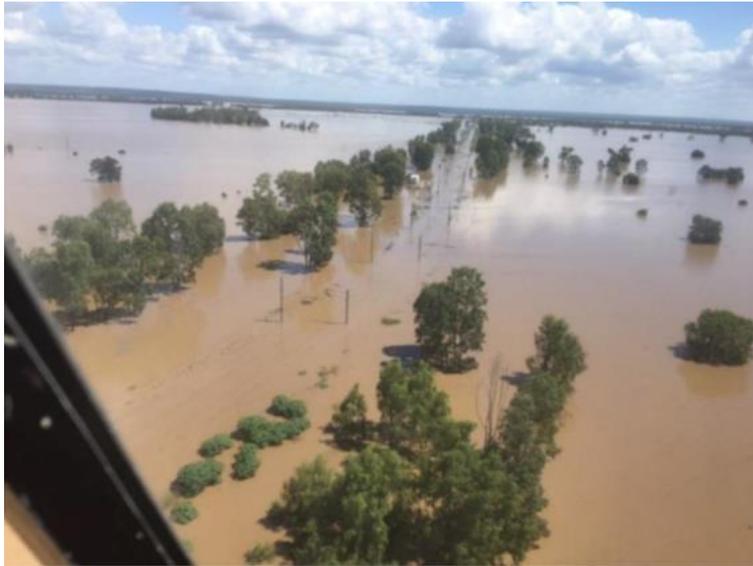
Figure 17 Flooding in the Blackwater System

The Blackwater system was significantly impacted by the heavy rainfall, flooding, wind and turbulence of cyclone Debbie. Most notably, being within a catchment area to the Fitzroy River the Blackwater system was impacted by flooding (Figure 17) and washout/scouring causing flood debris damage, signalling equipment damage and critical formation damage.

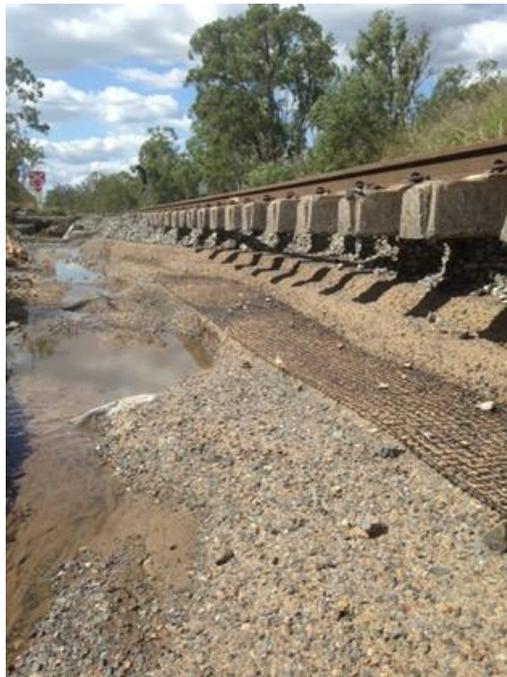
Figure 18 Moura system scours/washout

The rainfall, flooding, wind and turbulence of cyclone Debbie significantly impacted the Moura system. Due to downstream flows in creeks and gullies from foot hills of the Great Dividing Range, the Moura system was impacted by flooding with track washouts and scouring damaging ballast and track formation and access roads (Figure 18).

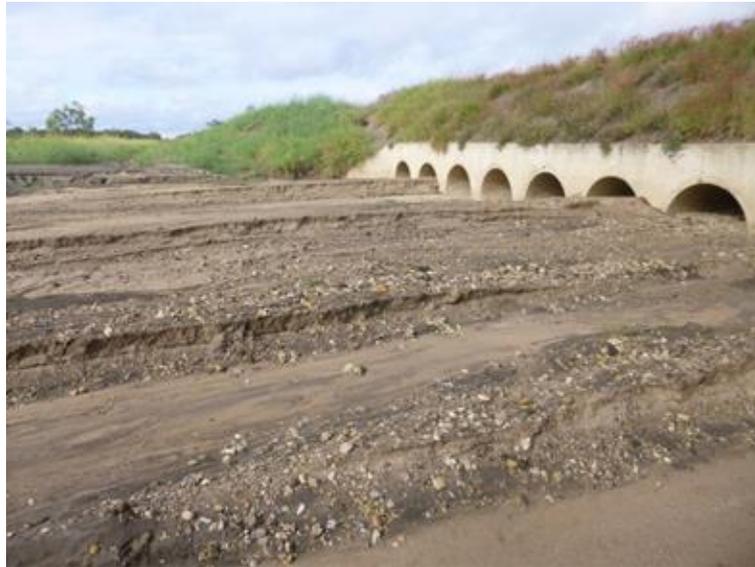
Figure 19 Pipe silting in the Newlands system

The Newlands system connects into the Abbot Point Coal Terminal, and was closed to rail traffic on 28 March 2017. Aerial inspections were conducted to assess flooding issues and damage to the rail infrastructure. The Newlands system was impacted by the rainfall, flooding, wind and turbulence of cyclone Debbie, experiencing residual flooding causing track formation damage and damage to level crossing signage, as well as silted pipes, as in Figure 19.
