GLADSTONE AREA WATER BOARD

CONDITION EVALUATION OF WATER SUPPLY & ASSOCIATED ASSETS

STAGE 1A REPORT

**ALF GRIGG
ALF GRIGG & ASSOCIATES
22nd DECEMBER, 2006**

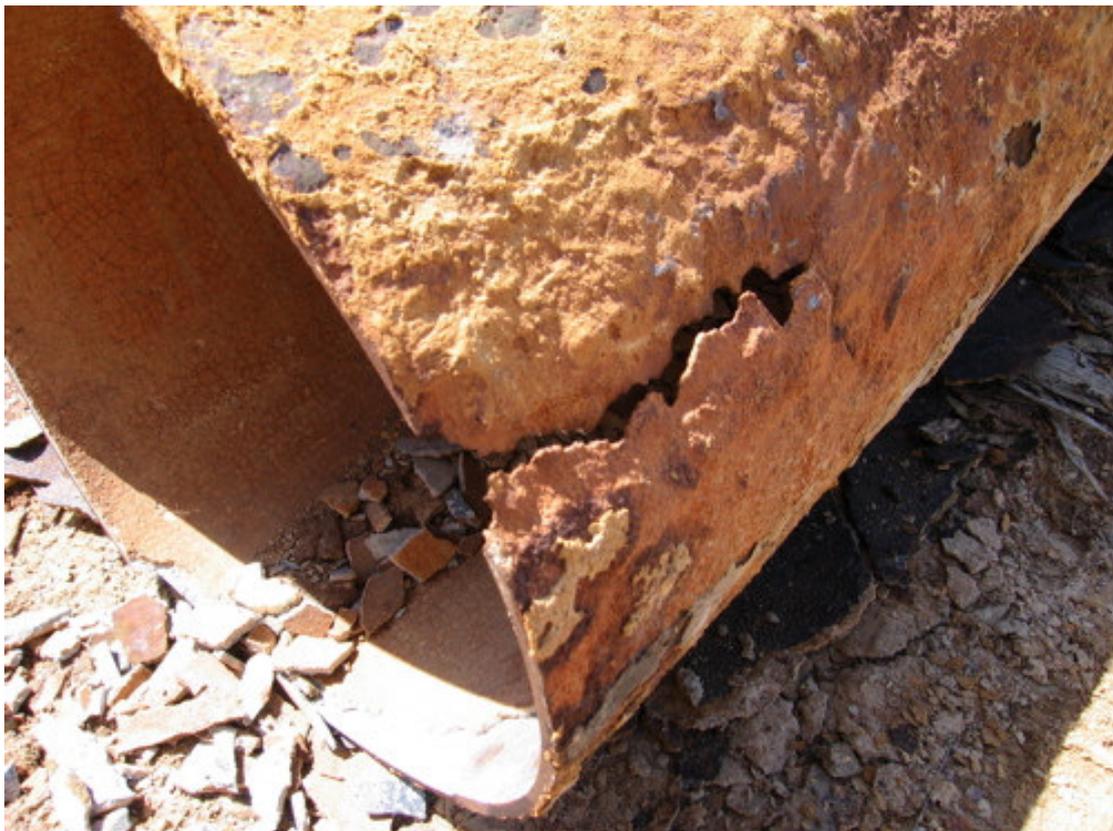
The buried 300 DI pipeline has burst at low points within 300-400 metres from the smelter boundary. The burst pipe sections remaining on site displayed extensive external corrosion with the most extreme corrosion around the bottom of the pipe. The internal pipe mortar liner was generally intact and displayed no signs of failure.

300 DI Raw Water Boyne Smelter Bottom Corrosion

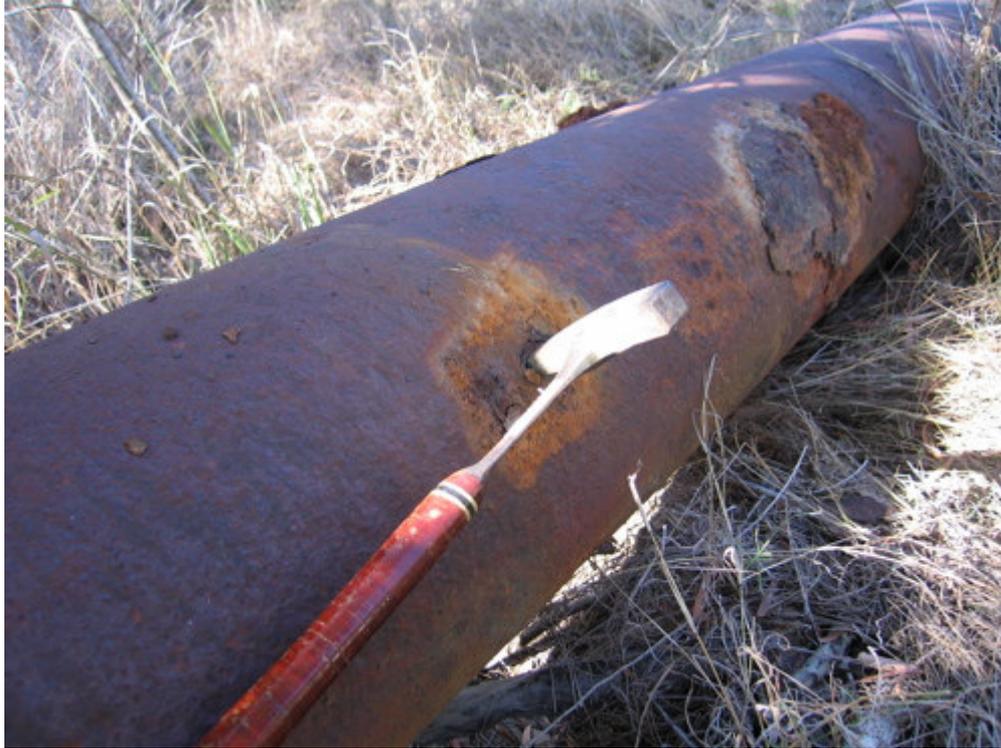
Bottom Corrosion of East End 300 DICL Treated Water

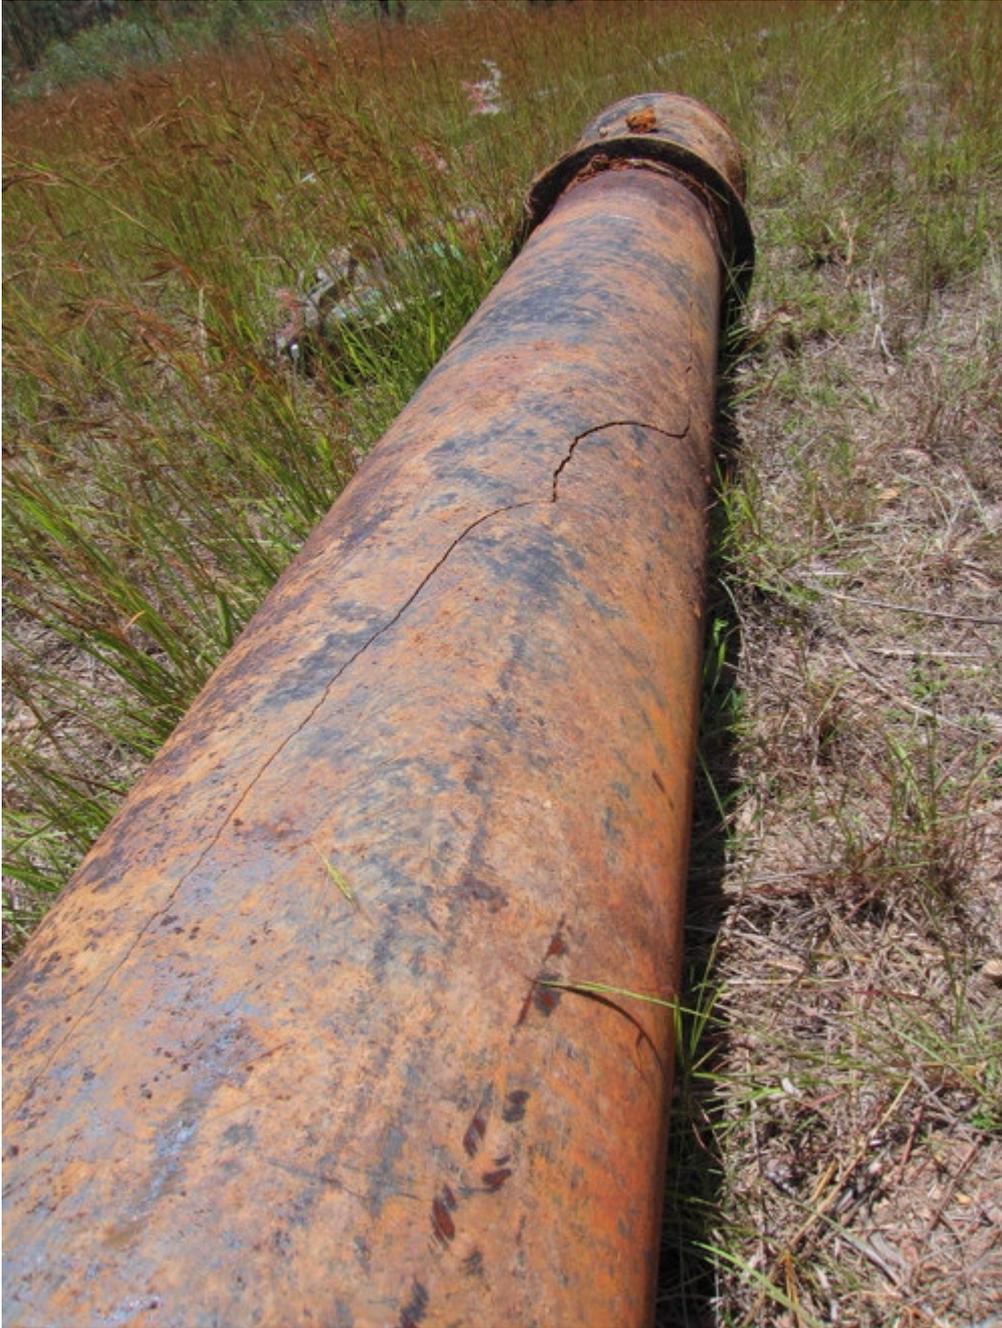
Only one failure at the air valve on the 300 CI pipeline at the ridgeline in Mann's paddock was considered a structural failure of the pipe section. This failure appeared to be a longitudinal structural failure of a visibly competent pipe with no evidence of corrosion or metal conversion processes.

Longitudinal Failure of 300 CICL Treated Water Pipeline, Manns' Ridge

- Undertake short time interval hydraulic pressure logging along those sections of the 300 CI pipeline remaining in service, analyse, graph, and report the data;
- Implement the proposed pipeline modifications to the 300 cast iron treated water pipeline to reduce the potential for, and the severity of hydraulic impact effects to minimise bursts.
