(Confidential) Worley Parsons – North Queensland Coal Systems: Site Visit Record, 18 August 2008

UT3 Parallel Active Comparison Exercise Supporting Document

Northern Queensland Coal Network Systems

Site Visit Record: May 2008

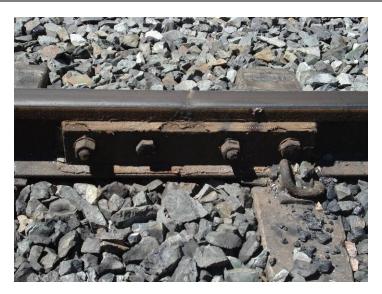
Figure 2 Coal corrodes fishplates

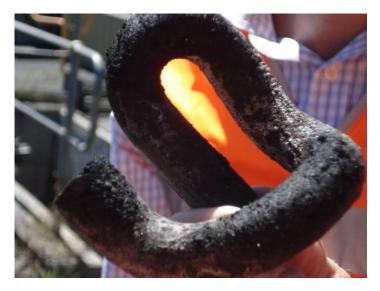
Figure 3 Coal corrodes clips

7.15 Pandrol clips corrode because of aggressive coal dust after a very short time. The normal service life of a Pandrol clips is in average on normal track 25 years (no coal). Due to corrosion the actual service life for galvanized pandrol clips lasts between 5 and 10 years.

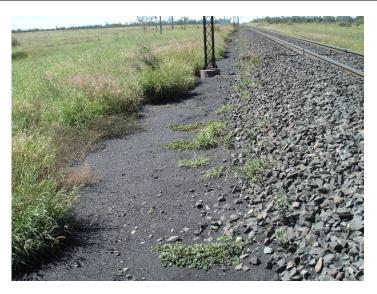
Figure 4 Coal dust contamination of track between mine and port, as can be seen this was taken at considerable distance to unloading & loading facilities

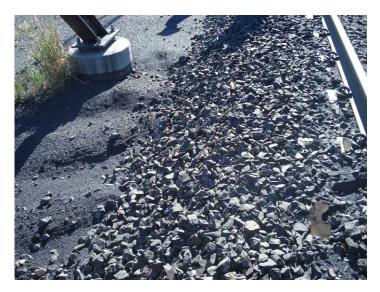
Figure 5 Coal dust contamination - Cess

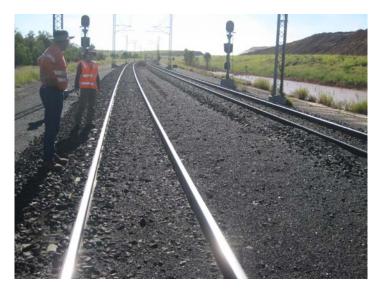
Figure 6 Coal dust contamination approaching accommodation crossing

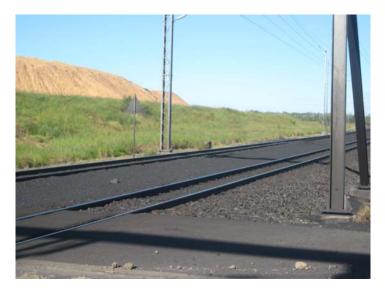
Figure 7 Coal contamination at crossing

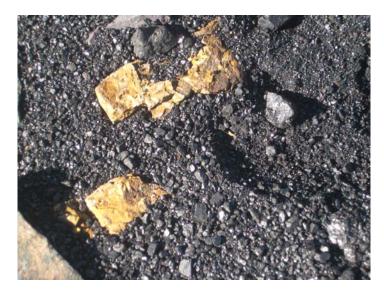
Figure 8 Coal contamination, little remains of the ballast (this location was not near unloading or loading facilities)

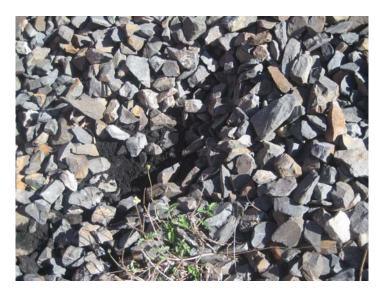
Figure 9 This ballast appears healthier but close examination reveals considerable contamination fairly low beneath surface level

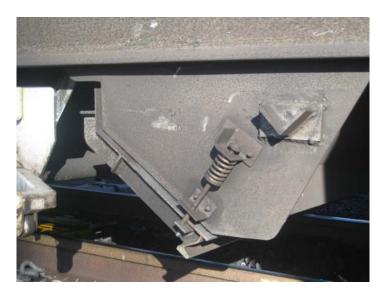
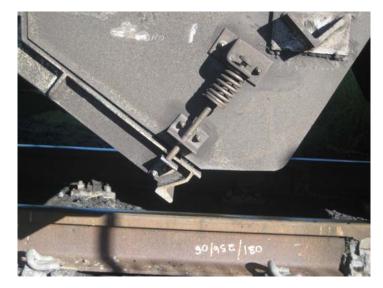
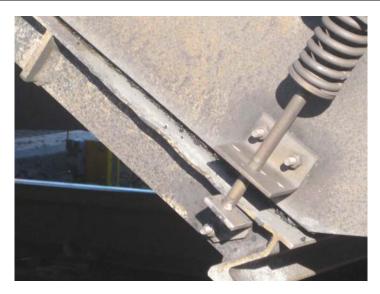
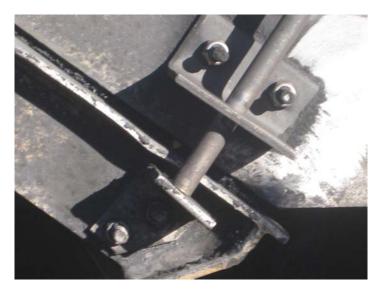
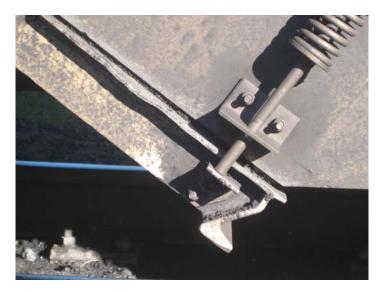
4.5 Bottom spillage may have more of a negative impact on ballast fouling, compared to blowing off the top, since the leakage is directly above and near the ballast.

Several examples of leakage from leaking bottom doors were taken. These are shown in the following pages.

> possible to see the falling specks of coal from the bottom of the wagons, as the camera used was not able to capture this. However it was fairly evident to the naked eye.

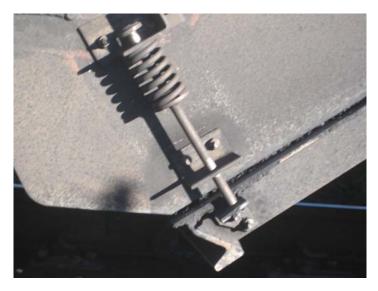
Figure 2 Wagon C, substantial fines were seen falling from these gaps which appeared to be in the range of 5-20mm

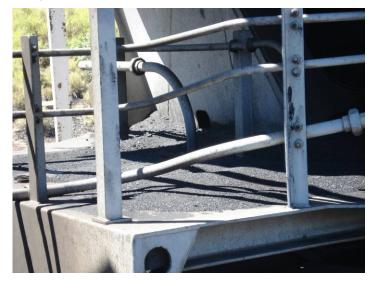
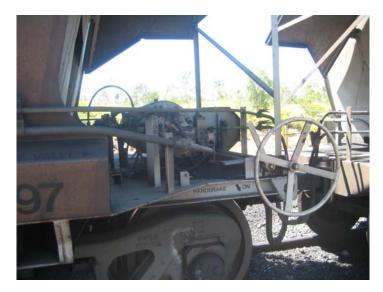
4.1 Coal spillage and blowing from wagon tops is usually due to poor loading practices. Several examples were sighted.

Figure 6 Spillage on wagon platforms can easily be blown or shaken off on route – this was commonly sighted

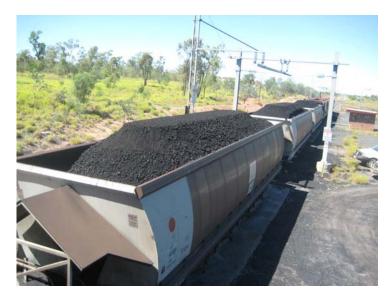
Figure 8 Coal left on edge of wagon from loading process

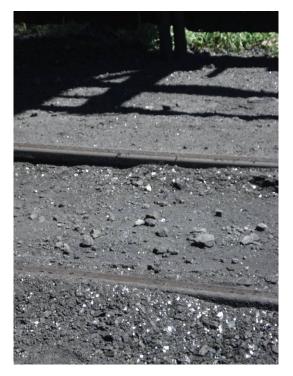
Figure 9 Coal contamination after loading zone

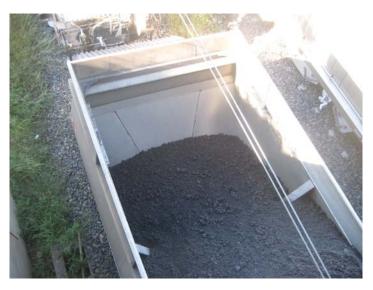
Inefficient loading operations were sighted with coal heights on top of wagons not adequately levelled, so that the back of a wagon was still empty whilst the front of the wagon was overfilled.

Figure 1 Wagons were found to be often heavily loaded at the front of the car whilst empty at the back

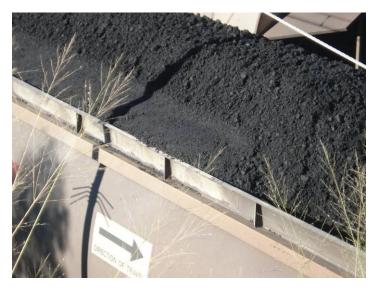
Figure 3 Some wagons were altered with an addition of a metal strip to allow additional loading capacity, as can be noted spillage is already occurring from this wagon

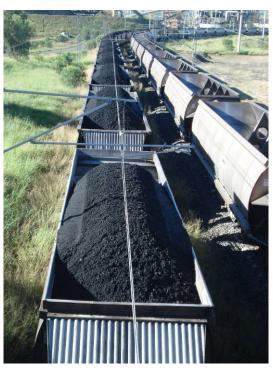
Figure 4 Wagon overloaded spillage occurring

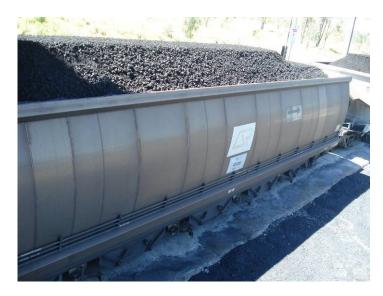
Figure 5 Further example of highly loaded wagons leaving the loading facilities

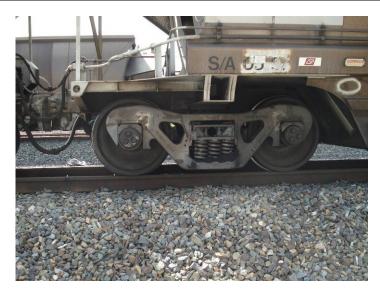
Figure 6 Coal dust on wheel set springs after loading process

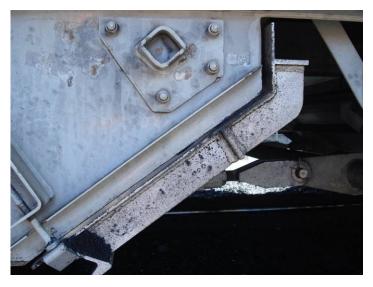
Figure 9 Gap and residual fines left on the bottom of wagon on completion of unloading process

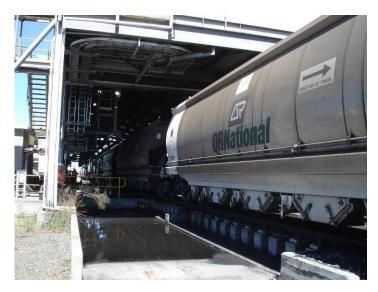
> Improvements were sighted in unloading facility design in the new unloading facility sited at Gladstone. This consisted of the construction of slab track immediately after the unloading process. The slab track facilitated cleaning of the immediate track directly after the unloading process hence reducing the cost of maintenance for this section of track

Figure 10 Slab track facilitates cleaning of spillage after unloading processes

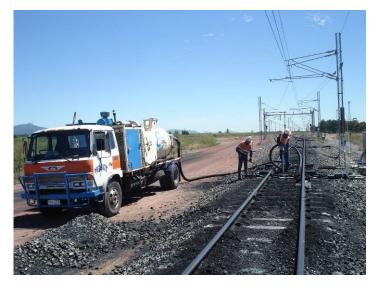
6.3 Due to intensive coal spillage and subsequent potential failure, it is necessary to vacuum turnouts periodically. Such maintenance is critical to maintain operations and minimise risk of failure of the turnout mechanism and signal operation.
