2015 Review Event - Moura Floods - Supplementary Report

Queensland Competition Authority

RO037900/RPT/003 | 0

Project No: RO037900
Document Title: Analysis of Aurizon Network's 2015 Review Event submission
Revision: 0
Date: 28 November 2016
Client Name: Queensland Competition Authority
Client No: 1-12-22y / QCA3908

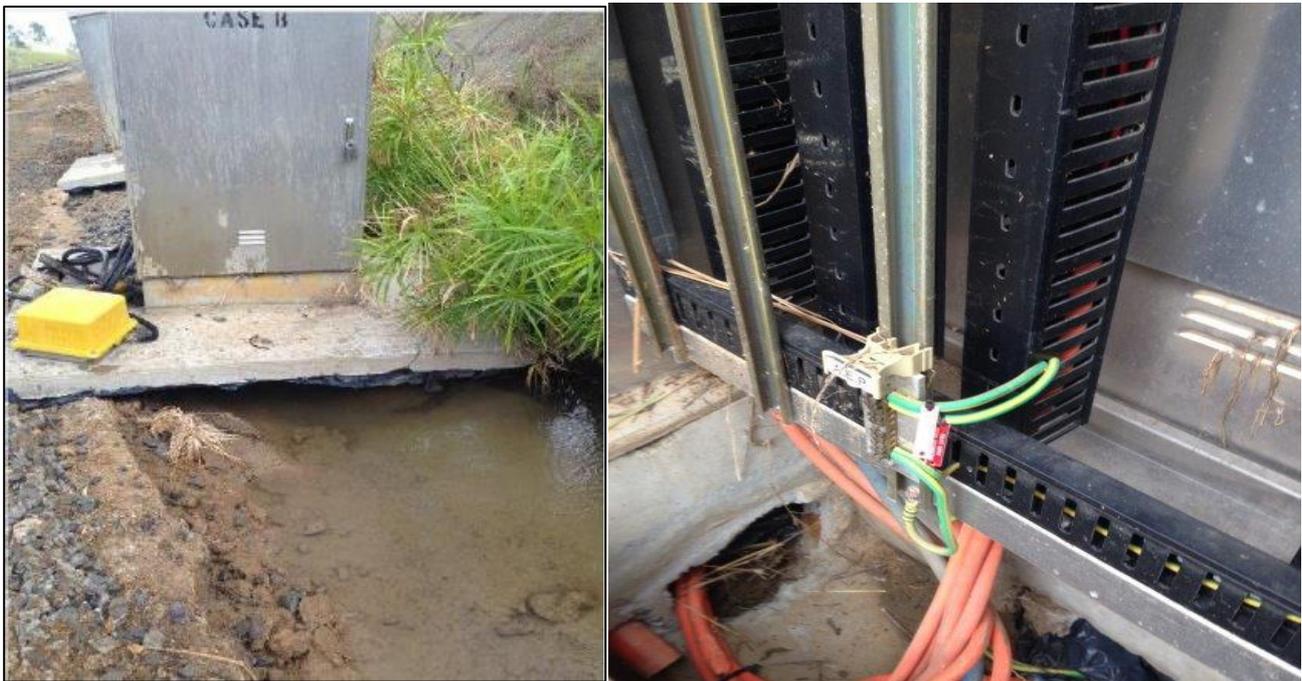
Figure 1 shows the damage that the flood caused to the area around one of Aurizon Network's signalling cabinets. It shows that the concrete slab on which the cabinet sits was damaged, and that the earthworks supporting the slab were washed out. It also shows that water and debris entered the signalling cabinet.

Figure 1: Damage to one of the signalling cabinets and the surrounding area at Mount Rainbow

We consider the flood did trigger the need for Aurizon Network to address the signalling-cabinet issues. Reinstating the earthworks and replacing the concrete slabs were necessary to remedy the defect, and the repair of the cabinet itself was necessary.

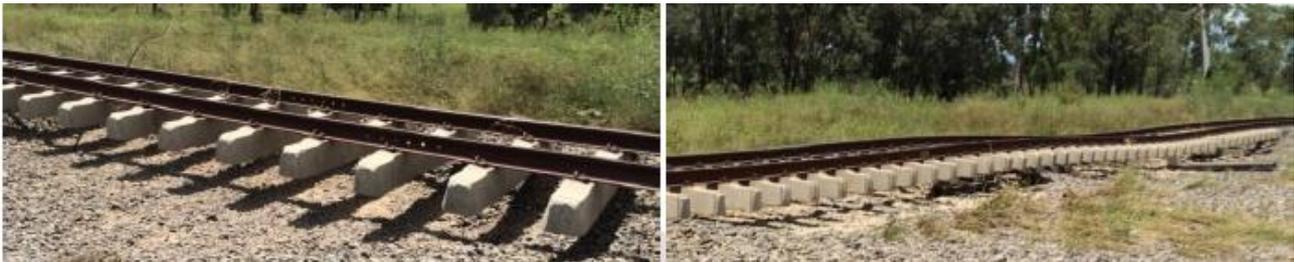
Figure 3: MSL-66 - ballast washout and formation loss between Earlsfield and Dakenba

The flood washed significant amount of ballast and formation away. The repairs were needed to reinstate the track in its former condition. Arguably, the overall standard of the track would have been higher after the repair because the ballast had been replaced. The same can be said about the formation reconstruction that accompanied the ballast replacement. However, given these activities would have been required at a minimum
