Review of Aurizon Network Review Event 2017 Submission

Tropical Cyclone Debbie

Client: Queensland Competition Authority

AECOM Australia Pty Ltd

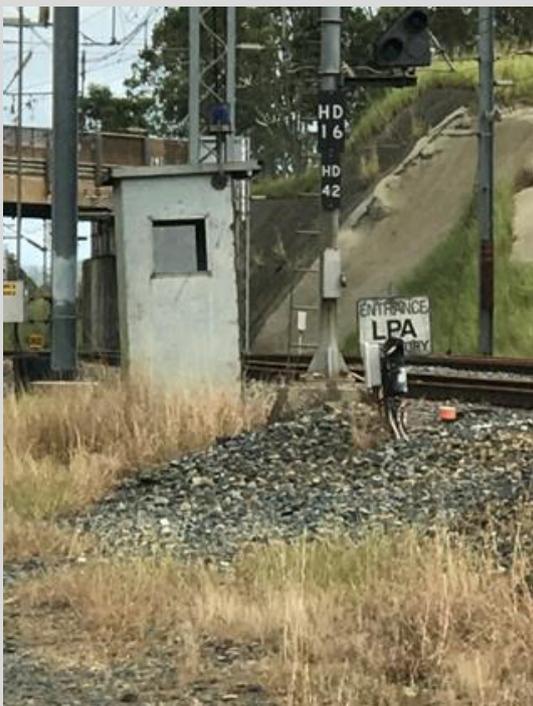
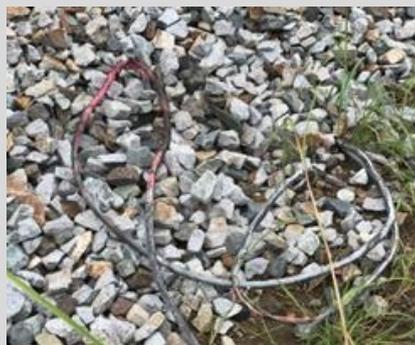
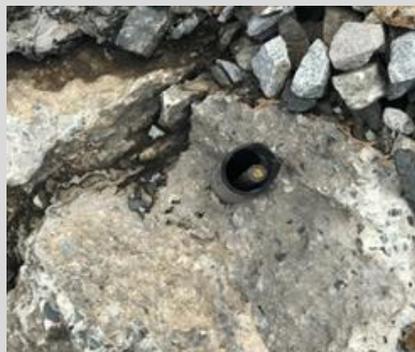
Whilst mostly intact, Copper Cable has isolated damage in a small number of locations. These areas were tested and if required the copper cable replaced and re tested.

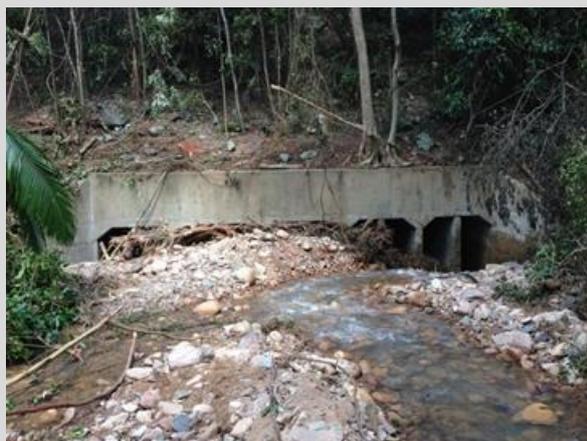
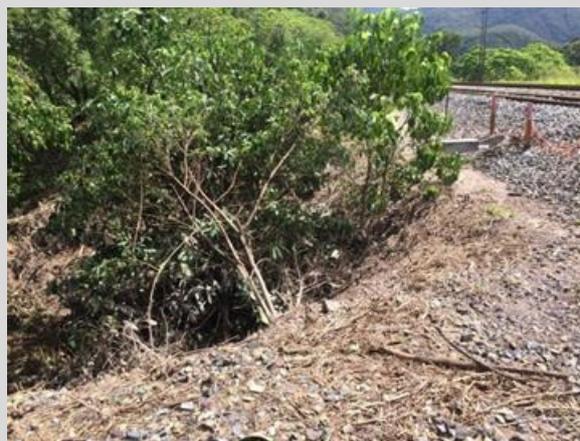
These included general rail corridor works to remove flood debris, which were undertaken at affected locations in response to the obstructions. Following work, the degree of damage was revised to category 3, rendering the section of track suitable for revenue services.

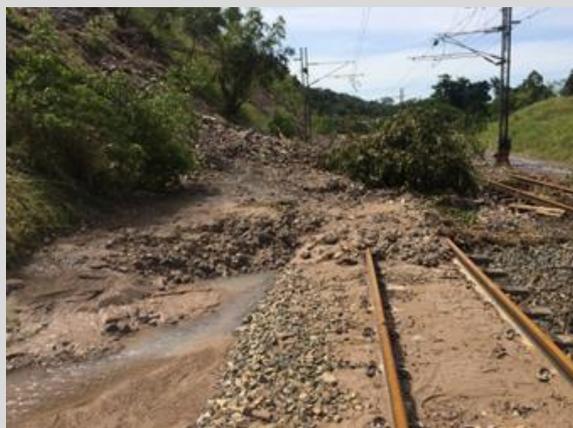
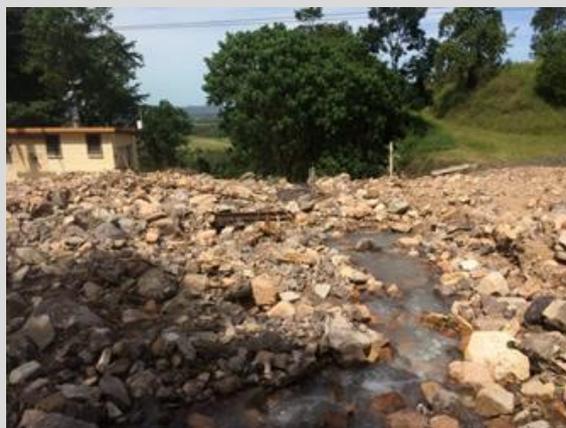
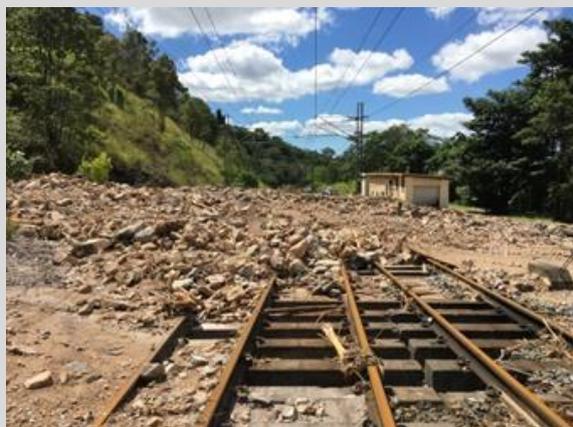
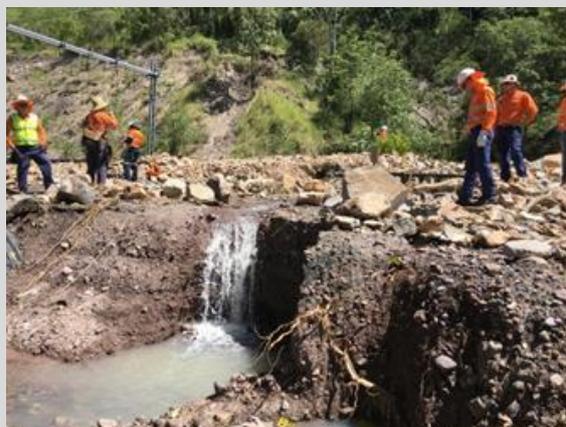
General rail corridor works to remove slip debris from UP road, DN road and turnouts, cess, culverts and access road, repair culvert structures, earthworks (cess and culvert clean, restoration of drainage, repair embankment erosion and access road) and track works (undercutting of ballast due to scouring, inspection of formation for damage) were undertaken in response to damage caused by the multiple landslips. The undertaken works restored track capacity to operate with uninhibited traffic flow.

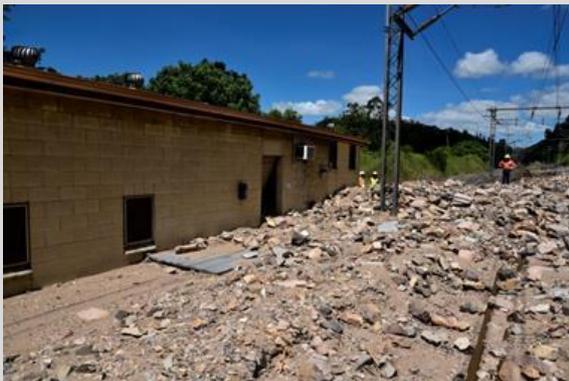
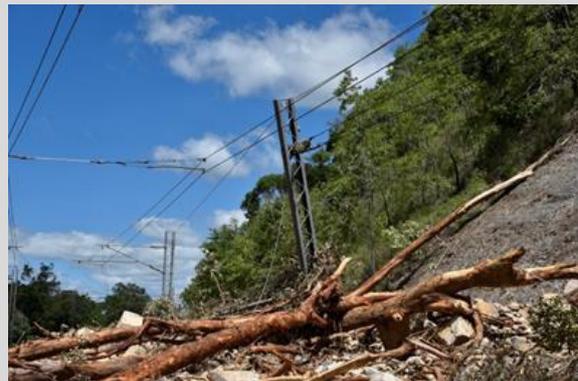
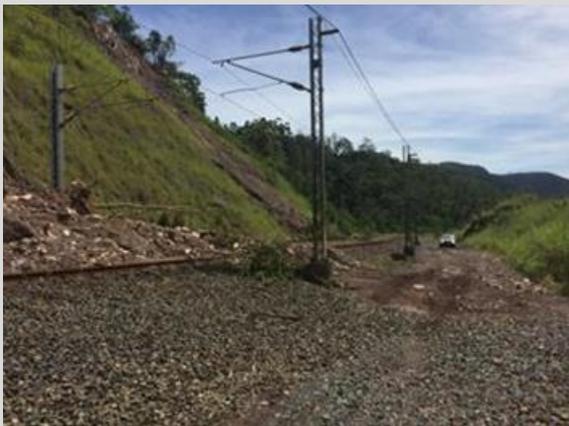
- Damaged structures and grading rings have been replaced.
- Asset Renewals as per the Infrastructure Delivery - Construction Program - QA Summary - Black Mountain Recovery - April 2017 Report provides details of the works carried out on a number of OHLE structures. The report has identified some of the works as 'Flood Recovery' and other works as 'Asset Renewals.' The reason being that works completed as asset renewals were completed in the down time between recovery works and charged to the Capital Asset Renewals budget.
- Two spans of OPGW replacement has been carried out between structure GA/35/449/U and GA/49/707/U.
- Six spans of feeder wire were replaced at 42.502km.
- Small sections of CAT/CON were replaced and repairs carried out.

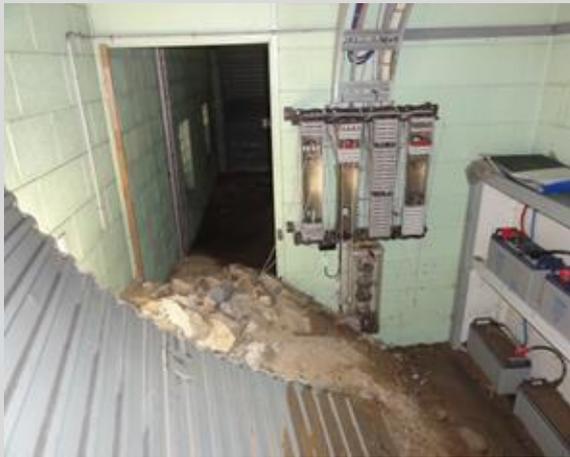
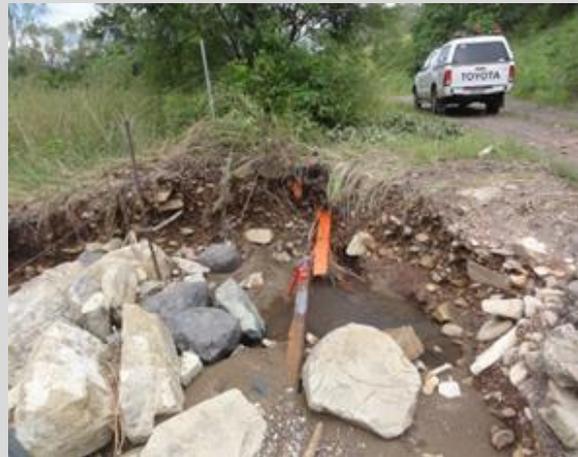
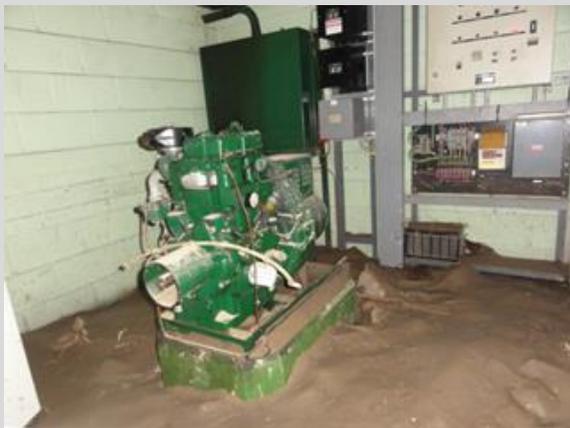
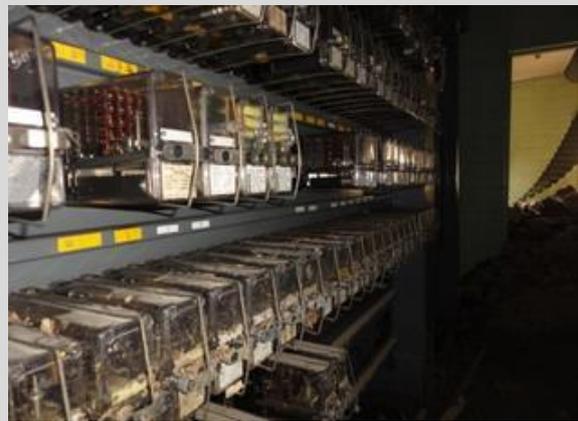
In response to the landslip debris was removed from the SER/CER/PER and from 12 Crossover. The existing SER/CER/PER was retained as only minor structural damage was incurred. Damaged relay components were replaced, whilst the existing relay interlocking and current alternator / controller arrangement were retained. UTC operation of 12 Crossover was not to be provided as part of these works. 8 Crossover was commissioned with full UTC operation. Following work, the degree of damage was revised to category 3.

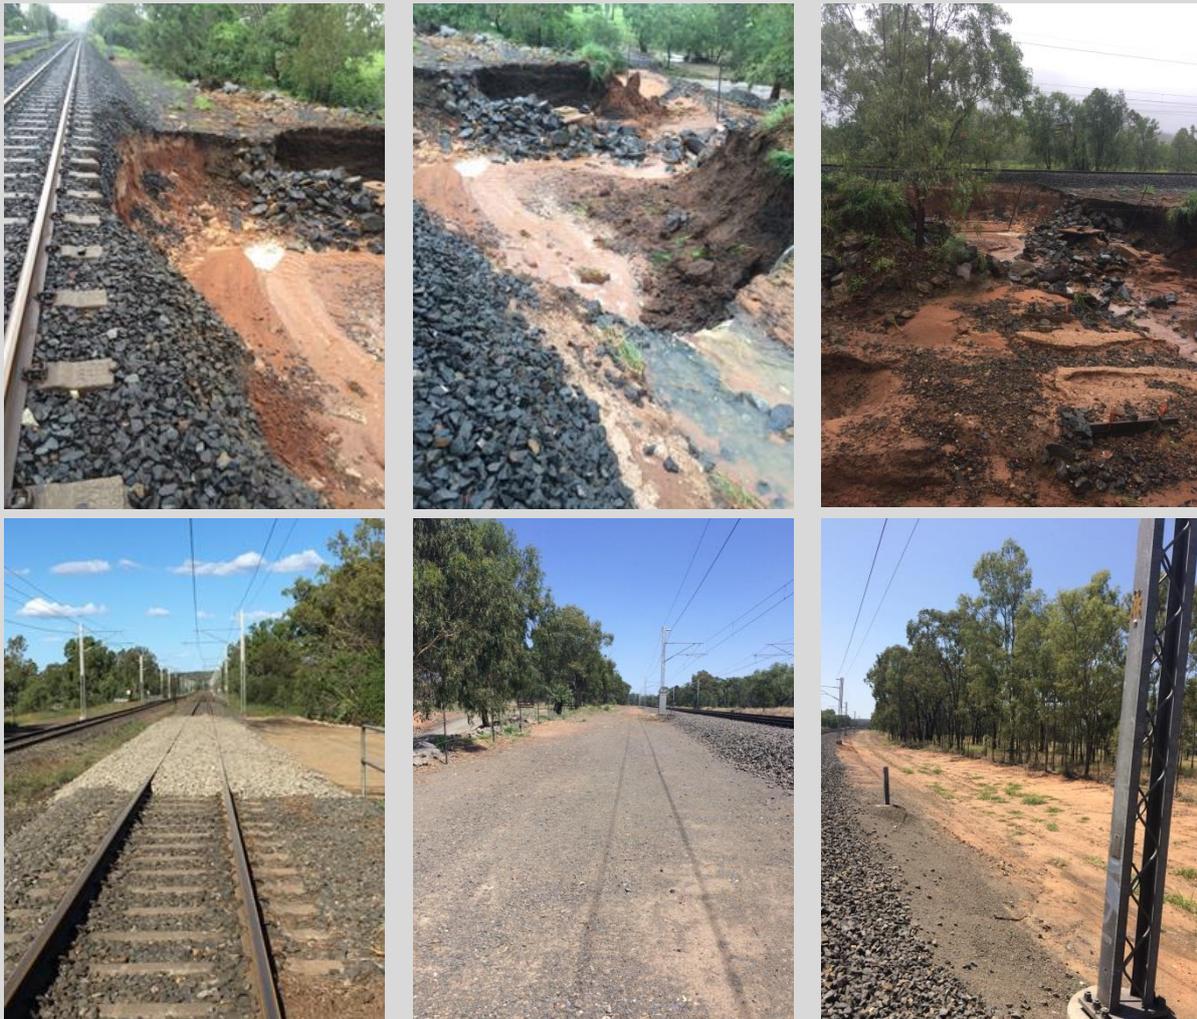
General rail corridor works to clean flood debris, earthworks (embankment & cutting scour repairs, flood-rock/gabion replacement, flood damaged formation) and track works (final track inspection, rail stress, resurfacing & dynamic stabiliser, track slewing, welding and clipping) were undertaken in response to the scouring failure, to restore rail traffic capacity. The undertaken works restored track capacity for uninhibited traffic flow.

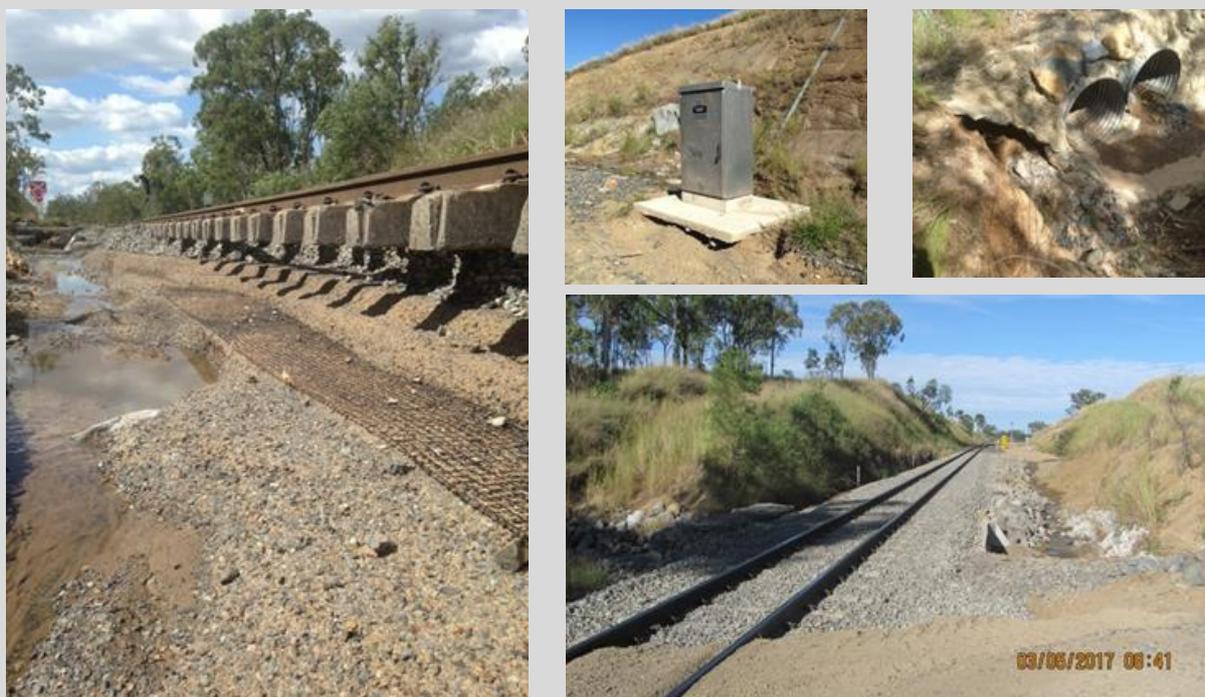
General rail corridor works (debris removal, site clean-up), earthworks (access road and cess drain reconstruction, flood-rock/gabion replacement, flood damaged formation) and track works (flood damaged ballast profile, final track inspection, level crossing reconstruction, rail stress, resurfacing & dynamic stabiliser, track slewing, welding and clipping up) were undertaken in response to this event. Following work, the degree of damage was revised to category 3.

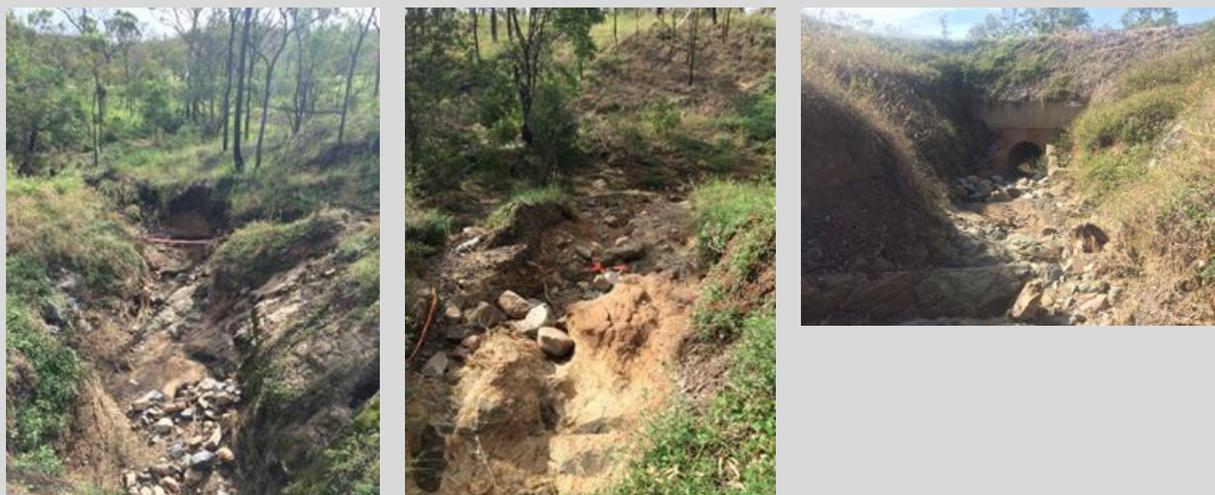
The scope of work involved debris removal, site clean-up, slip void backfill with gabion rock, re-establishing cess drain, re-grading and re-compacting road. The undertaken works restored operation of the access road.

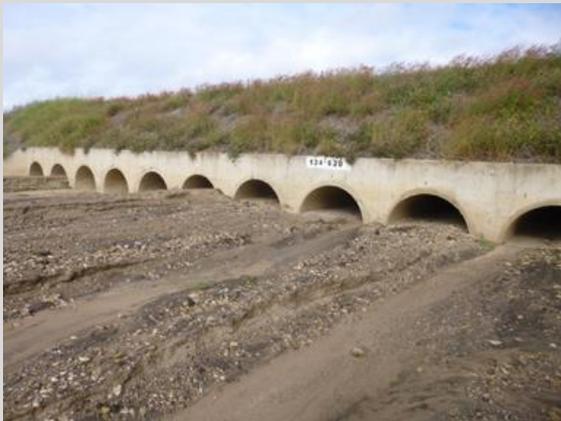
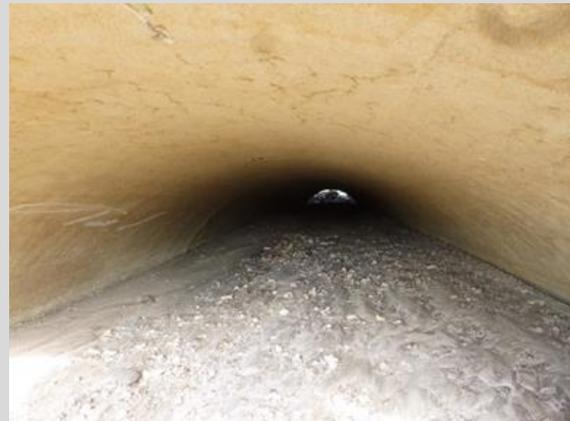
Flooding and storm debris led to damage to off-road pipes on the Abbot Point - Newlands track section of the CQCN Network. Storm debris caused pipe inlets and outlets to become silted. The damage was located at 134.630 km. This is an off-road asset, and the damage was not prohibitive to rail traffic movements (category 3). The scope of work in response to damages involved inlet and outlet siltation and debris removal.

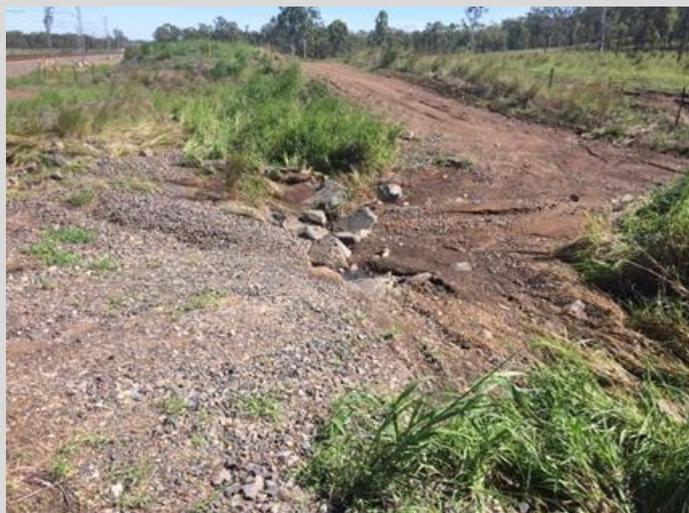
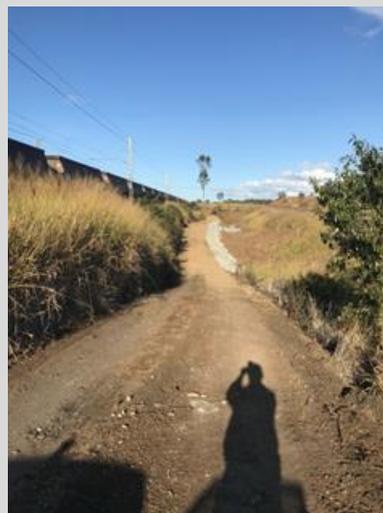
Scope of works involved placement of 150mm rock at scour points followed by ballast and road base. The undertaken works restored operation of the access road.

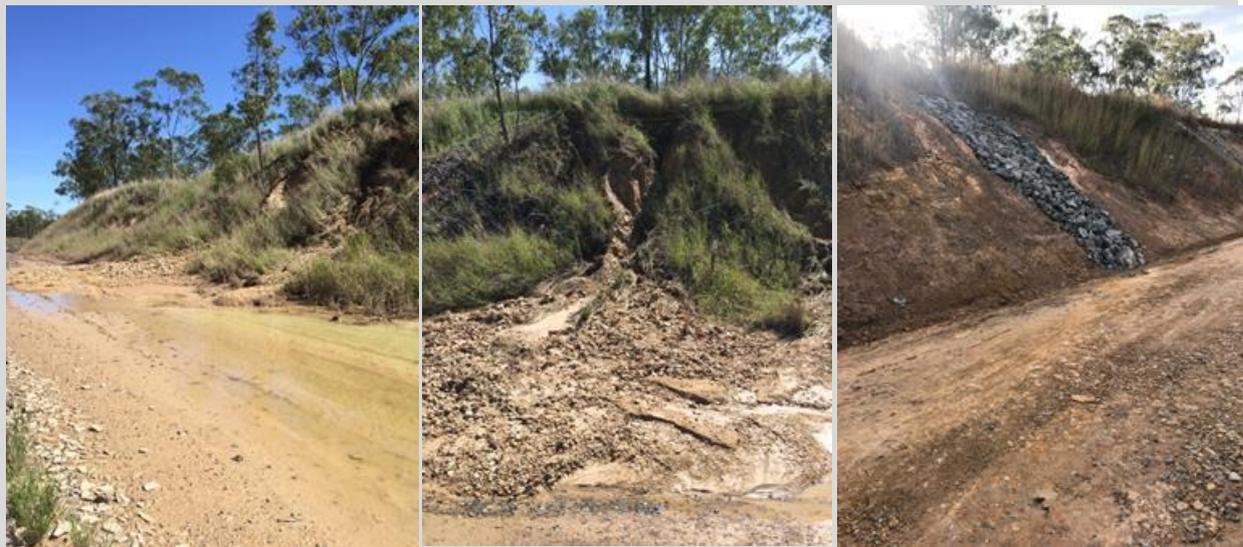
The scope of work undertaken in response slip involved debris removal, site clean-up, slip void backfill with gabion rock, re-establishing cess drain, re-grading and re-compacting road. The undertaken works restored operation of the access road.
