(Confidential) Worley Parsons – North Queensland Coal Systems: Site Visit Record, 18 August 2008

UT3 Parallel Active Comparison Exercise Supporting Document

Northern Queensland Coal Network Systems

Site Visit Record: May 2008

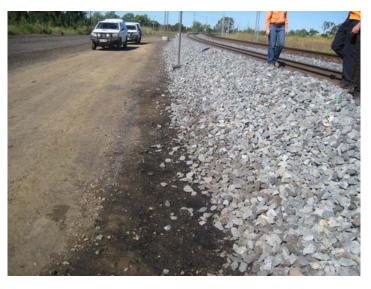
Figure 10 In contrast, ballast from newly ballast cleaned site

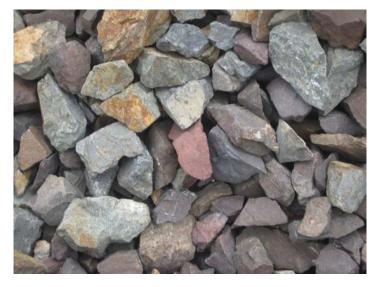
Figure 11 In contrast clean ballast

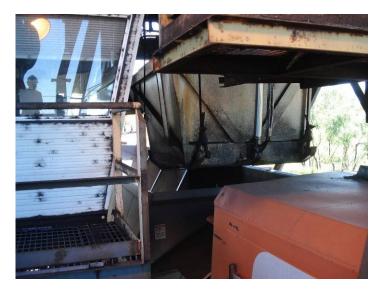
During loading procedures, if coal is overloaded, even those wagons with cowls/raves that are intended to reduce spillage from within the wagon will cause problems if coal is spilt onto the top of the raves. This coal can easily slide or be blown off when the train gathers sufficient speed.

Figure 2 Loading process

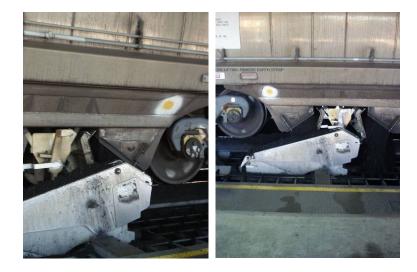
5.2 The unloading process was observed at Gladstone. The system is mechanised, where bottom doors are automatically opened when rolls touch a fixed unloading blank sheet. After unloading, the bottom doors close automatically through pressure of a bottom door spring.

Figure 7 Unloading with mechanical barrier

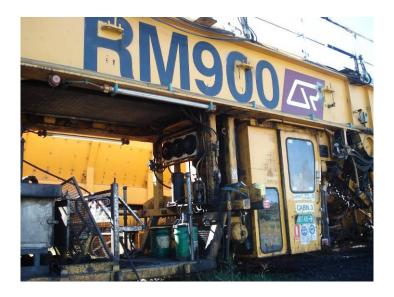
6.1 The ballast cleaning machine shown in Figure 34 is currently the only ballast cleaning machine owned by QR. To maximise efficiency the machine has been upgraded and modified several times. However, due to limited capacity for attached ballast wagons the machine's performance is limited.

The machine works by scooping up the 'dirty ballast' and screening it to remove fines and other contaminates. Reusable ballast is returned to the track, whilst the contaminated ballast is removed.

Figure 11 The machine has a ballast cleaning capacity of 900m3 per shift

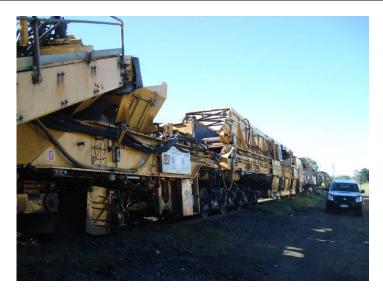
Figure 12 Hauling six ballast wagons; the total length of the machine is 1500m

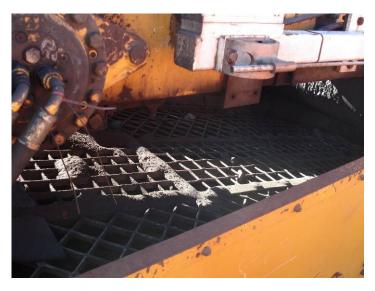
Figure 13 Screen for separating the fine parts and damaged ballast from reusable ballast

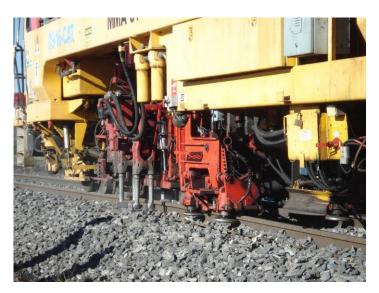
6.2 Tamping measurements have shown for QR that a two-tamping hammer machine is the most efficient in quality.

Figure 14 Tamping machine at work
