**Annex AC**

**[REDACTED] Aurizon Network – Ballast Fouling,  
4 March 2013**

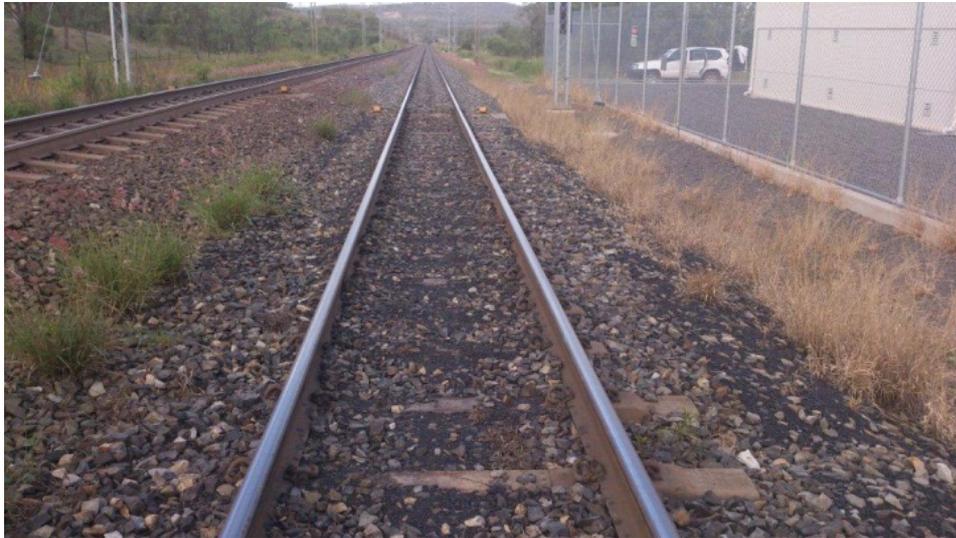
Figure 3 shows an example of the network where ballast has been contaminated with coal spillage.

**Figure 3: Ballast contaminated with coal spillage**

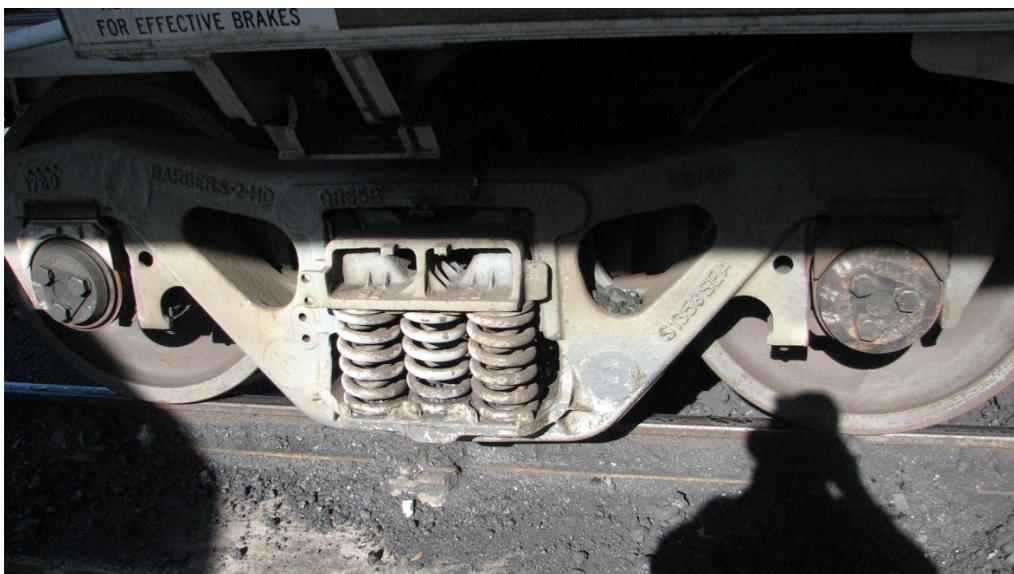
Figures 4 and 5 shows evidence of the build up of parasitic coal on a wheel bogie and on a wagon.

**Figure 4: Example of parasitic coal on a wheel bogie**

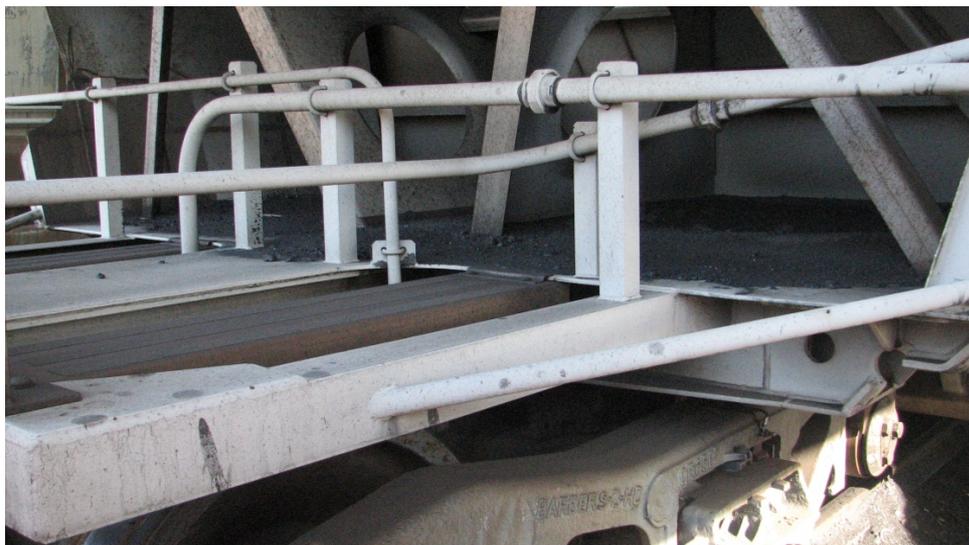
**Figure 5: Example of parasitic coal on a wagon**
