# Rural Irrigation Capital Expenditure Review

Sunwater

Client: Queensland Competition Authority

**AECOM Australia Pty Ltd**

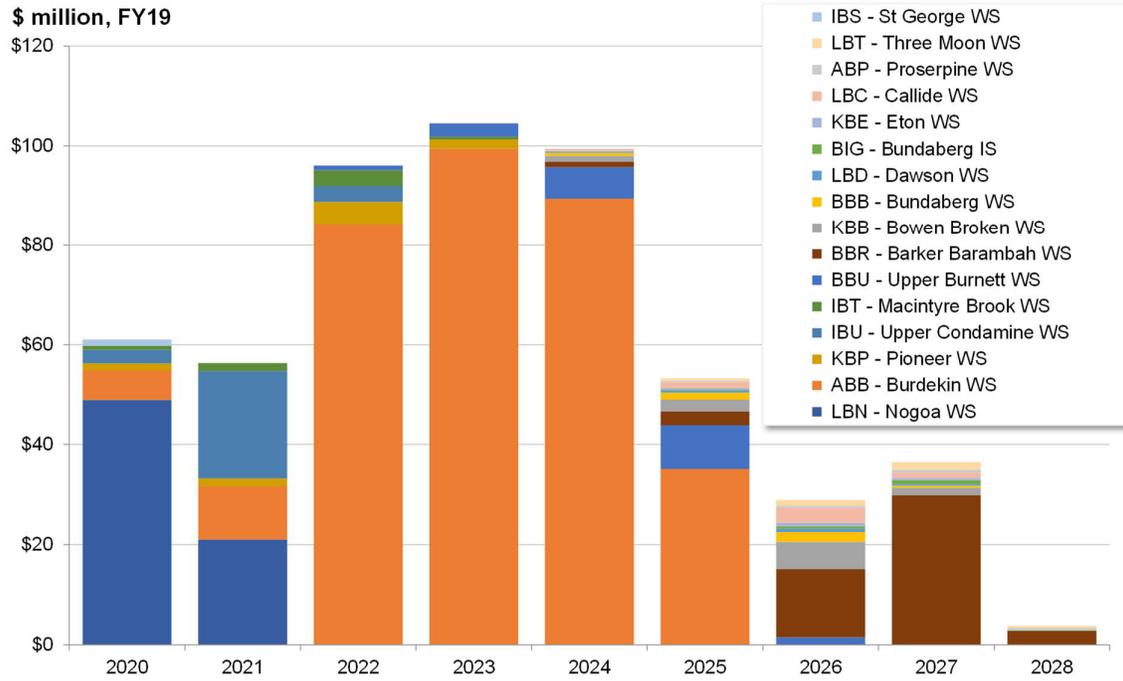
Figure 4 Dam Safety Improvement Upgrade Works by Scheme, FY20-FY28 (\$ million, FY19)

Dam safety upgrade works for regulated schemes amount to \$540.8 million (in \$FY19 terms) over the FY20 to FY28 period. As presented in Figure 4, the two most significant schemes by project value are Burdekin WS and Nogoia WS.

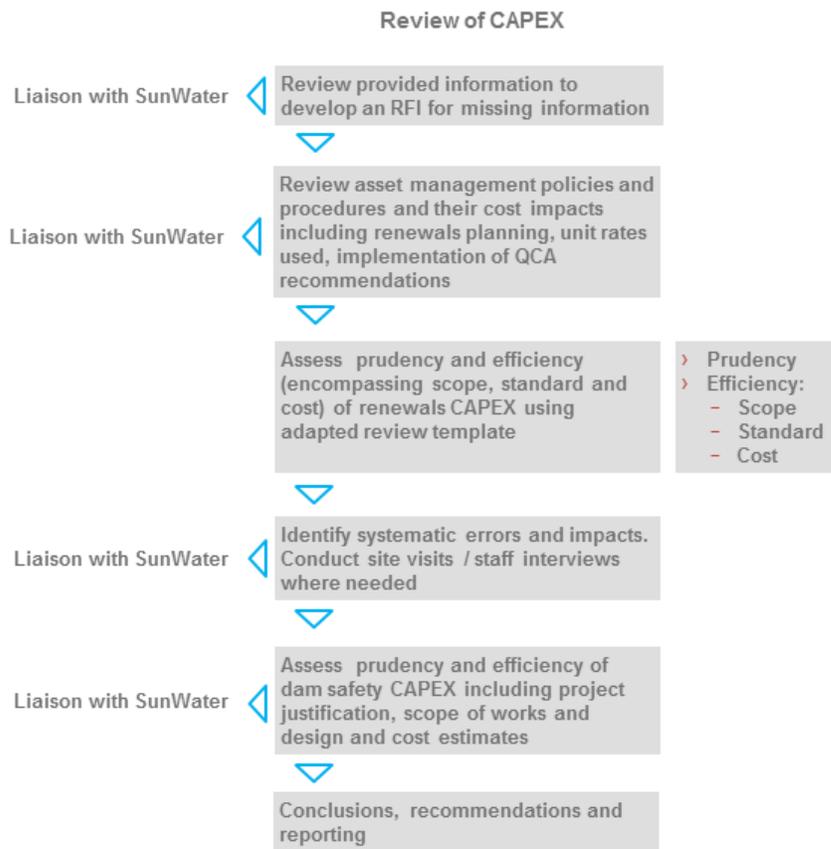
Figure 5 Outline of Methodology

The selected sample of projects was evaluated using the methodology summarised in Figure 5.

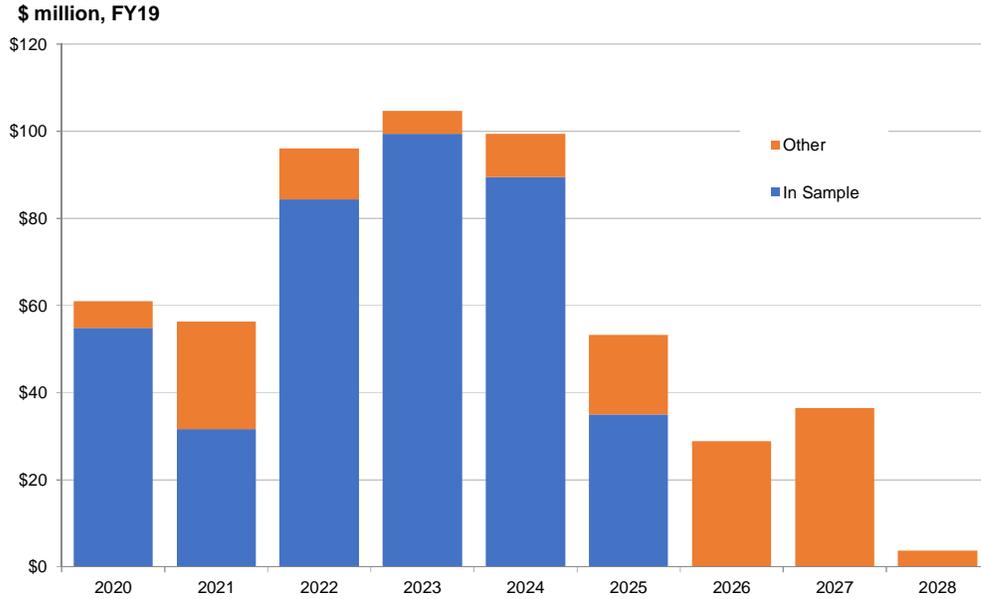
Figure 13 Dam Safety Upgrade Projects, FY20-FY28 (\$ millions, FY19)

Dam safety improvement works occurring in regulated schemes over the FY2020 to FY2028 period amounts to \$540.8 million, as presented in Figure 13. Two sample projects have been selected for review based on materiality, which amount to 73% of dam upgrade works over the period by value.

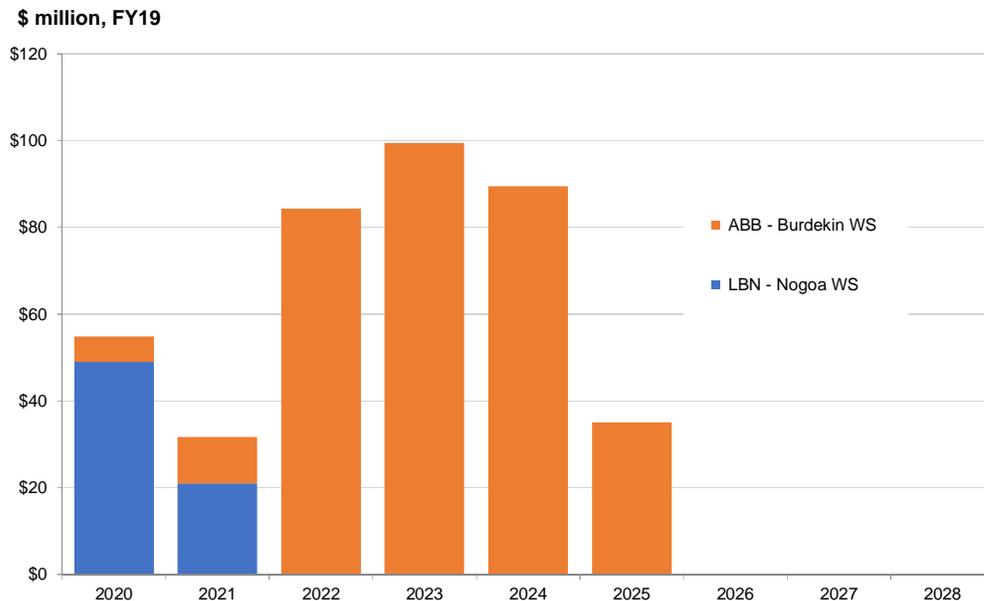
Figure 14 Dam Safety Upgrade Sample Profile (\$ millions, FY19)

Burdekin (Burdekin WS) and Fairbairn (Nogoa WS) dam upgrade works are outlined separately in Figure 14.

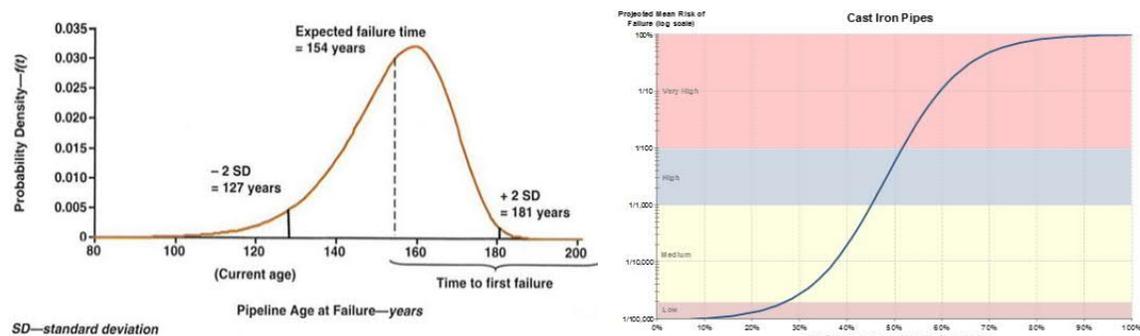
**Figure 15 Failure Distribution and Risk of Failure of Cast Iron Pipes**

An example of the risk-based approach is shown in Figure 15, which presents a typical failure curve for cast iron pipes based primarily on history. It should be noted that:

- The life expectancy for the asset class is set at 154 years, which is the median (the age at which 50% of the class is considered to have failed)
- The asset manager uses two standard deviations (in advance of the median) to define the end of life for critical assets, which in this case is 127 years (implying a maximum acceptable risk of failure in this case of approximately 5 in 1000)

Service life and the rate of deterioration (increase in the risk of failure) typically varies considerably site to site, and curves derived from experience elsewhere are only indicative – there is no substitute for local experience. In the absence of useful local experience, however, the failure curve is often assumed initially to be a normal distribution, and procedures are put in place to revise that assumption based on experience.

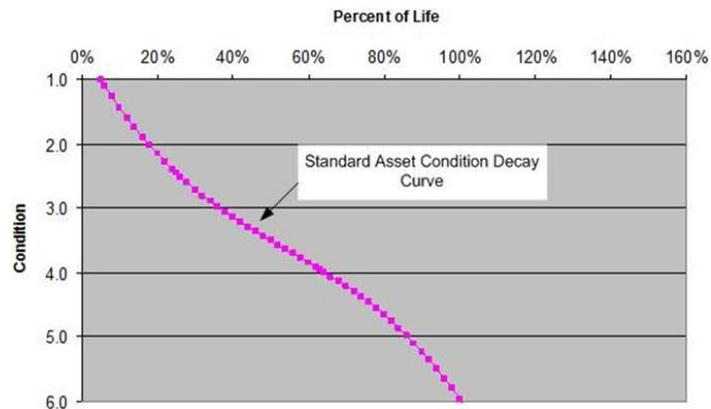
Figure 16 Sunwater's 'Standard' Decay Curve

The methodology includes reference to a 'standard asset condition decay curve' (as shown in Figure 16), for which a formula is provided (with a note to the effect that it was developed in 2006). In 2011, SKM recommended that Sunwater adopt decay curves for different asset types, instead of a standard decay curve.<sup>13</sup>

The paper notes that Sunwater, presumably in FY10-FY11, intended to undertake a detailed analysis of historic condition and maintenance data to develop a family of standardised decay curves for different classes in recognition that different asset types decay in different ways (Section 4.1.3).

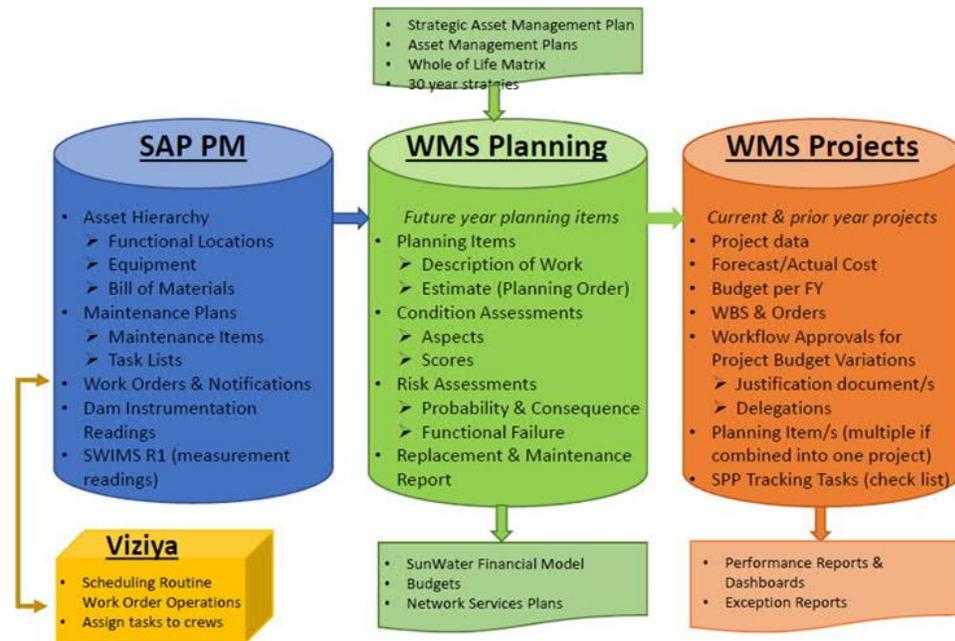
Figure 17 Sunwater's Asset Management Systems

Sunwater uses SAP PM to manage its asset register and to maintain its work management system and has recently introduced Viziya to optimise work schedules. Whole of life asset management planning is carried out using WMS, a SAP module (Figure 17). A GIS system is used to provide a spatial record.

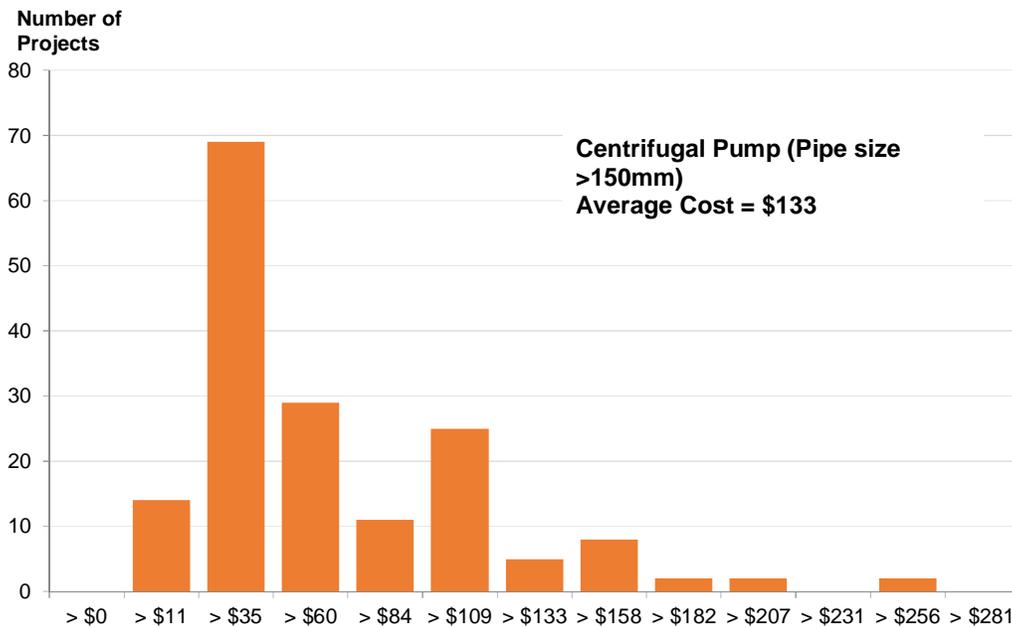
Figure 27 Variability in Cost Estimates (\$'000s, FY19)

Review of the cost estimates recorded for projects that appear to be similar shows considerable variation in cost estimates (refer to Figure 27 as an example). This suggests that Sunwater's procedures are not being followed consistently.

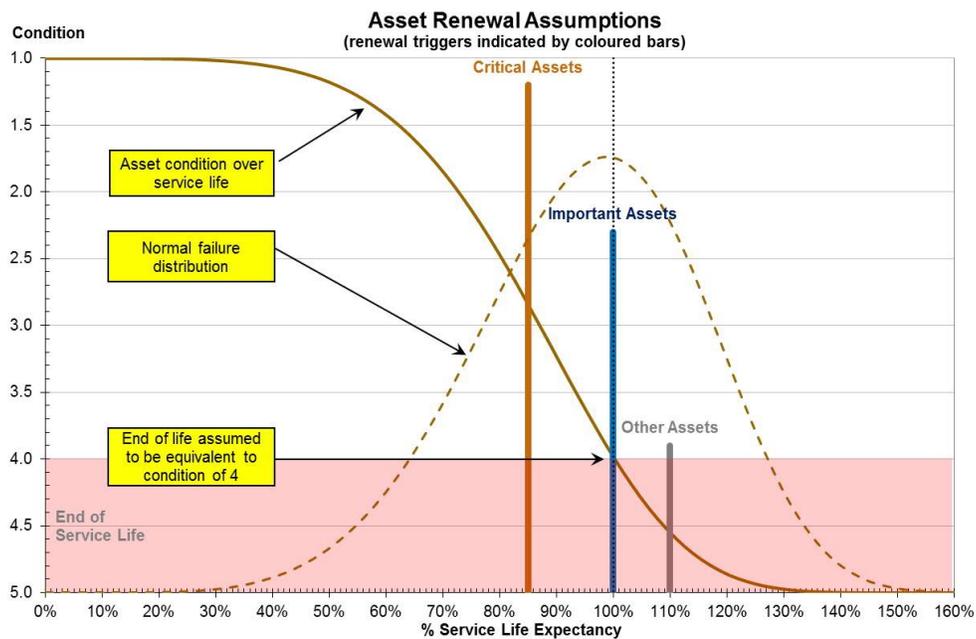
Figure 28 Example of Weibull Curve Equivalent to a Normal Distribution of Failure

End of life is generally defined as the point in the lifecycle where the risk of failure becomes unacceptable (the assets can generally be used after that time, but service interruption will become more severe and maintenance costs will usually be significantly higher). Critical assets are held to a lower tolerance of risk, as indicated by the first vertical line in Figure 28.

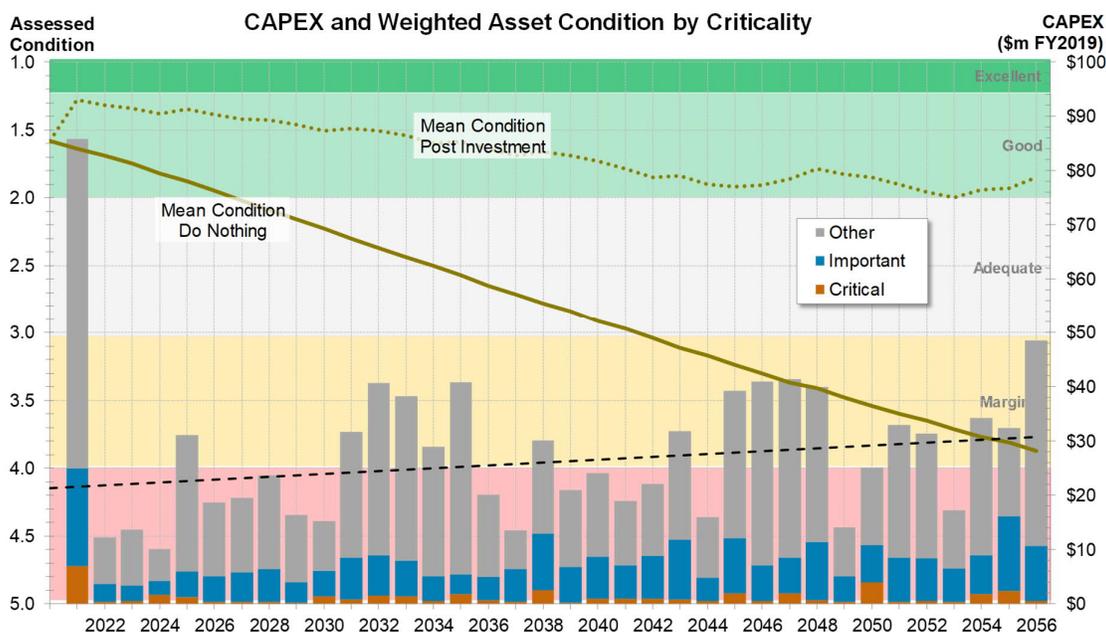
The result of copying Sunwater’s annuity program data into an AECOM asset investment planning model which use a Weibull curve as the basis for developing lifecycle costs is shown in Figure 29. The figure shows the investment required each year (in current dollars) aggregated by asset criticality, and shows:

- a solid brown line that indicates the weighted asset condition (for all assets in the submission scheduled for renewal, weighted using replacement value) assuming that no investment takes place
- a dotted brown line that shows the weighted asset condition after the scheduled investment (renewal). This line indicates a higher mean asset condition, because deteriorated assets are replaced with new assets.

The range of asset condition between the ratings of 2 and 3 is often referred to as the ‘State of Good Repair’, and generally infrastructure maintainers are advised that it is prudent and most cost-effective to maintain their assets in that range (allowing the weighted average condition to deteriorate below the rating of 3 on this scale increases the risk of failure, and allowing it to improve past 2 is generally a more expensive option than necessary (noting that the rating of 4 is defined as ‘end-of-life’, where the risk of failure is no longer acceptable).

The dotted black line is a trend line of annual investment needed. It increases because higher value assets with longer service lives fall due for renewal later in the planning period.

The renewal program as configured in this model, which applies Sunwater’s renewal strategies, would typically keep the weighted asset condition above the State of Good Repair range, suggesting that the condition of assets is being maintained at too high a level using Sunwater’s existing strategies.

Figure 29 Sunwater’s Annuity Program Developed Using an AECOM Model, Presented by Asset Criticality

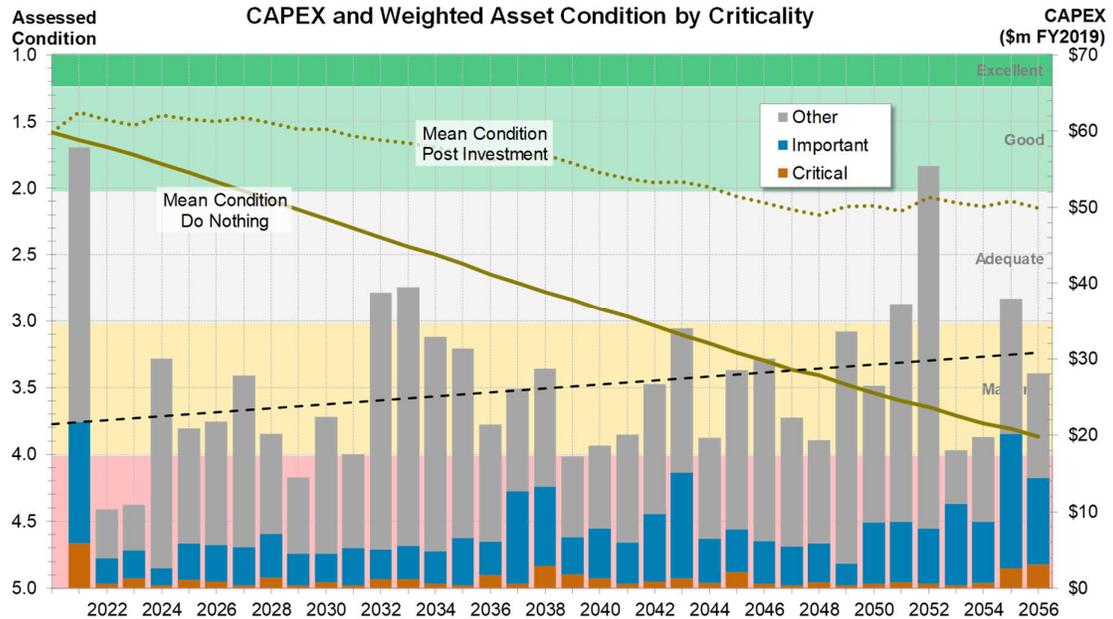
Figure 30 presents the impact of applying a 10% deferment (delay in renewals). The renewal program as configured in this model, applying the 10% deferment in renewal timing, would typically keep the weighted asset condition closer to the top of the State of Good Repair range.

Figure 30 Sunwater’s Annuity Program Developed Using an AECOM Model, Applying a 10% Renewals Deferment

The figures presented in these charts are for illustrative purposes to indicate projected post-investment asset condition; the annual values in these charts vary to those in Sunwater’s submission and in our adjusted submission, mainly due to:

- The specification of a differing decay curve; in this case a single Weibull curve reflecting typical infrastructure failure rates
- The application of a risk based method to determine prudent renewal timing for critical assets. Misalignment exists between the renewals timing specified in Sunwater’s submission and the timing implied by Sunwater’s renewal strategies and asset condition projected using Sunwater’s data (discussed in Section 7.5)
- The aggregation of Sunwater’s asset and project data by type of asset rather than using discrete assets for simplicity

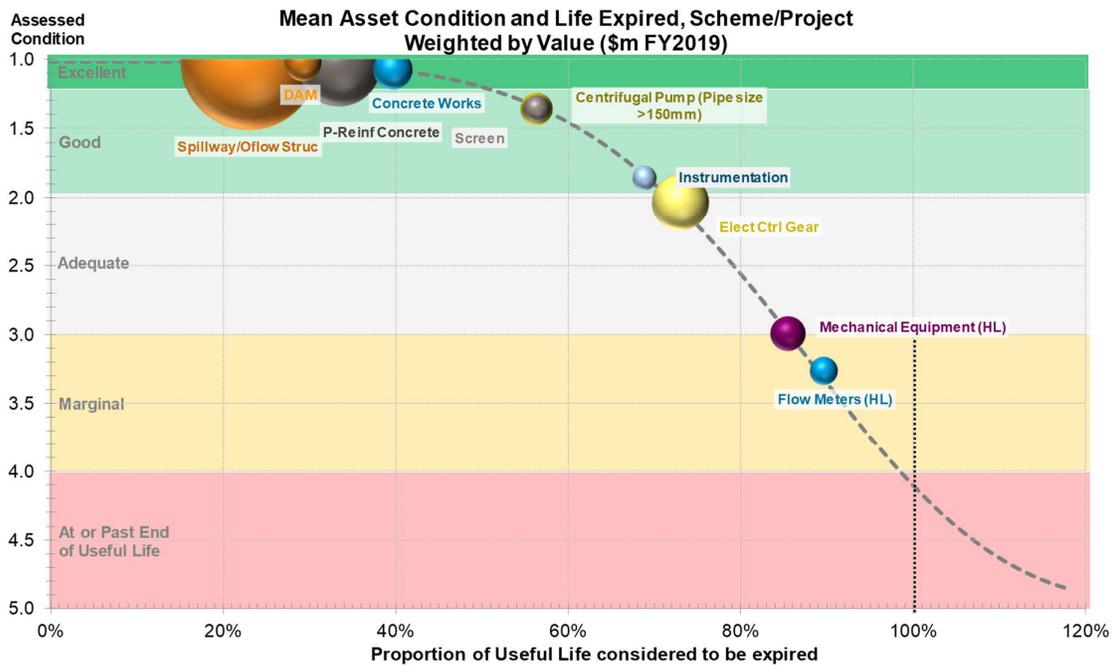
It may be useful to note the current condition of the assets included in Sunwater’s submission. This is shown in Figure 31, which positions Sunwater’s assets according to weighted condition by asset class, where the bubble size indicates the value of each class of assets. The bubbles are presented using the same Weibull curve as used in the previous charts from our model to indicate the approximate stage in their lifecycle.

Figure 31 Current Condition of Sunwater's Assets Included in the Annuity Submission

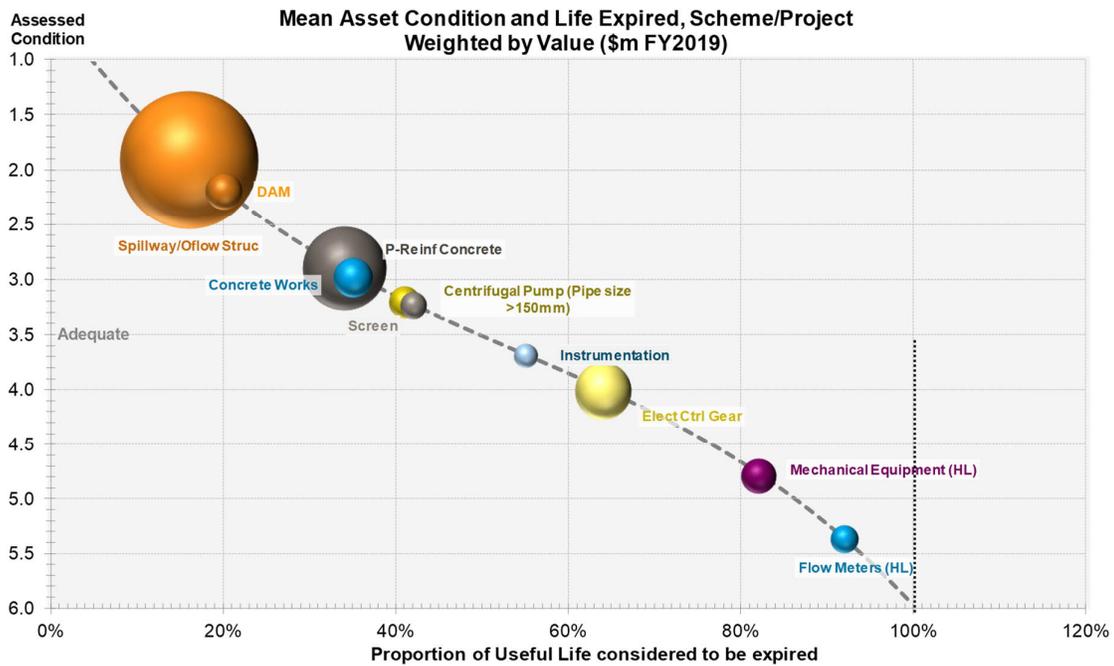
For comparison purposes, the current condition of the assets included in Sunwater's submission is also presented using Sunwater's standard decay curve and Sunwater's condition rating definitions in Figure 32. We note that Sunwater's standard decay curve is notably steeper to the more typical Weibull curve we have employed. We note that both curves assume that asset failures will follow a similar distribution (which is unlikely to be the case in practice).

Figure 32 Current Condition of Sunwater’s Assets in the Annuity Submission Modelled Using Sunwater’s Decay Curve

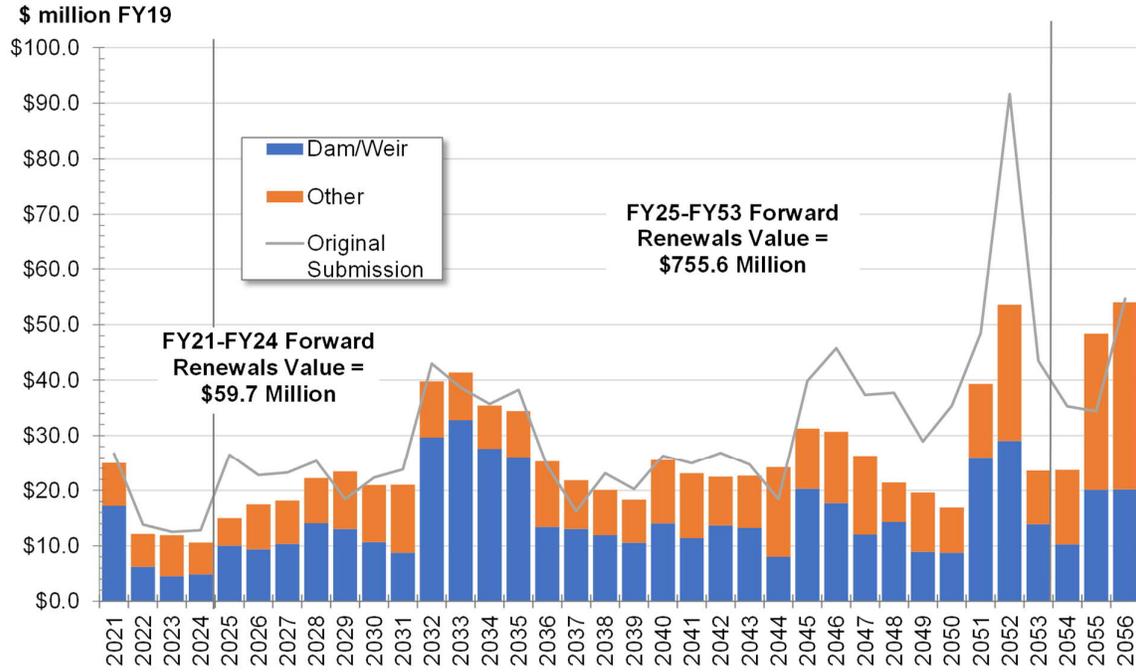
As indicated in Figure 33, the value of the annuity reduces to \$59.7 million and \$755.6 million for the price path period and beyond price path period respectively. As indicated in Figure 34, the annuity value is sensitive to asset life expectancies.

Figure 33 Revised Forward Renewal Program Applying a 10% Increase in Useful Life (\$ million, FY19)

- We recommend that our revision of Sunwater's data as indicated in Figure 33 be used for calculating the annuity. This would reduce the value of the annuity to \$59.7 million and \$755.6 million for the price path period and beyond price path period respectively (in \$FY19). This adjustment is primarily a prudence adjustment to account for overly-conservative renewals timing.

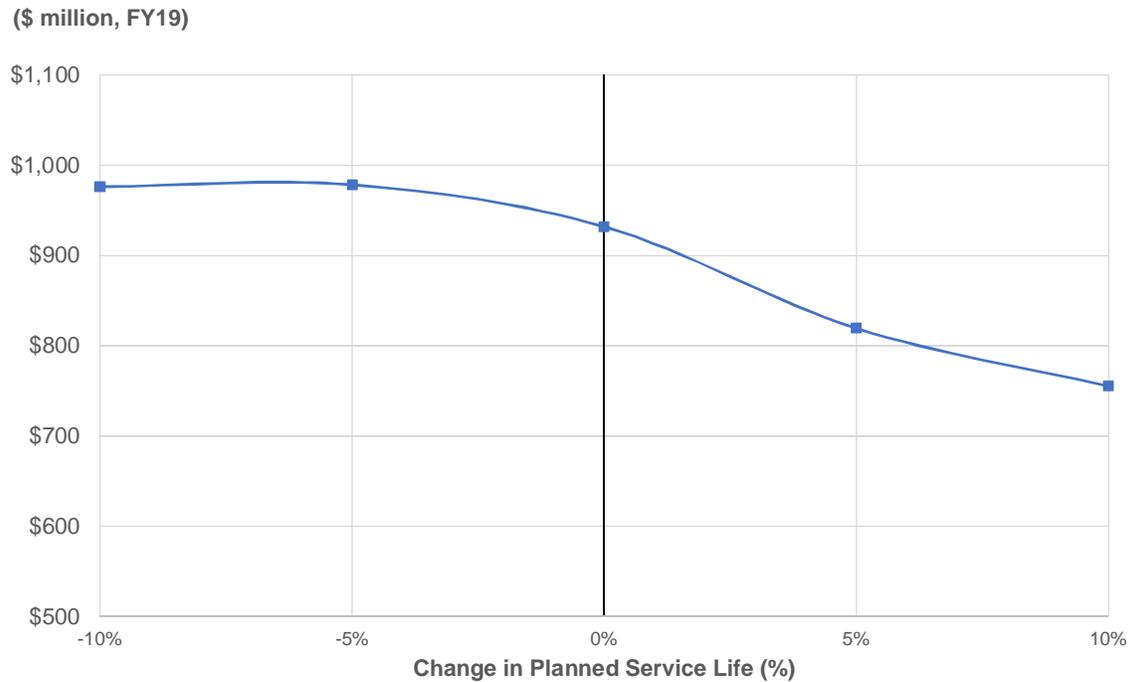
Figure 34 Sensitivity of Sunwater's FY25-FY53 Forward Renewals Value to Changes in the Service Life Expectancy of Assets to be Replaced

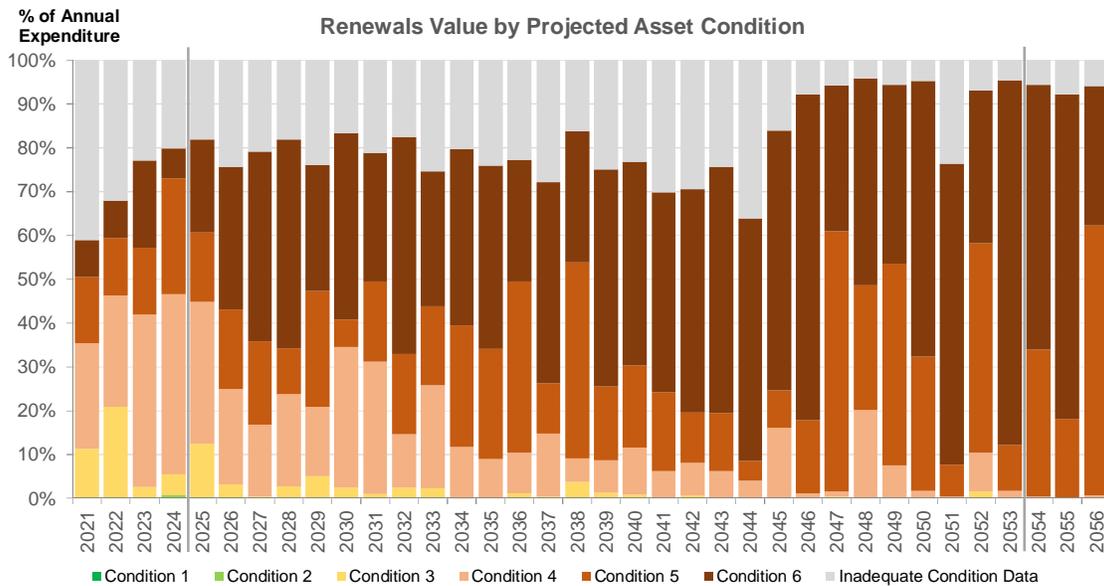
Figure 35 and Figure 36 present the value of the Sunwater's proposed renewal and refurbishment works programs respectively, showing the predicted asset condition at the planned time for renewal. The predicted asset condition (using Sunwater's criteria and decay curve) is colour-coded, ranging from one (as new, in green) to six (at end-of-life, in dark brown).

**Figure 35 Sunwater’s Proposed Renewals Expenditure by Predicted Asset Condition**

Our analysis finds that 15% of the planned works (by value) are for assets where the projected condition assessment data is expected to be a condition state of 3 or better at the time of renewal, which using Sunwater’s standard decay curve represents assets which have less than 37% of their life expectancy expired.

We note that Sunwater has specified triggers for replacement of assets according to the assessed risk (or criticality) of the assets, which provide for renewal of ‘high risk’ (the most critical) assets when 63% of their expected life has expired, or approximately equivalent to a condition rating of four using Sunwater’s criteria. Using this definition, there should not be any assets scheduled for renewal with a condition rating of less than four.

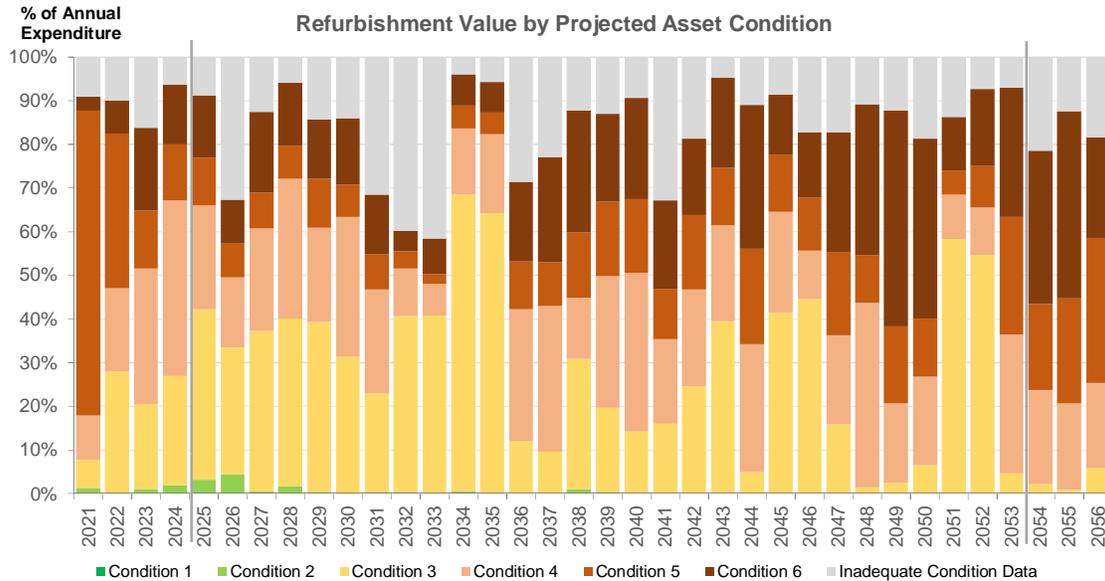
**Figure 36 Sunwater’s Proposed Refurbishment Expenditure by Predicted Asset Condition**

Very limited information has been provided by Sunwater on the frequency of asset refurbishment (as opposed to renewal), the specific trigger points applied, or the actual scope of works expected to be undertaken.

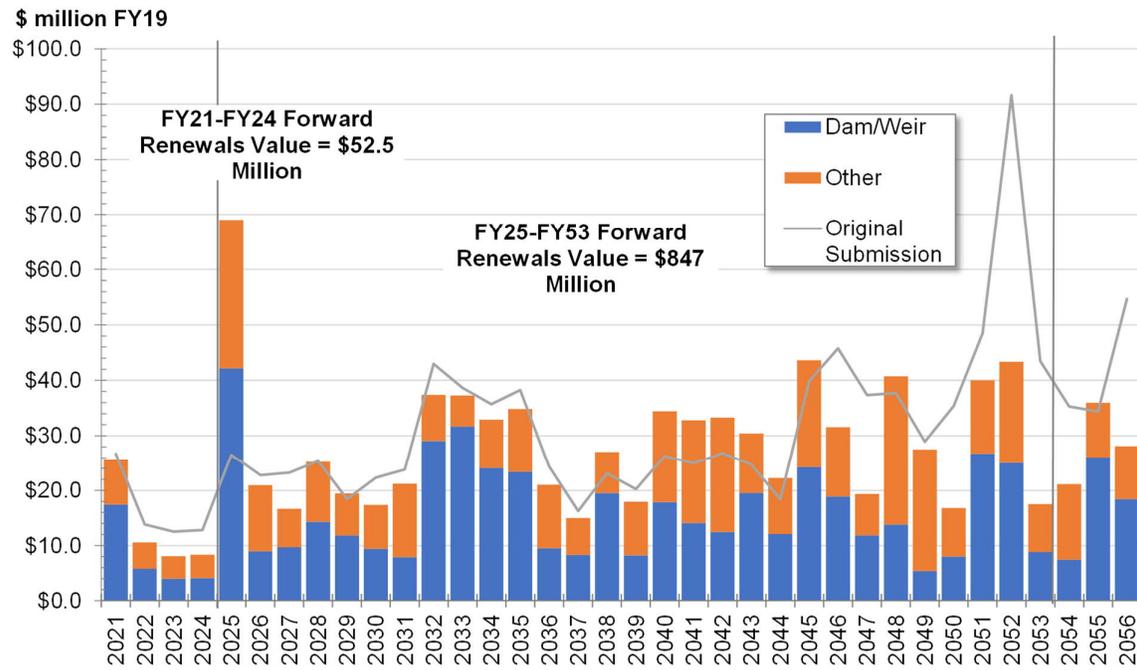
We have applied Sunwater’s rules to the proposed renewal projects as we believe they should have been applied, following Sunwater’s own documented procedures. The result is shown in Figure 37, with Sunwater’s revised submission shown as a line above the bars. A breakdown of the adjustments made due to the timing of projects is presented in Figure 38.

The revision reduces the value of the annuity to \$52.5 million and \$847.0 million for the price path period and beyond price path period respectively (in \$FY19). This finding is in support of the adjustment made in Section 7.4.2, indicating that Sunwater’s renewals program as submitted would result in over-maintenance of assets. This adjustment based on projected condition is shown for indicative purposes only, and is considered to be captured by the adjustment made in Section 7.4.2 reflecting an increase in useful life.

Figure 37 Revised Renewal Program Applying Sunwater's Rules (\$ million, FY19)

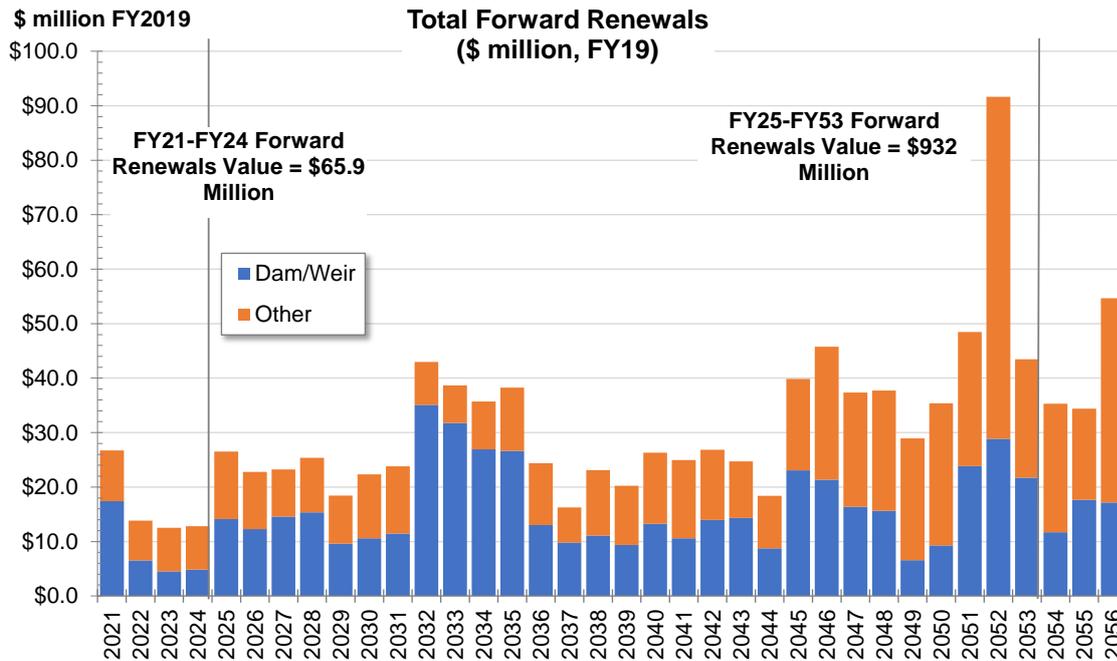
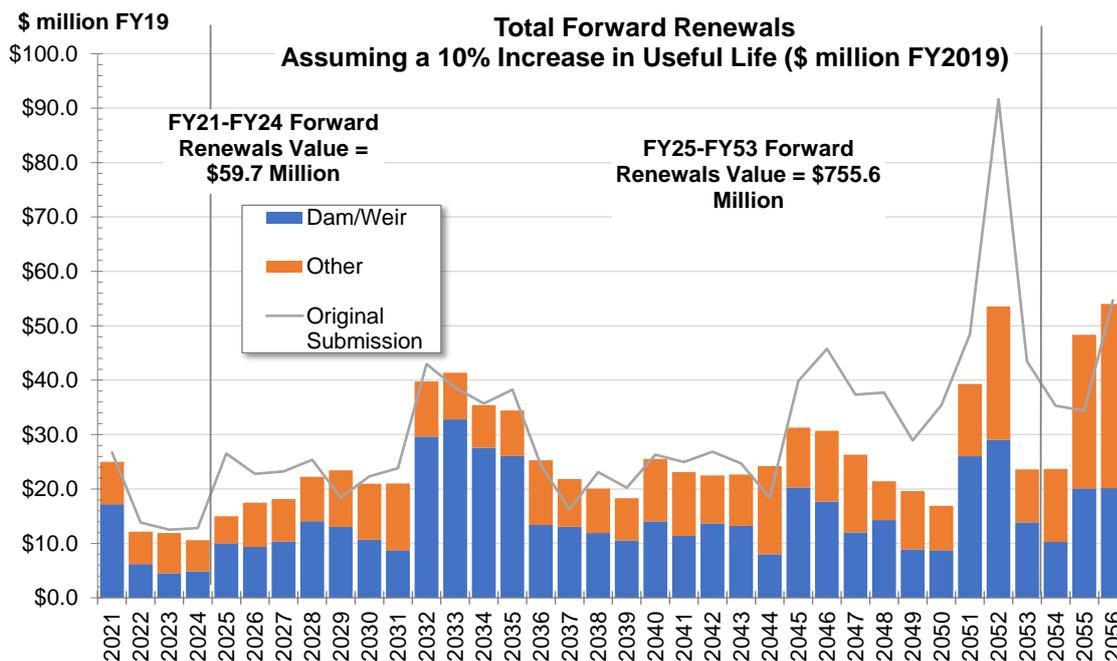
**Figure 1** presents Sunwater's revised forward renewals submission.  
**Figure 2** presents Sunwater's revised forward renewals submission adjusted for the impact of applying a 10% life extension.  
**Table 1** presents a tabulated annual comparison of the submitted and adjusted forward renewals submission.

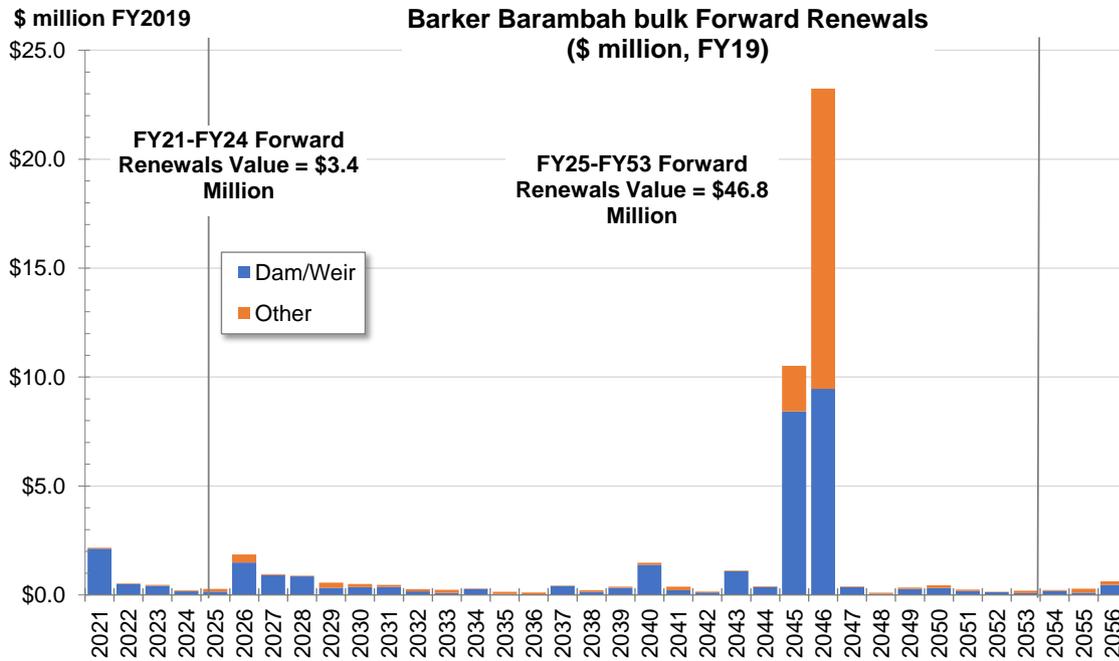
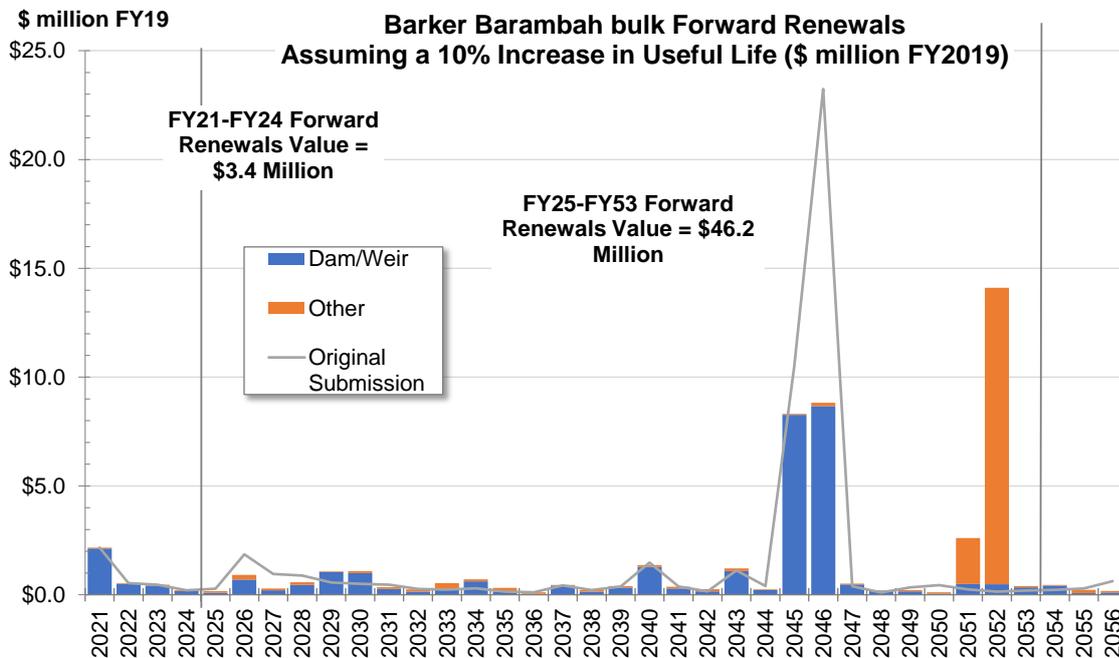
**Figure 1** presents Sunwater's revised forward renewals submission.  
**Figure 2** presents Sunwater's revised forward renewals submission adjusted for the impact of applying a 10% life extension.  
**Table 1** presents a tabulated annual comparison of the submitted and adjusted forward renewals submission.

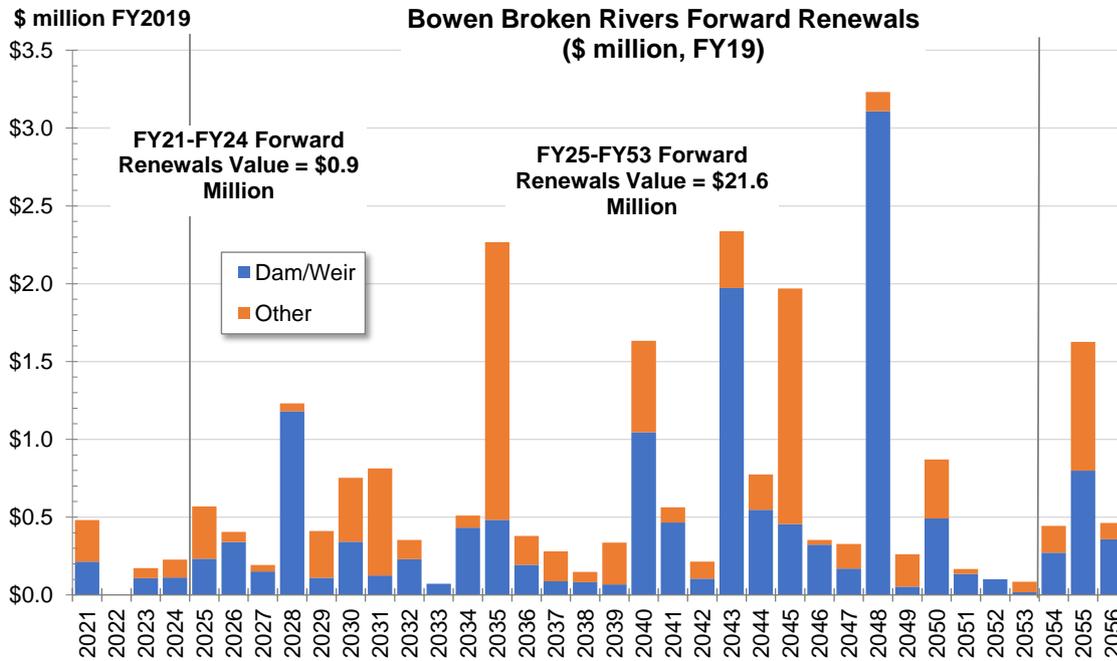
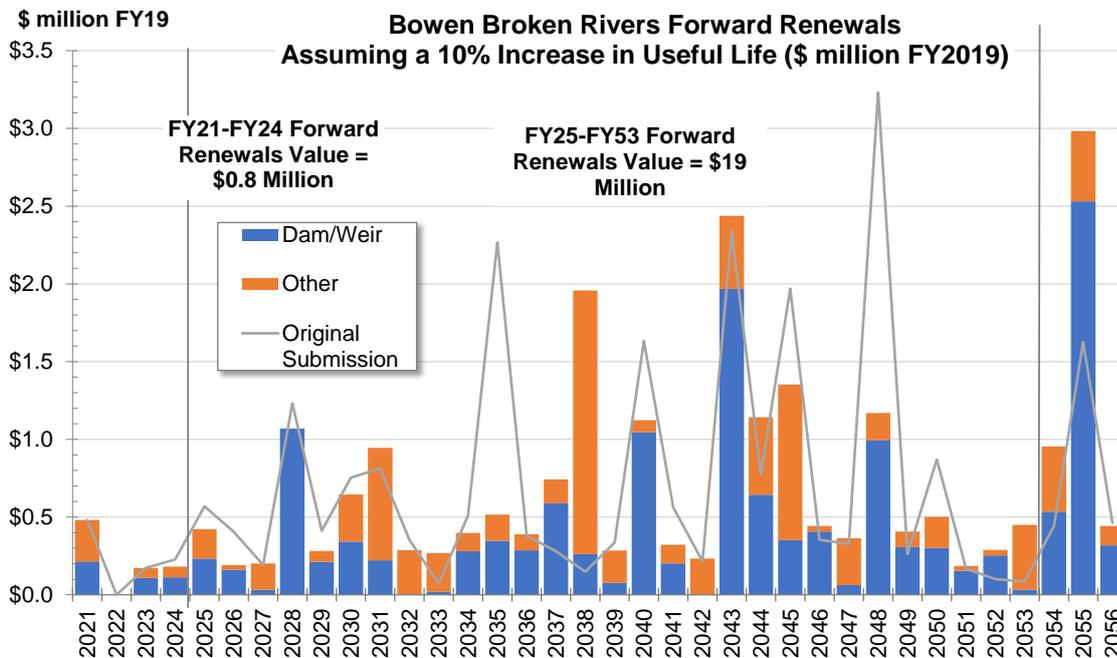
**Figure 1** presents Sunwater's revised forward renewals submission.  
**Figure 2** presents Sunwater's revised forward renewals submission adjusted for the impact of applying a 10% life extension.  
**Table 1** presents a tabulated annual comparison of the submitted and adjusted forward renewals submission.

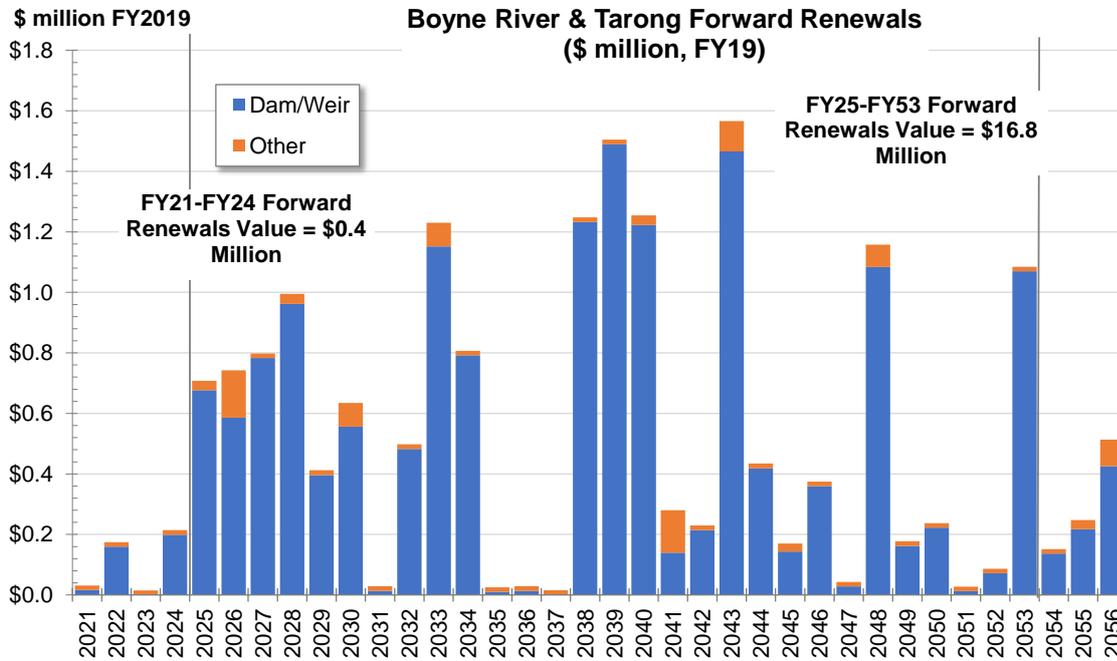
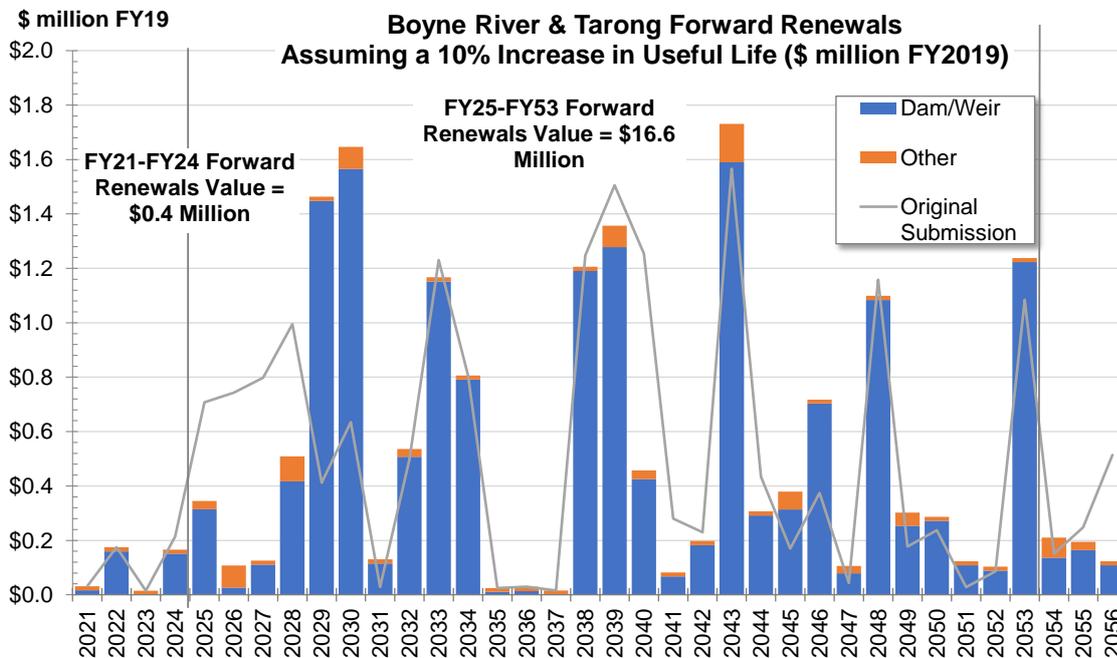
**Figure 1** presents Sunwater's revised forward renewals submission.  
**Figure 2** presents Sunwater's revised forward renewals submission adjusted for the impact of applying a 10% life extension.  
**Table 1** presents a tabulated annual comparison of the submitted and adjusted forward renewals submission.

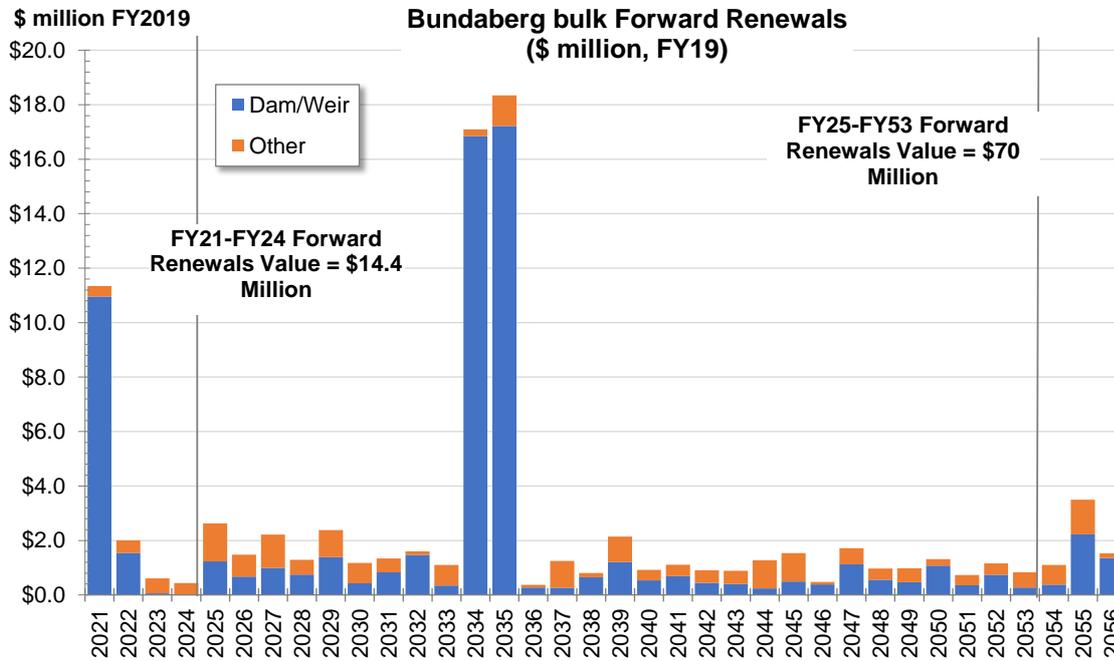
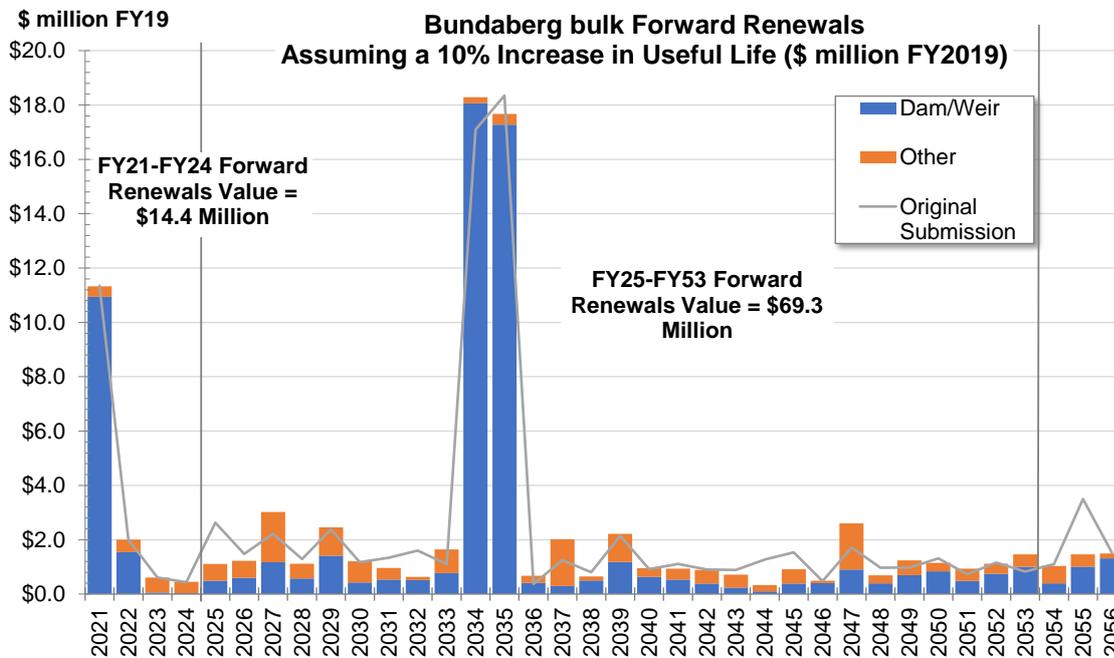
**Figure 1** presents Sunwater's revised forward renewals submission.  
**Figure 2** presents Sunwater's revised forward renewals submission adjusted for the impact of applying a 10% life extension.  
**Table 1** presents a tabulated annual comparison of the submitted and adjusted forward renewals submission.
