# Rural Irrigation Capital Expenditure Review

Sunwater

Client: Queensland Competition Authority

**AECOM Australia Pty Ltd**

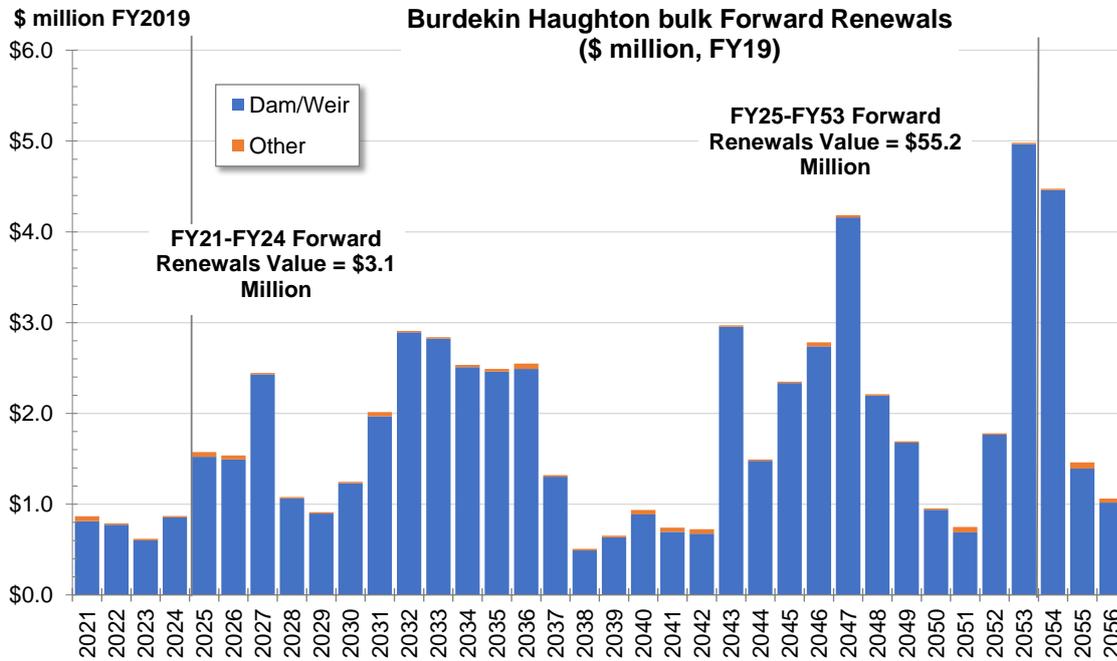
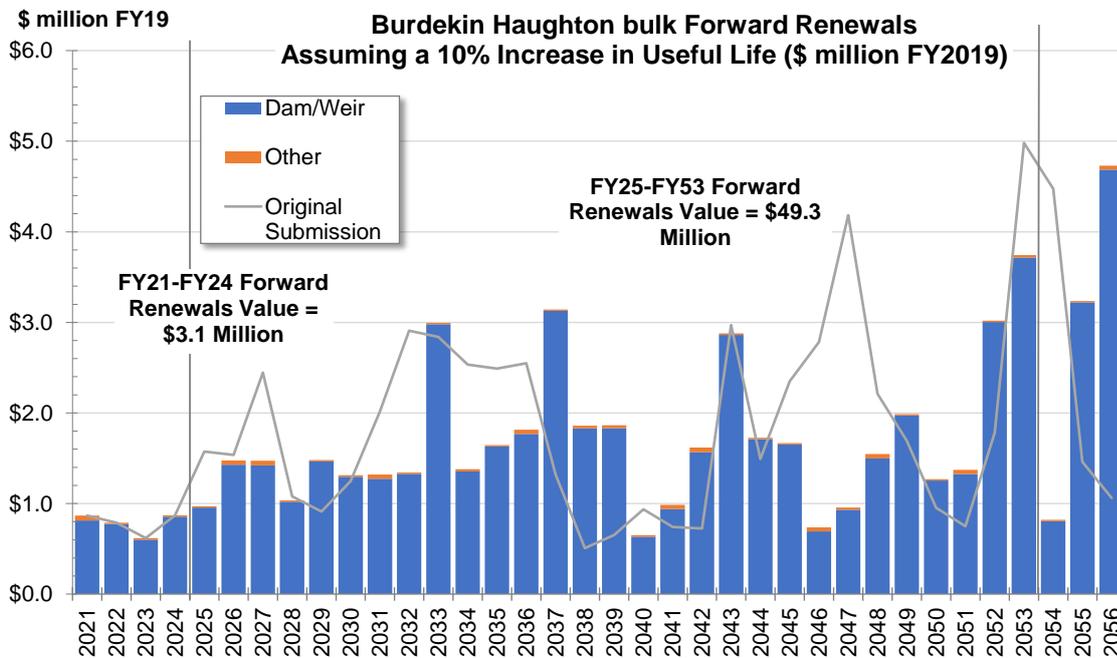
**Figure 1** presents Sunwater's revised forward renewals submission.  
**Figure 2** presents Sunwater's revised forward renewals submission adjusted for the impact of applying a 10% life extension.  
**Table 1** presents a tabulated annual comparison of the submitted and adjusted forward renewals submission.

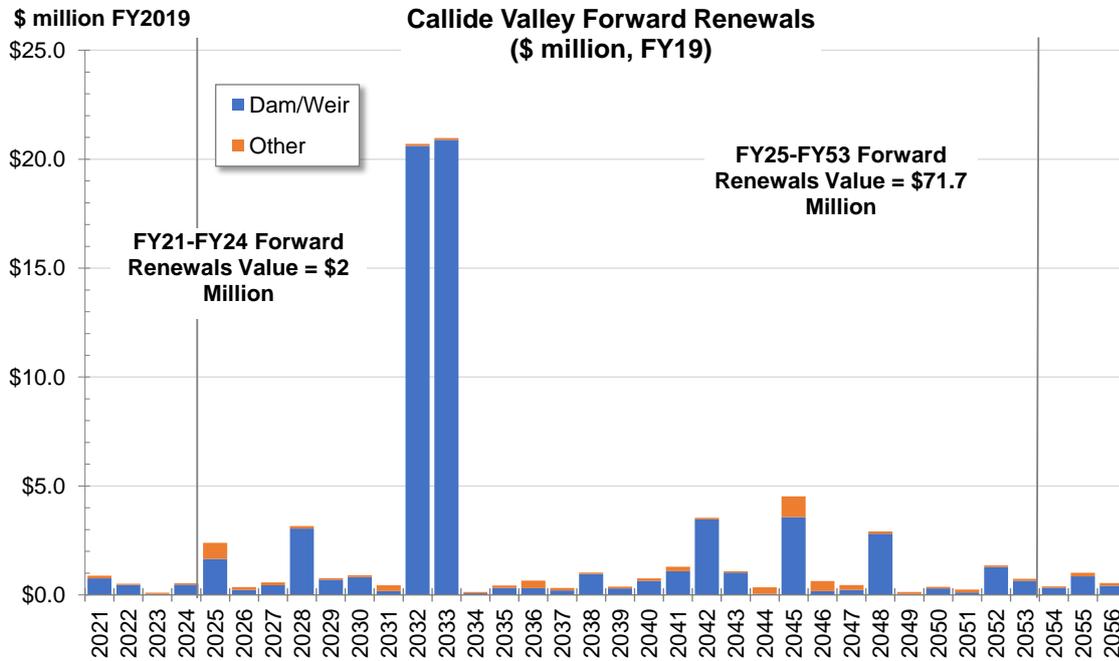
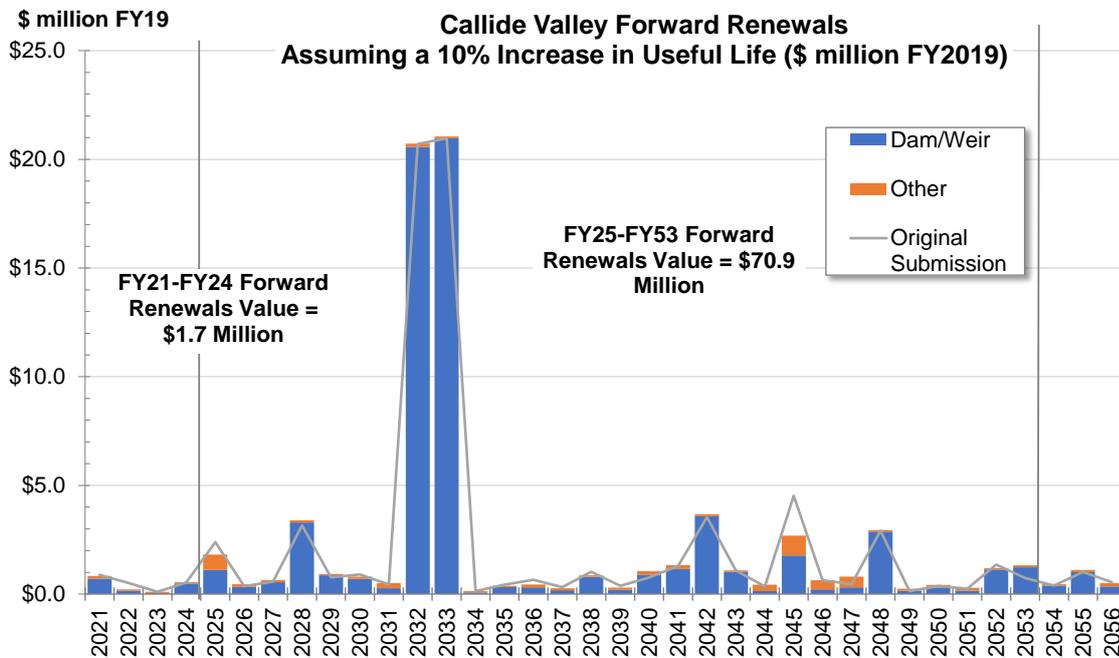
**Figure 1** presents Sunwater's revised forward renewals submission.  
**Figure 2** presents Sunwater's revised forward renewals submission adjusted for the impact of applying a 10% life extension.  
**Table 1** presents a tabulated annual comparison of the submitted and adjusted forward renewals submission.

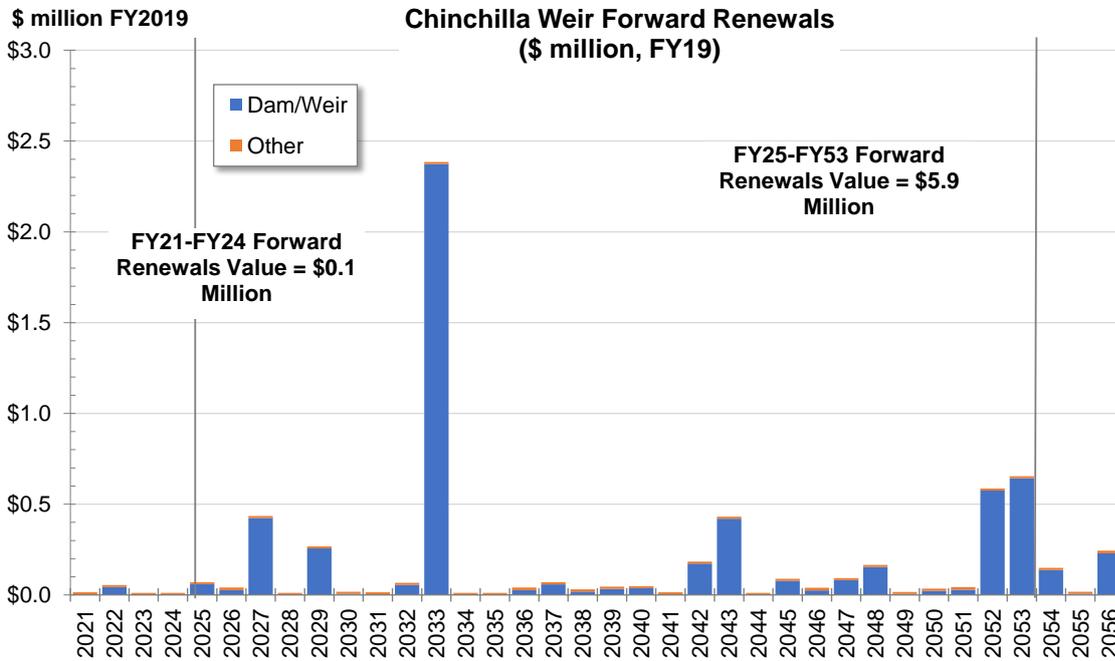
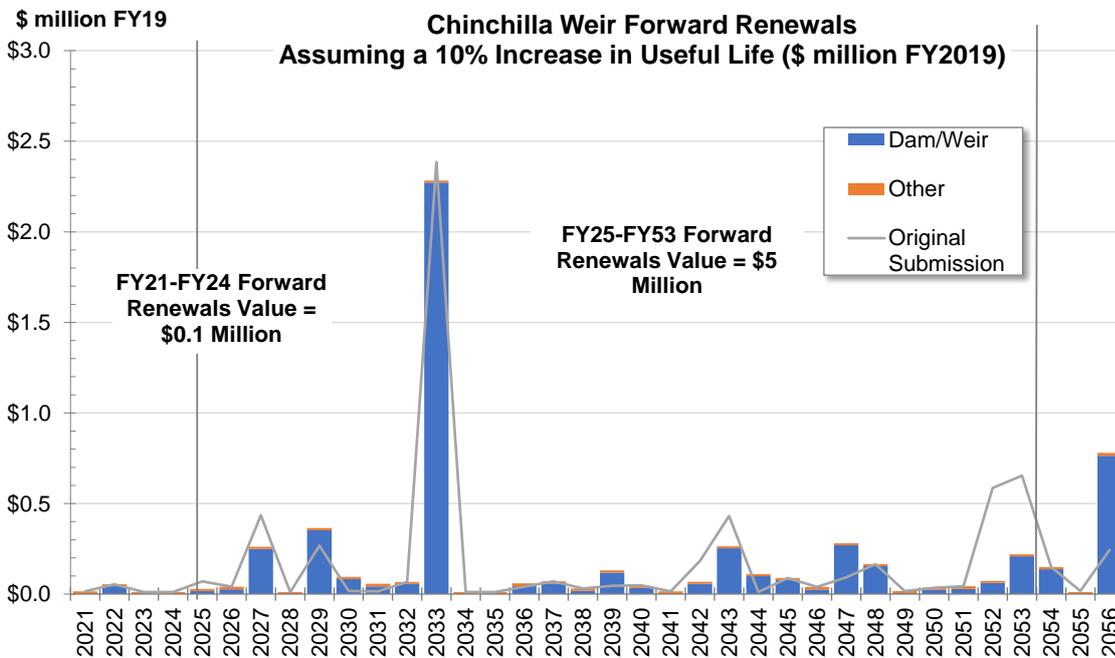
**Figure 1** presents Sunwater's revised forward renewals submission.  
**Figure 2** presents Sunwater's revised forward renewals submission adjusted for the impact of applying a 10% life extension.  
**Table 1** presents a tabulated annual comparison of the submitted and adjusted forward renewals submission.

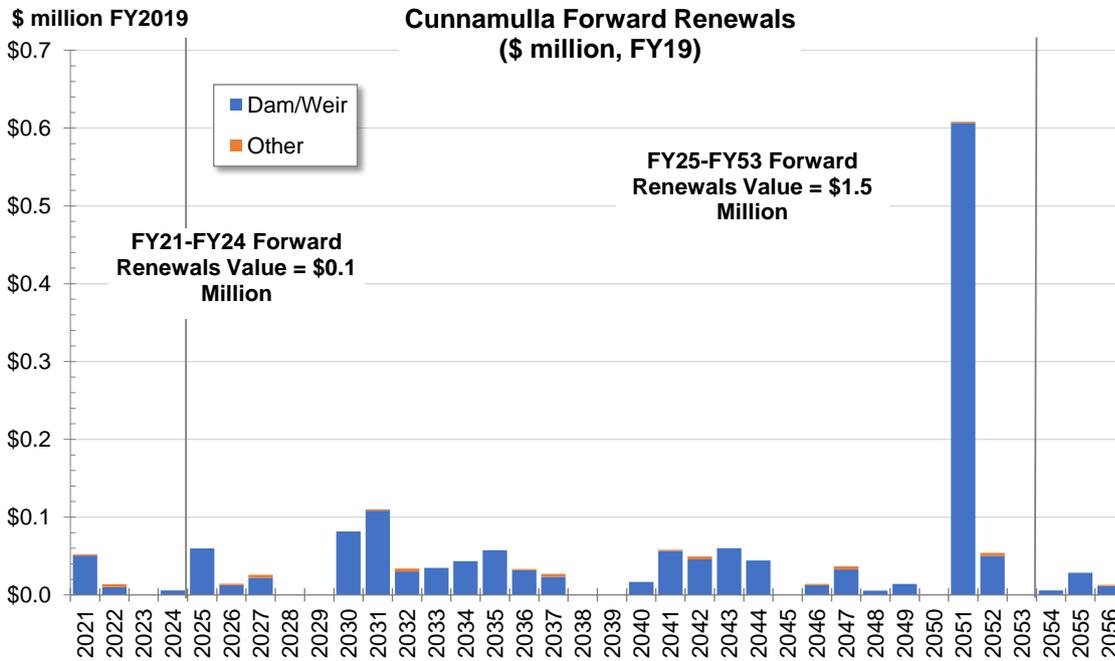
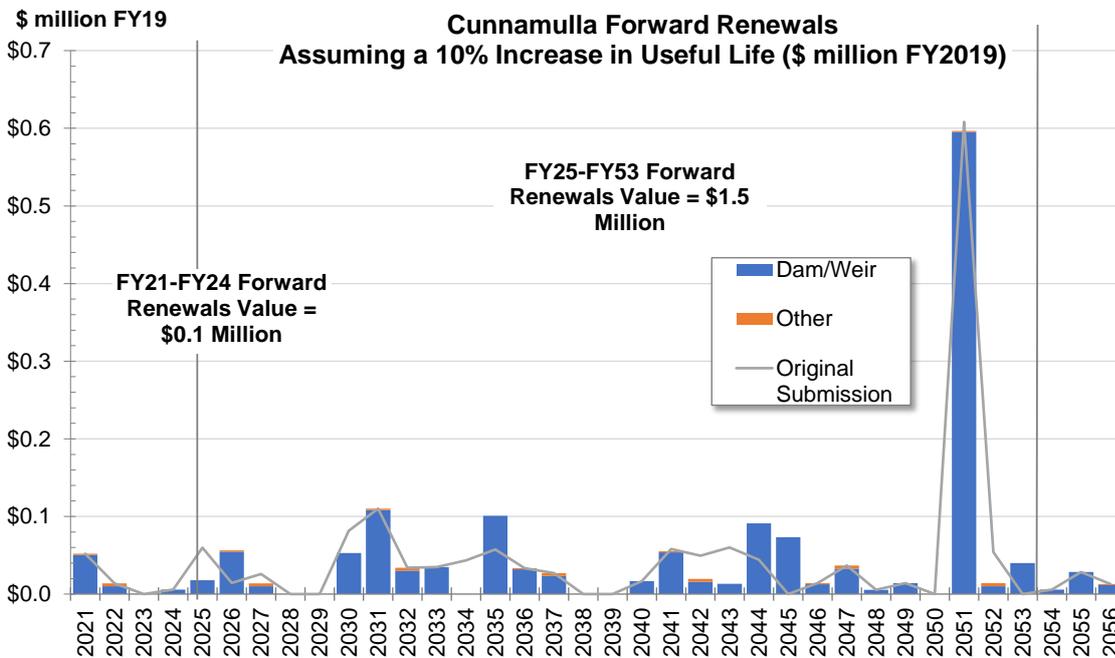
**Figure 1** presents Sunwater's revised forward renewals submission.  
**Figure 2** presents Sunwater's revised forward renewals submission adjusted for the impact of applying a 10% life extension.  
**Table 1** presents a tabulated annual comparison of the submitted and adjusted forward renewals submission.
