Rural Irrigation Capital Expenditure Review

Sunwater

Client: Queensland Competition Authority

AECOM Australia Pty Ltd

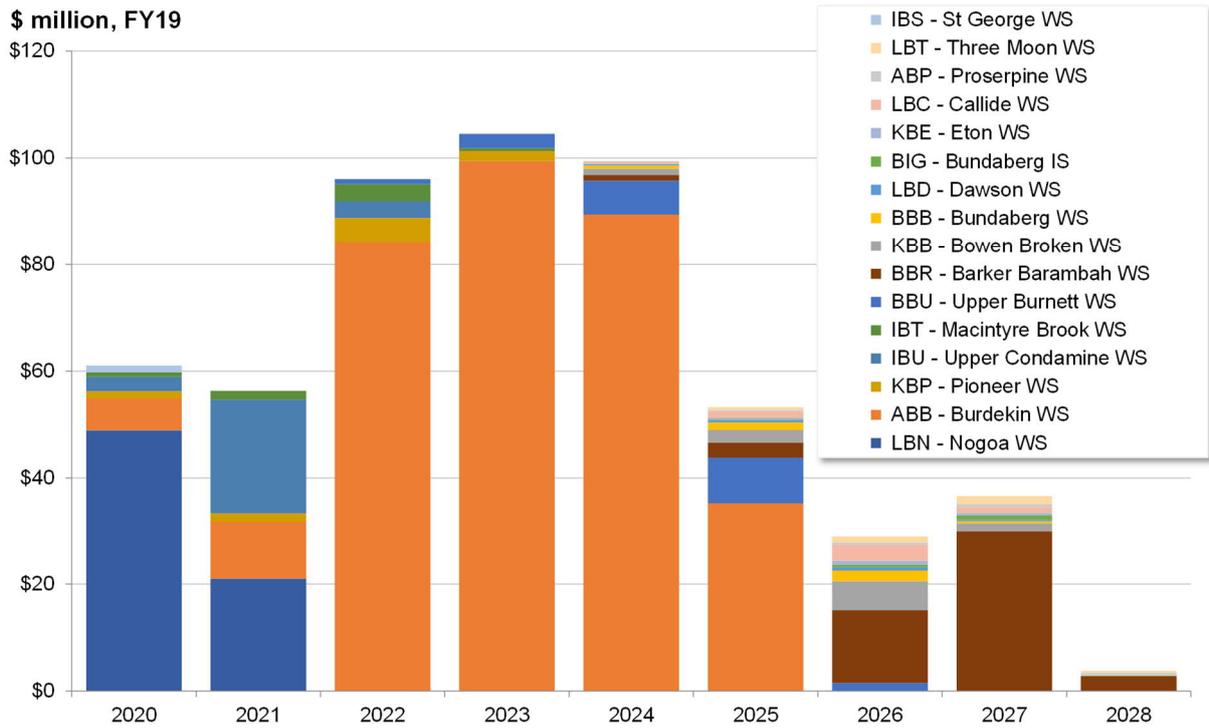
Figure 4 Dam Safety Improvement Upgrade Works by Scheme, FY20-FY28 (\$ million, FY19)

Dam safety upgrade works for regulated schemes amount to \$540.8 million (in \$FY19 terms) over the FY20 to FY28 period. As presented in Figure 4, the two most significant schemes by project value are Burdekin WS and Nogoia WS.

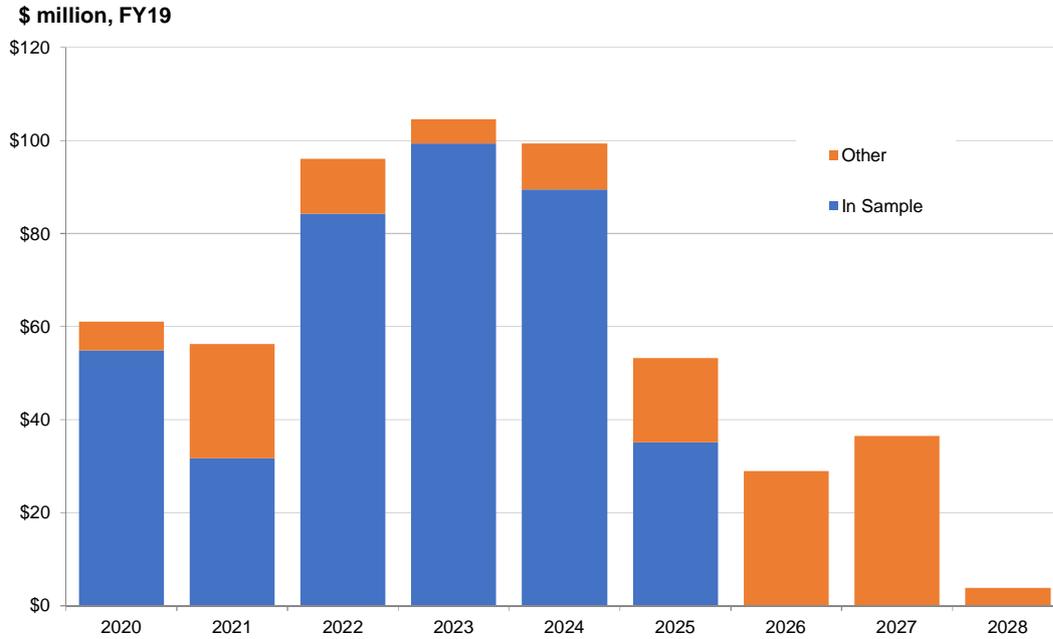
Figure 12 Dam Safety Upgrade Projects, FY20-FY28 (\$ millions, FY19)

Dam safety improvement works occurring in regulated schemes over the FY2020 to FY2028 period amount to \$540.8 million, as presented in Figure 12. Two sample projects have been selected for review based on materiality, which amount to 73% of dam upgrade works over the period by value.

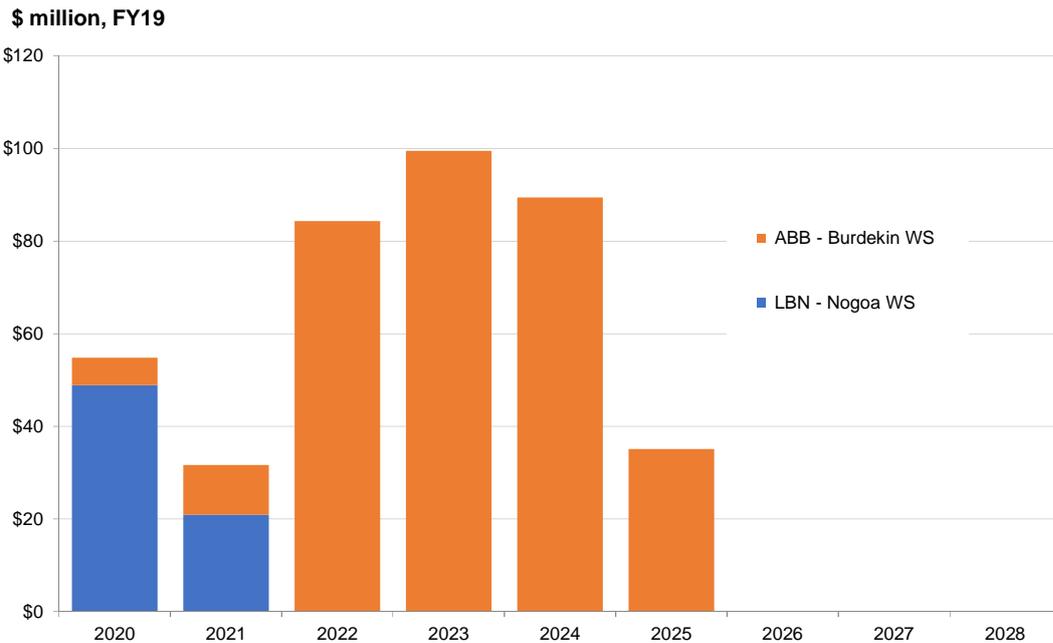
Figure 13 Dam Safety Upgrade Sample Profile (\$ millions, FY19)

Burdekin (Burdekin WS) and Fairbairn (Nogoa WS) dam upgrade works are outlined separately in Figure 13.

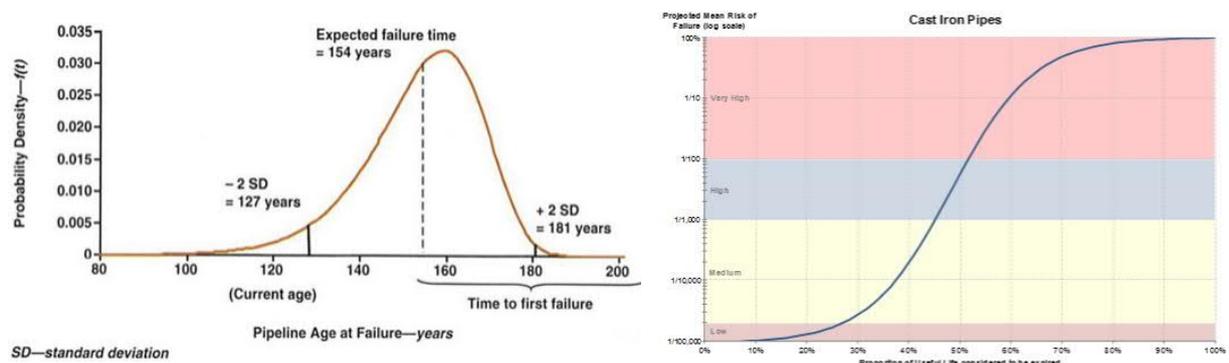
Figure 14 Failure Distribution and Risk of Failure of Cast Iron Pipes

An example of the risk-based approach is shown in Figure 14, which presents a typical failure curve for cast iron pipes based primarily on history. It should be noted that:

- The life expectancy for the asset class is set at 154 years, which is the median (the age at which 50% of the class is considered to have failed)
- The asset manager uses two standard deviations (in advance of the median) to define the end of life for critical assets, which in this case is 127 years (implying a maximum acceptable risk of failure in this case of approximately 5 in 1000)

Service life and the rate of deterioration (increase in the risk of failure) typically varies considerably site to site, and curves derived from experience elsewhere are only indicative – there is no substitute for local experience. In the absence of useful local experience, however, the failure curve is often assumed initially to be a normal distribution, and procedures are put in place to revise that assumption based on experience.

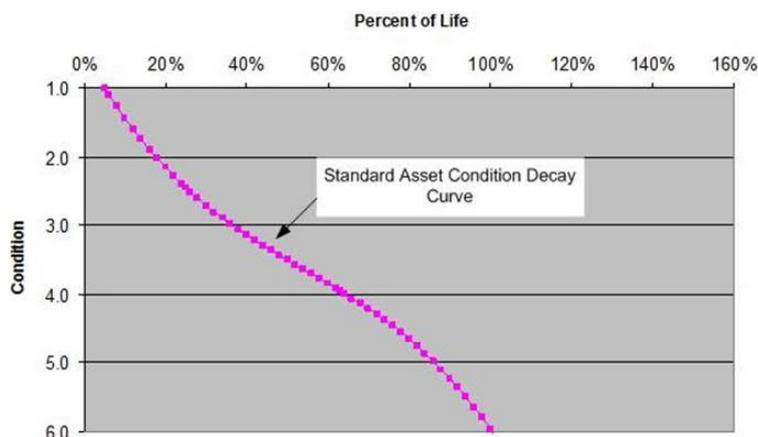
Figure 15 Sunwater's 'Standard' Decay Curve

The methodology includes reference to a 'standard asset condition decay curve' (as shown in Figure 15), for which a formula is provided (with a note to the effect that it was developed in 2006). In 2011, SKM recommended that Sunwater adopt decay curves for different asset types, instead of a standard decay curve.¹⁵

The paper notes that Sunwater, presumably in FY10-FY11, intended to undertake a detailed analysis of historic condition and maintenance data to develop a family of standardised decay curves for different classes in recognition that different asset types decay in different ways (Section 4.1.3).

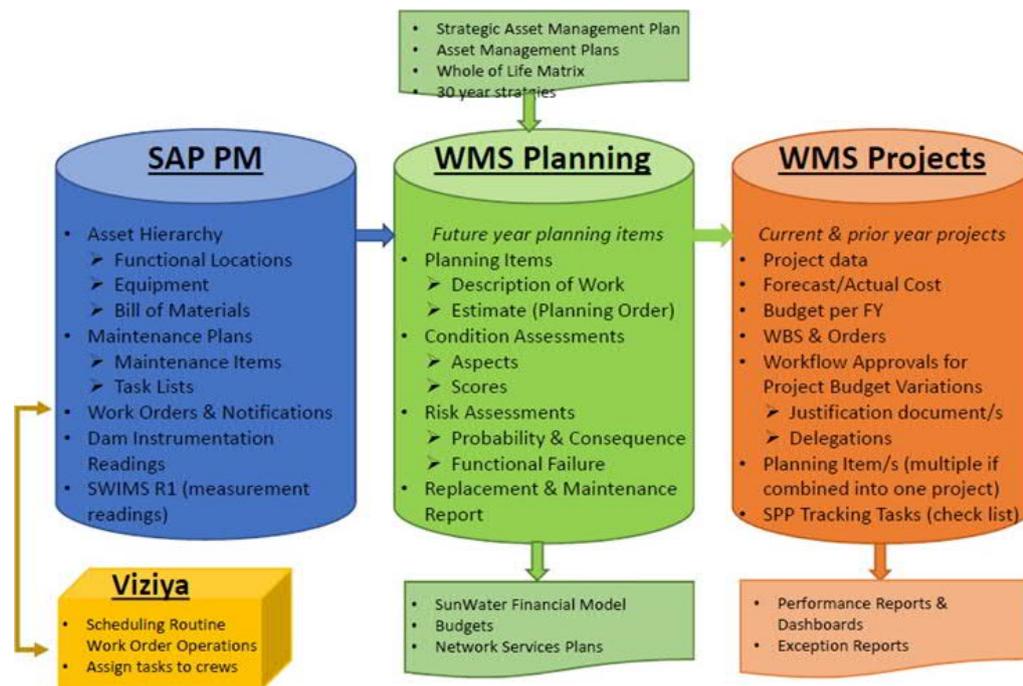
Figure 16 Sunwater's Asset Management Systems

Sunwater uses SAP PM to manage its asset register and to maintain its work management system and has recently introduced Viziya to optimise work schedules. Whole of life asset management planning is carried out using WMS, a SAP module (Figure 16). A GIS system is used to provide a spatial record.

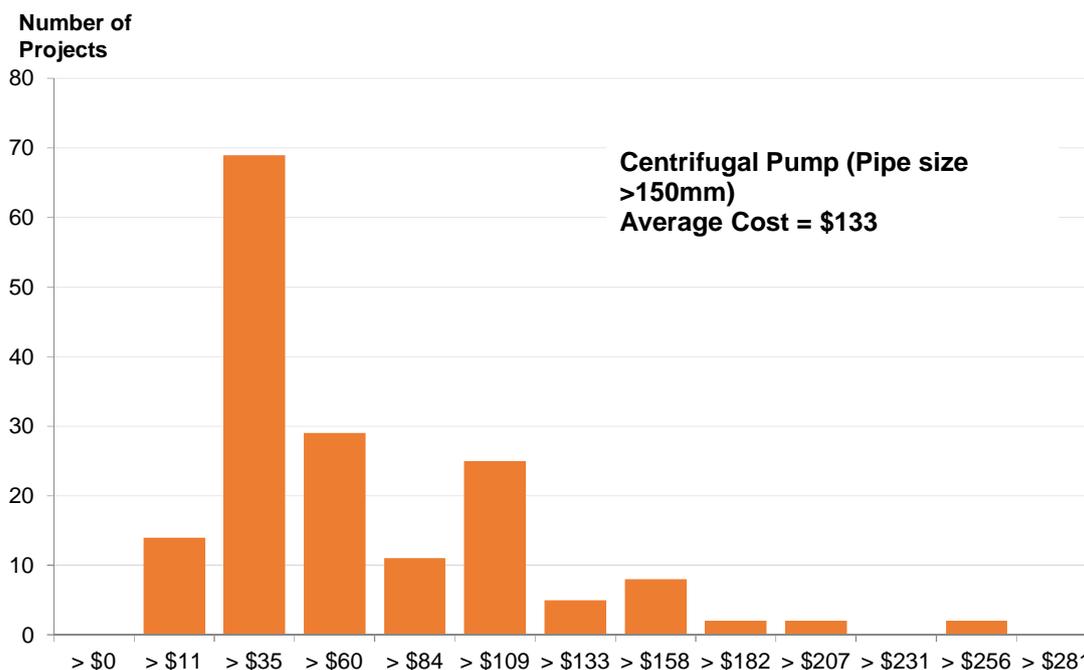
Figure 28 Variability in Cost Estimates (\$'000s, FY19)

Review of the cost estimates recorded for projects that appear to be similar shows considerable variation in cost estimates (refer to Figure 28 as an example). This suggests that Sunwater’s procedures are not being followed consistently.

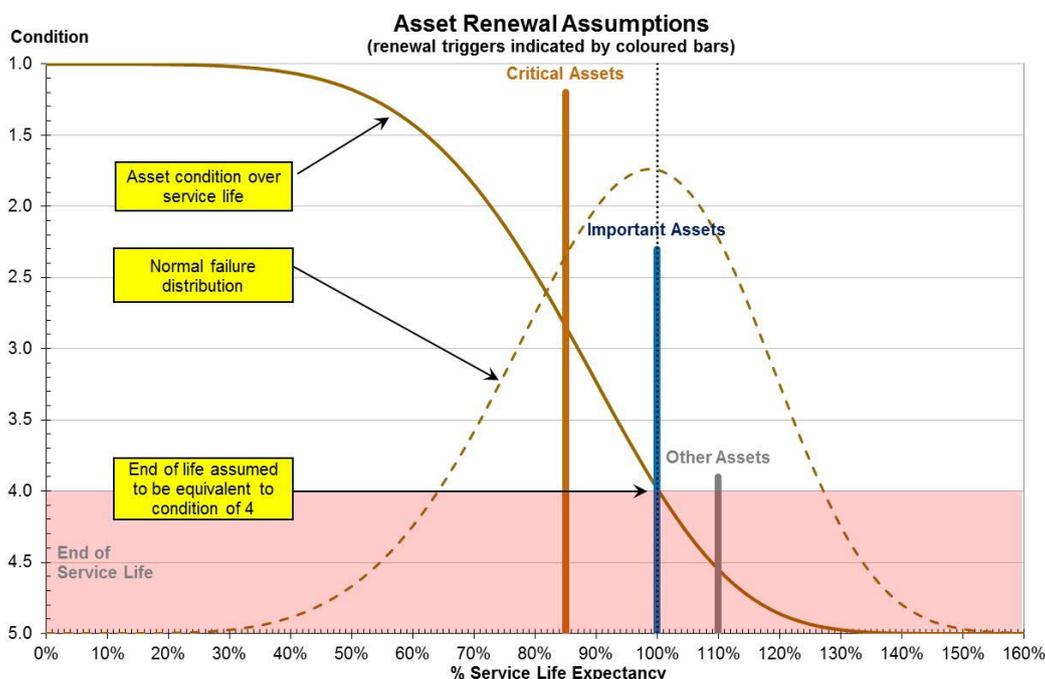
Figure 29 Example of Weibull Curve Equivalent to a Normal Distribution of Failure

End of life is generally defined as the point in the lifecycle where the risk of failure becomes unacceptable (the assets can generally be used after that time, but service interruption will become more severe and maintenance costs will usually be significantly higher). Critical assets are held to a lower tolerance of risk, as indicated by the first vertical line in Figure 29.

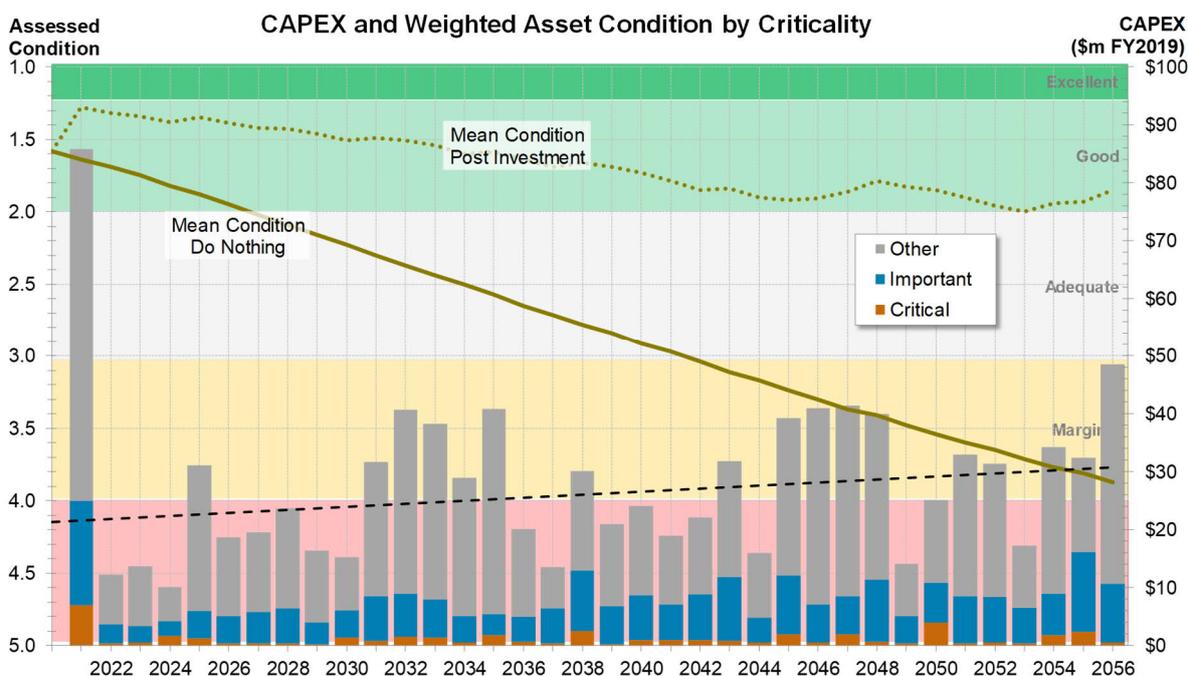
The result of copying Sunwater’s annuity program data into an AECOM asset investment planning model which use a Weibull curve as the basis for developing lifecycle costs is shown in Figure 30. The figure shows the investment required each year (in FY19 dollars) aggregated by asset criticality, and shows:

- a solid brown line that indicates the weighted asset condition (for all assets in the submission scheduled for renewal, weighted using replacement value) assuming that no investment takes place
- a dotted brown line that shows the weighted asset condition after the scheduled investment (renewal). This line indicates a higher mean asset condition, because deteriorated assets are replaced with new assets.

The dotted black line is a trend line of annual investment needed. It increases because higher value assets with longer service lives fall due for renewal later in the planning period.

The renewal program as configured in this model, which applies Sunwater’s renewal strategies, would typically keep the weighted asset condition above the State of Good Repair range, suggesting that the condition of assets is being maintained at too high a level using Sunwater’s existing strategies.

Figure 30 Sunwater’s Annuity Program Developed Using an AECOM Model, Presented by Asset Criticality

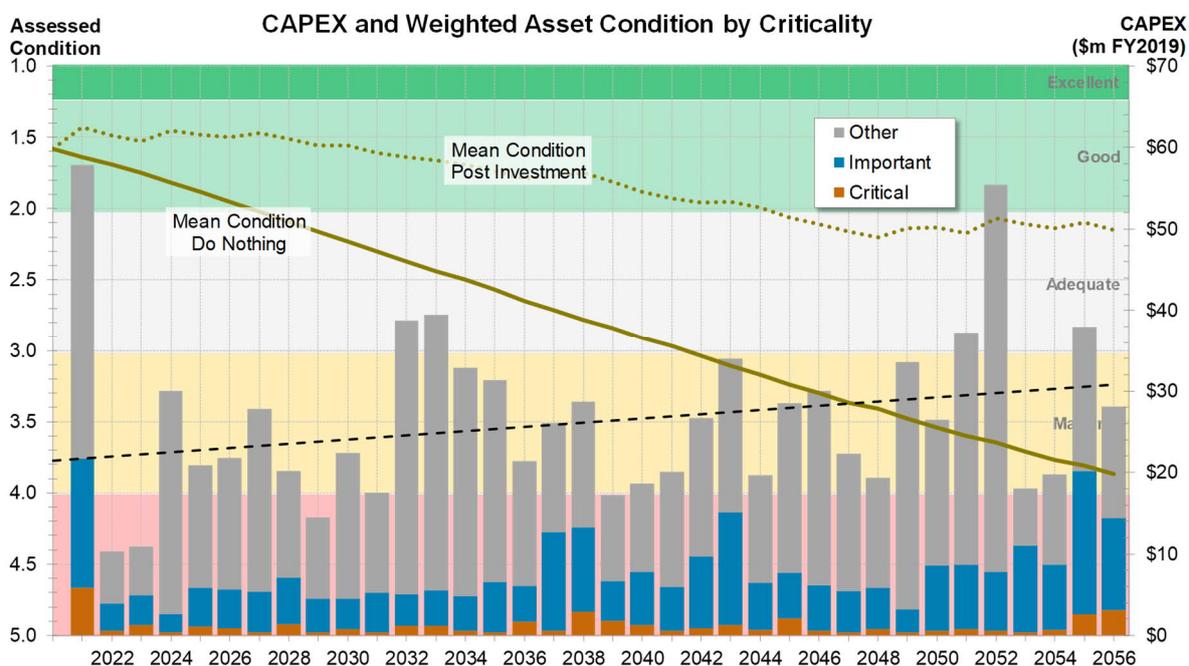
Figure 31 presents the impact of applying a 10% deferment (delay in renewals). The renewal program as configured in this model, applying the 10% deferment in renewal timing, would typically keep the weighted asset condition closer to the top of the State of Good Repair range.

Figure 31 Sunwater’s Annuity Program Developed Using an AECOM Model, Applying a 10% Renewals Deferment

The figures presented in these charts are for illustrative purposes to indicate projected post-investment asset condition; the annual values in these charts vary to those in Sunwater’s submission and in our adjusted submission, mainly due to:

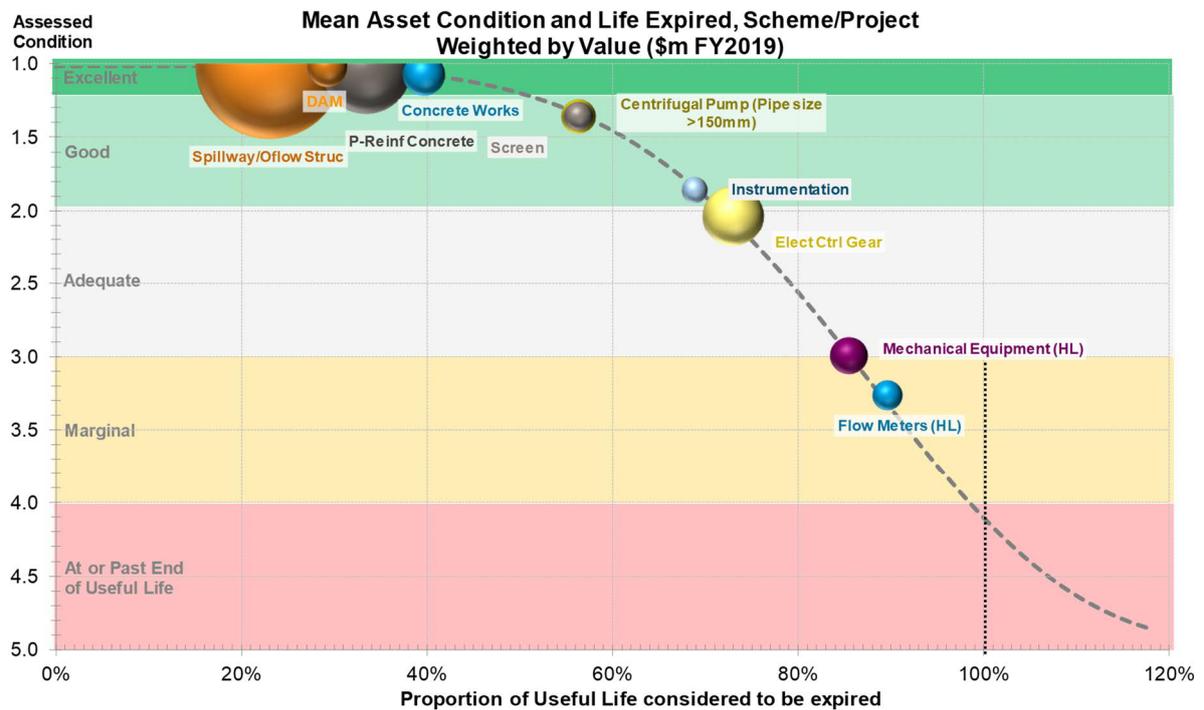
It may be useful to note the current condition of the assets included in Sunwater’s submission. This is shown in Figure 32, which positions Sunwater’s assets according to weighted condition by asset class, where the bubble size indicates the value of each class of assets. The bubbles are presented using the same Weibull curve as used in the previous charts from our model to indicate the approximate stage in their lifecycle.

Figure 32 Current Condition of Sunwater’s Assets Included in the Annuity Submission

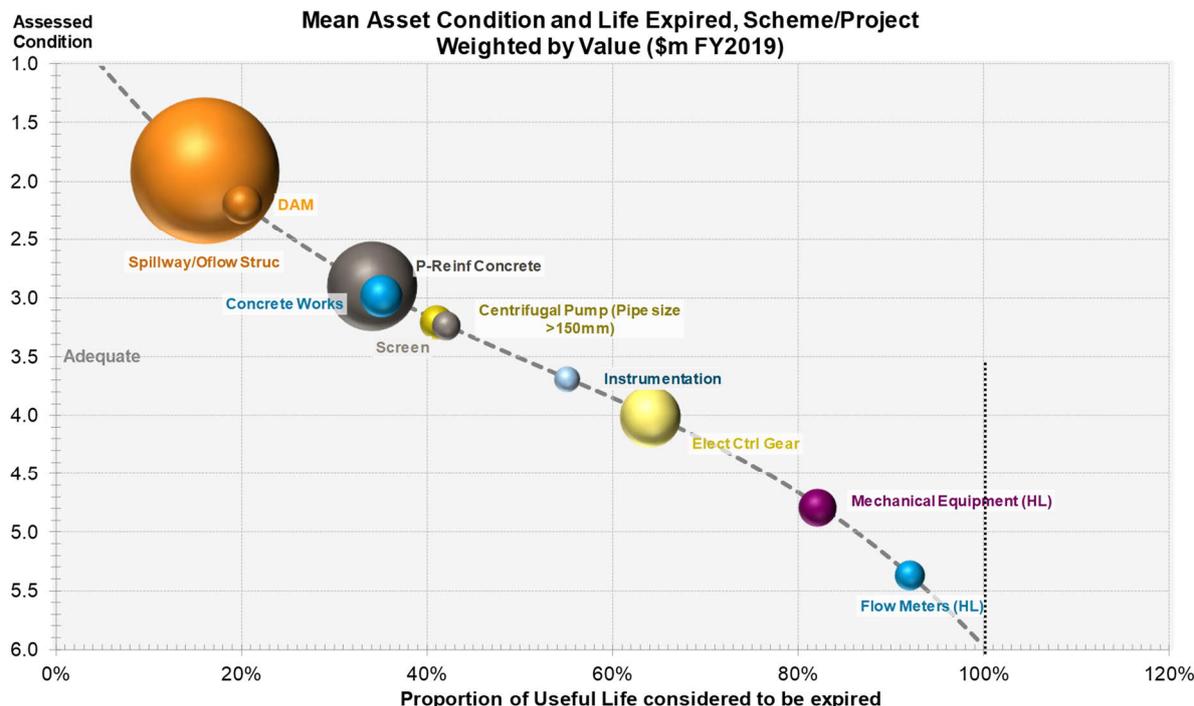
For comparison purposes, the current condition of the assets included in Sunwater’s submission is also presented using Sunwater’s standard decay curve and Sunwater’s condition rating definitions in Figure 33. We note that Sunwater’s standard decay curve is notably steeper to the more typical Weibull curve we have employed. We note that both curves assume that asset failures will follow a similar distribution (which is unlikely to be the case in practice).

Figure 33 Current Condition of Sunwater’s Assets in the Annuity Submission Modelled Using Sunwater’s Decay Curve

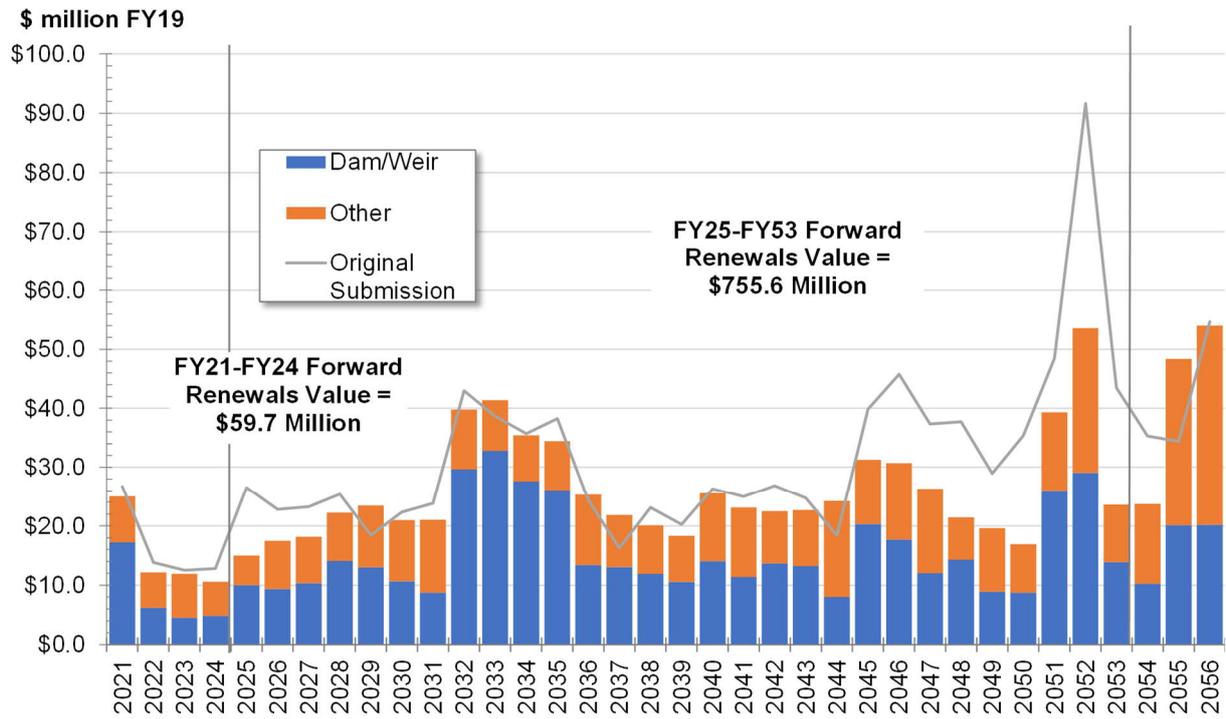
Figure 34 Revised Forward Renewal Program Applying a 10% Increase in Useful Life (\$ million, FY19)

As indicated in Figure 34, the value of the annuity reduces to \$59.7 million and \$755.6 million for the price path period and beyond price path period respectively. As indicated in Figure 35, the annuity value is sensitive to asset life expectancies.

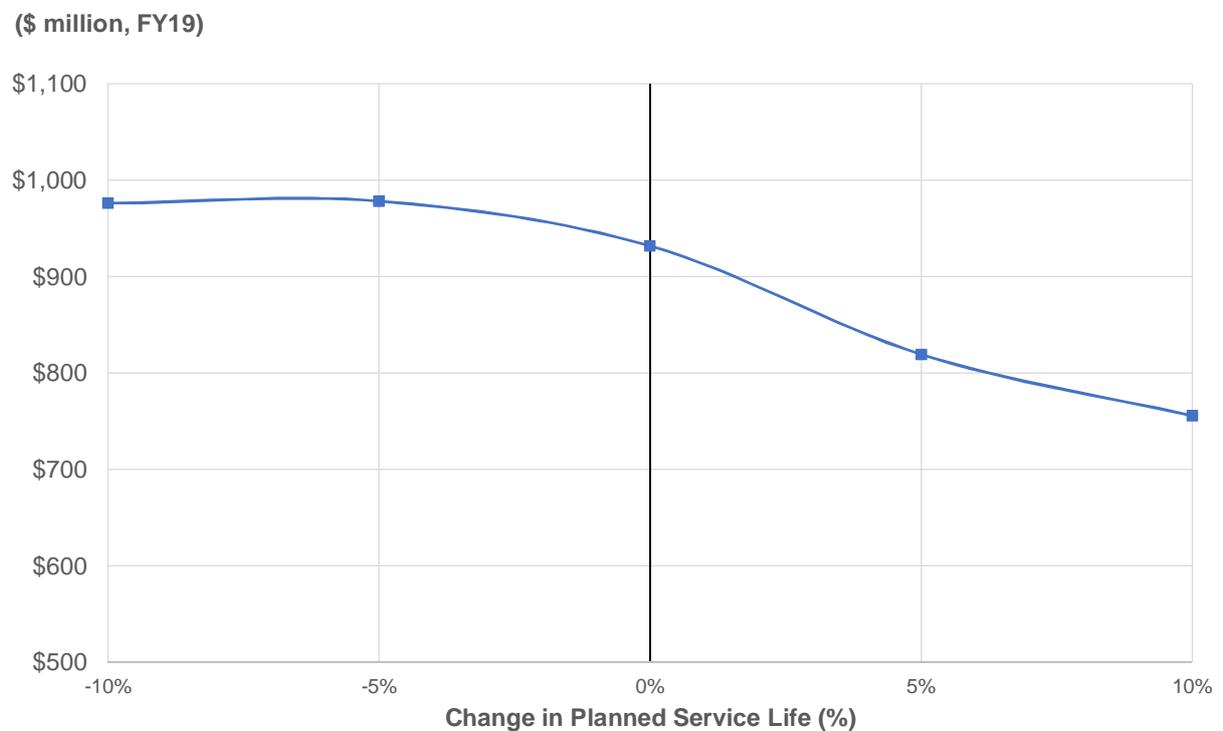
Figure 35 Sensitivity of Sunwater's FY25-FY53 Forward Renewals Value to Changes in the Service Life Expectancy of Assets to be Replaced

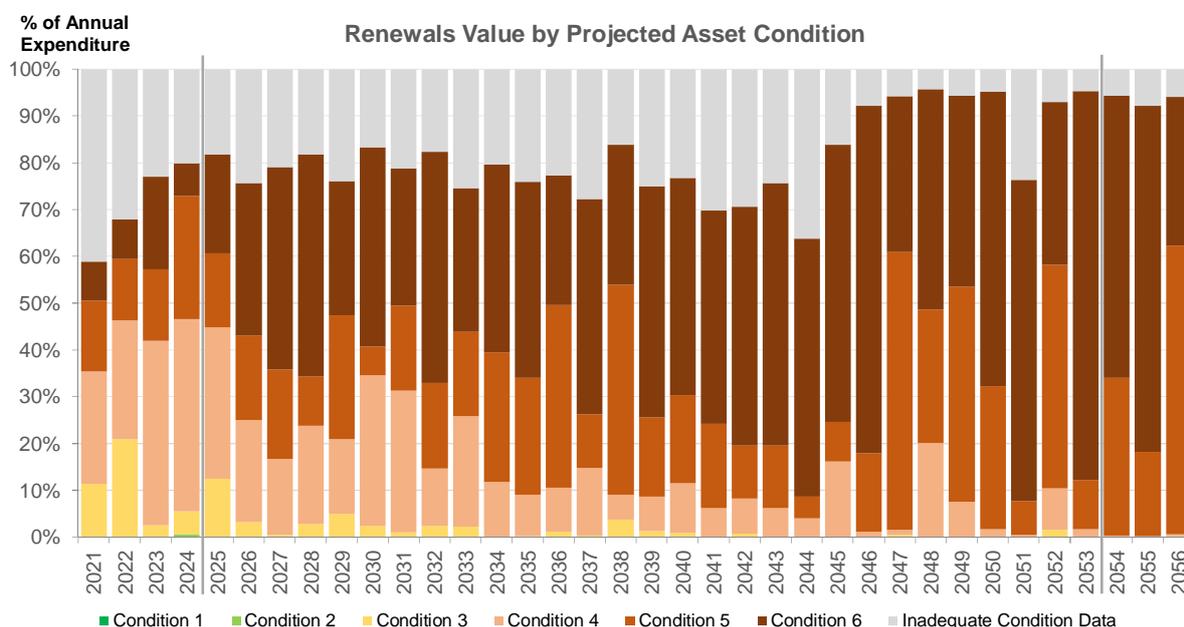
Figure 36 and Figure 37 present the value of the Sunwater’s proposed renewal and refurbishment works programs respectively, showing the predicted asset condition at the planned time for renewal. The predicted asset condition (using Sunwater’s criteria and decay curve) is colour-coded, ranging from one (as new, in green) to six (at end-of-life, in dark brown).

Figure 36 Sunwater’s Proposed Renewals Expenditure by Predicted Asset Condition

Our analysis finds that 15% of the planned works (by value) are for assets where the projected condition assessment data is expected to be a condition state of three or better at the time of renewal, which using Sunwater’s standard decay curve represents assets which have less than 37% of their life expectancy expired.

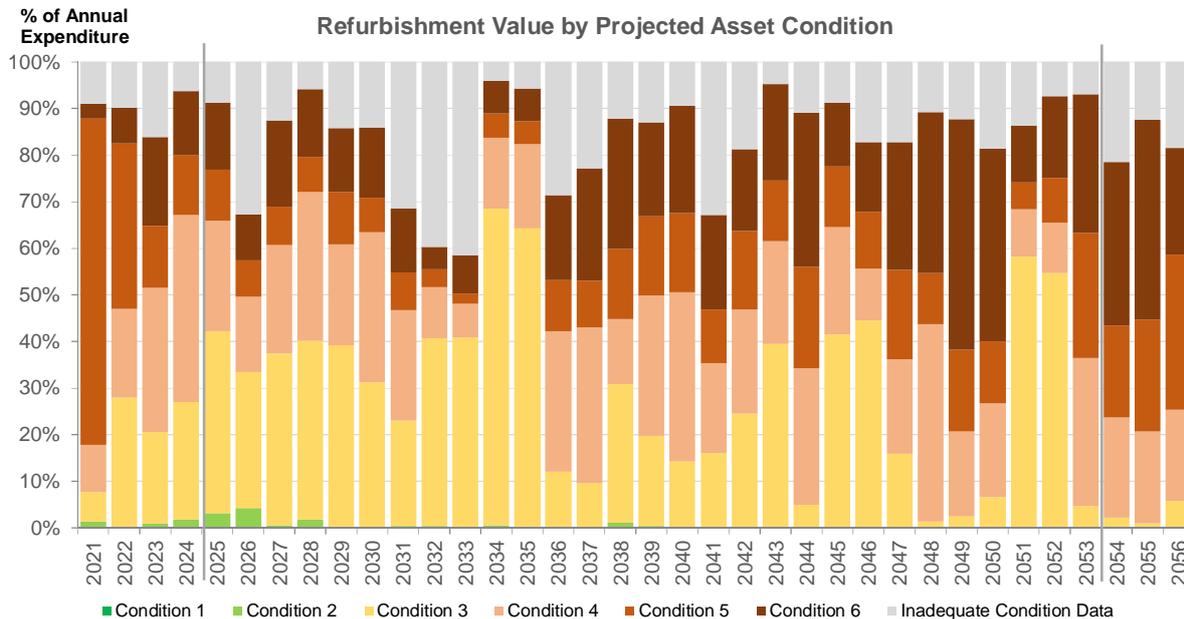
Figure 37 Sunwater’s Proposed Refurbishment Expenditure by Predicted Asset Condition

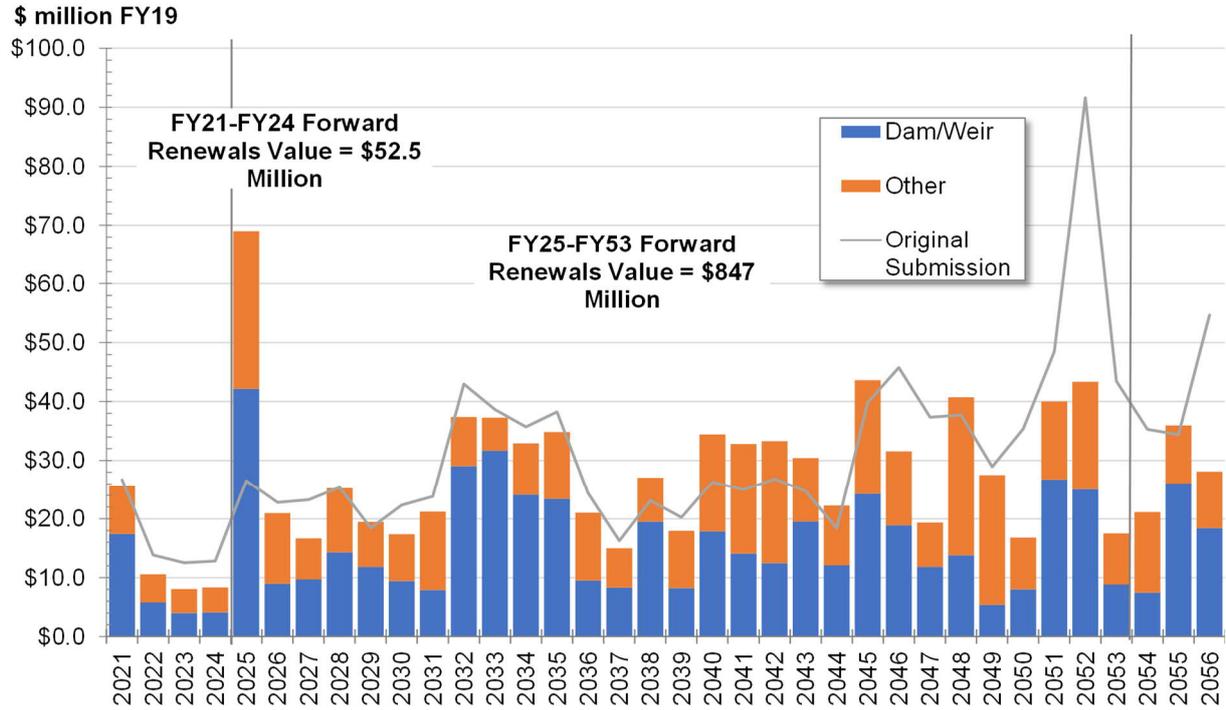
We have applied Sunwater’s rules to the proposed renewal projects as we believe they should have been applied, following Sunwater’s own documented procedures. The result is shown in Figure 38, with Sunwater’s revised submission shown as a line above the bars. A breakdown of the adjustments made due to the timing of projects is presented in Figure 39.

Figure 38 Revised Renewal Program Applying Sunwater's Rules (\$ million, FY19)

The revision reduces the value of the annuity to \$52.5 million and \$847.0 million for the price path period and beyond price path period respectively (in \$FY19). This finding is in support of the adjustment made in Section 7.4.2, indicating that Sunwater’s renewals program as submitted would result in over-maintenance of assets. This adjustment based on projected condition is shown for indicative purposes only, and is considered to be captured by the adjustment made in Section 7.4.2 reflecting an increase in useful life.

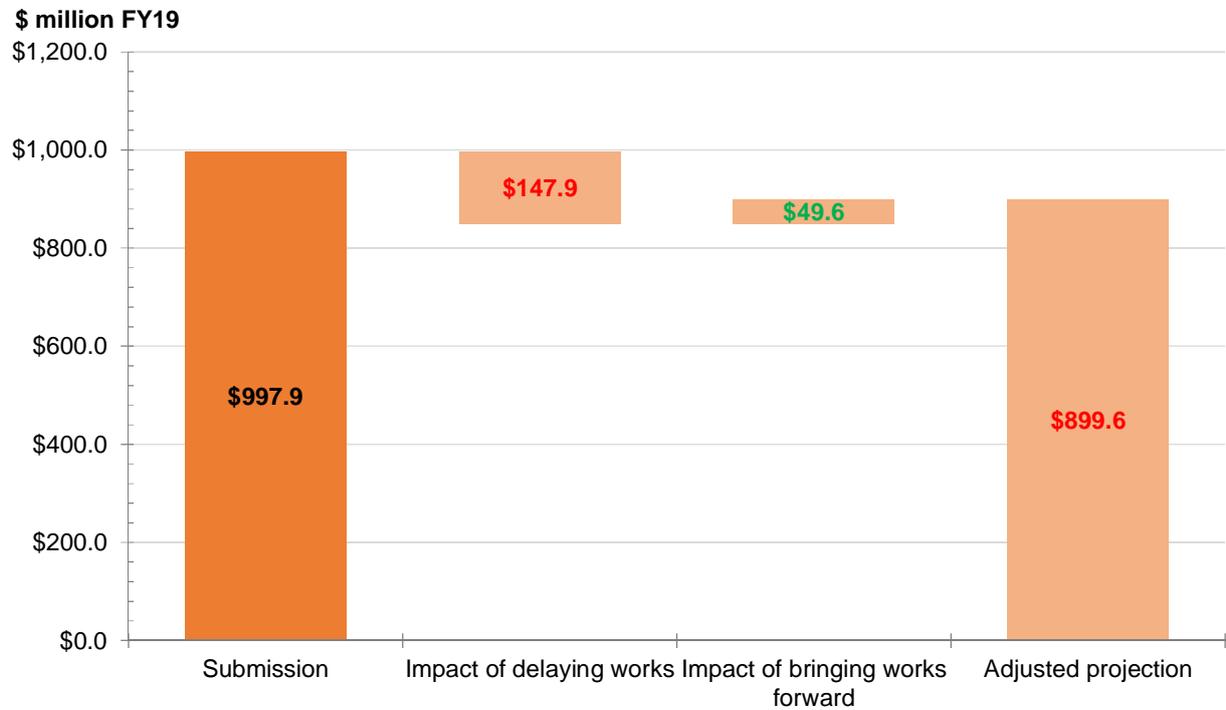
Figure 39 Breakdown of Adjustments made Applying Sunwater's Rules, FY21-FY53 (\$ million, FY19)

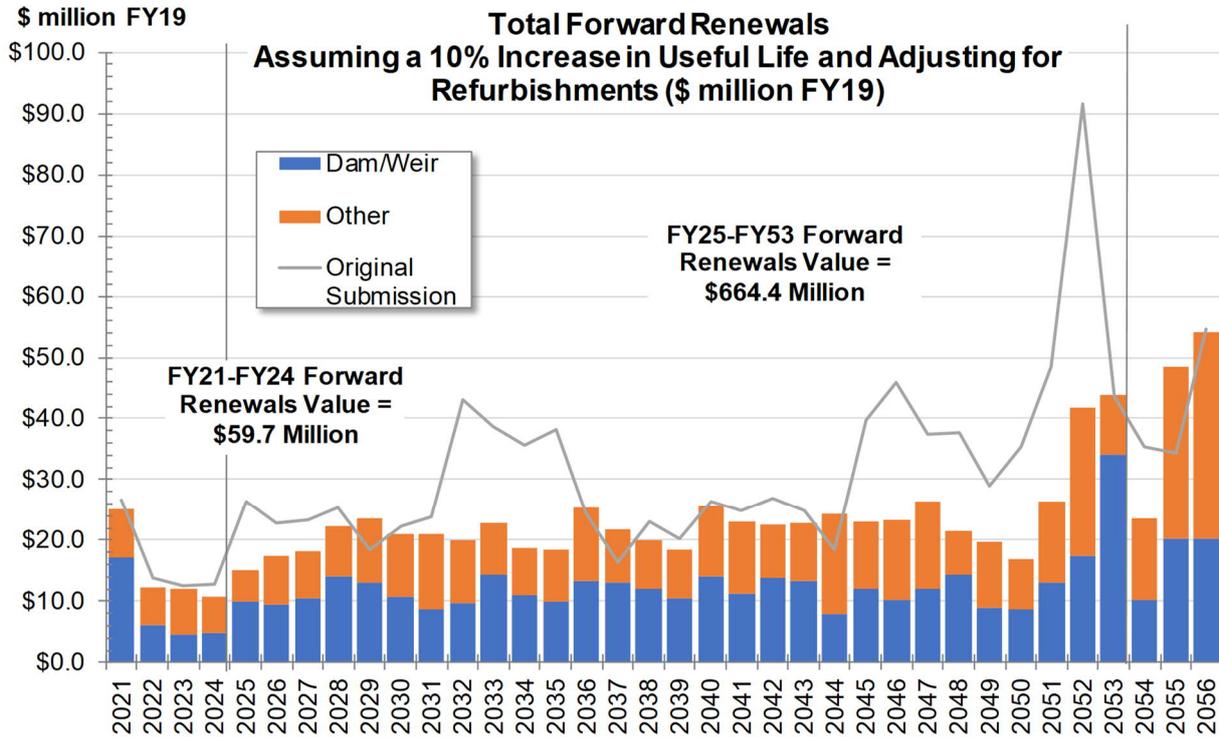
The impact of this on the annuity (additional to the renewals adjustment outlined in Section 7.4.2) is presented in Figure 40. This would reduce the value of the annuity to \$59.7 million and \$664.4 million for the price path period and beyond price path period respectively (in \$FY19).

Figure 40 Revised Forward Renewal Program Applying a 10% Increase in Useful Life and Adjusting for Refurbishments (\$ million, FY19)

- We recommend that our revision of Sunwater’s data as indicated in Figure 40 be used for calculating the annuity. We recommend that, the value of annuities (in \$FY19) for the price path period be reduced from \$65.9 million to \$59.7 million, a reduction of \$6.2 million or 9.4% and the

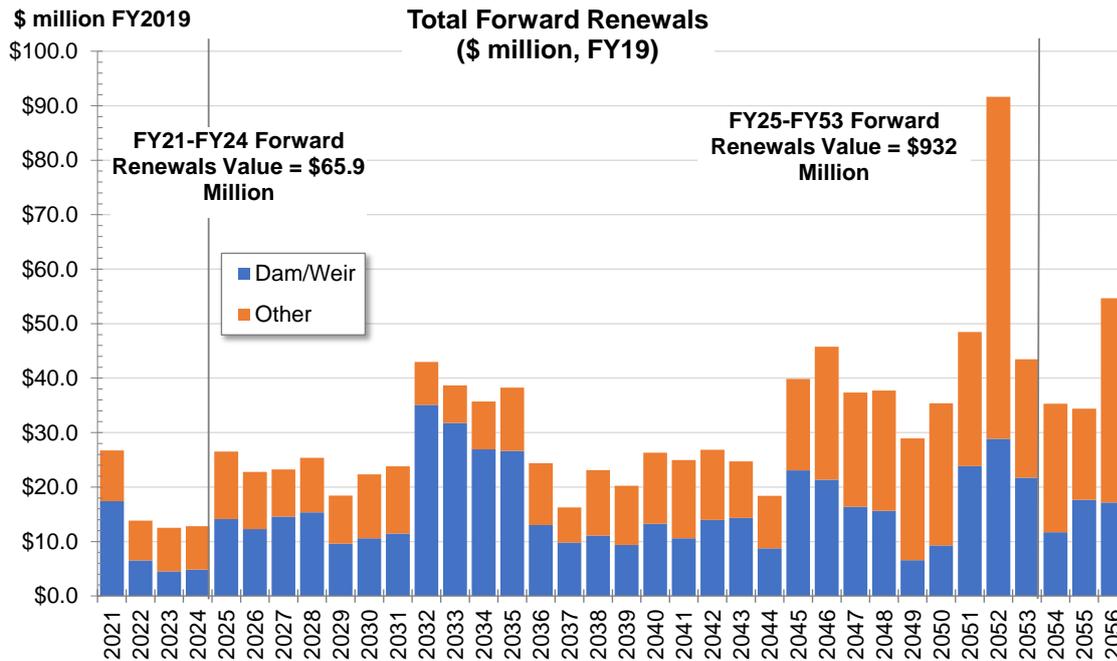
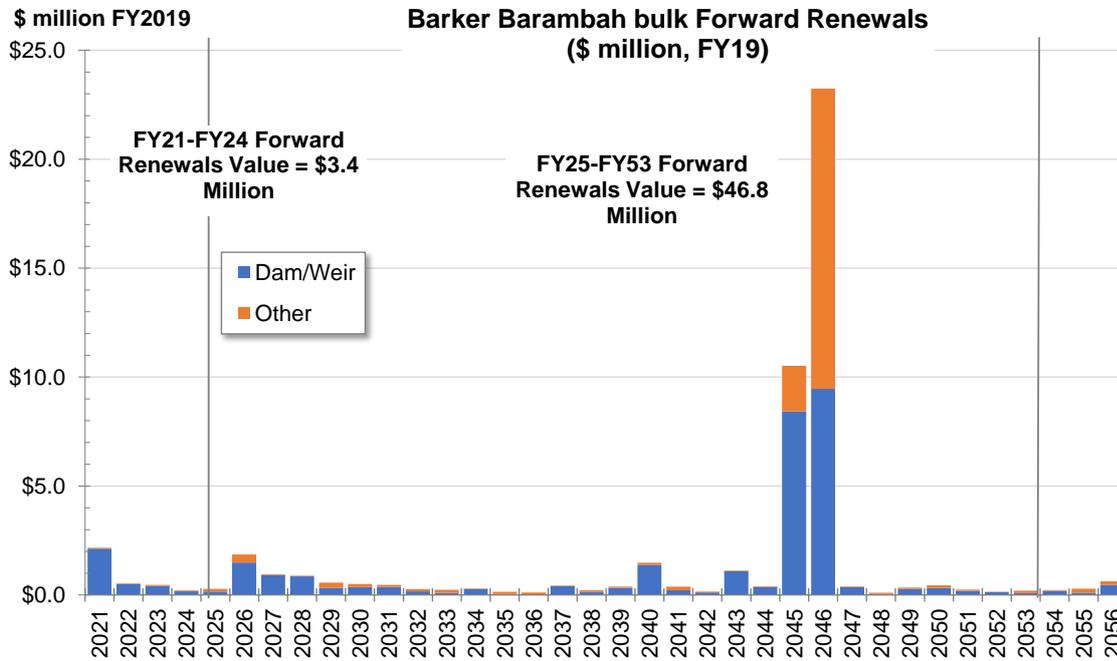
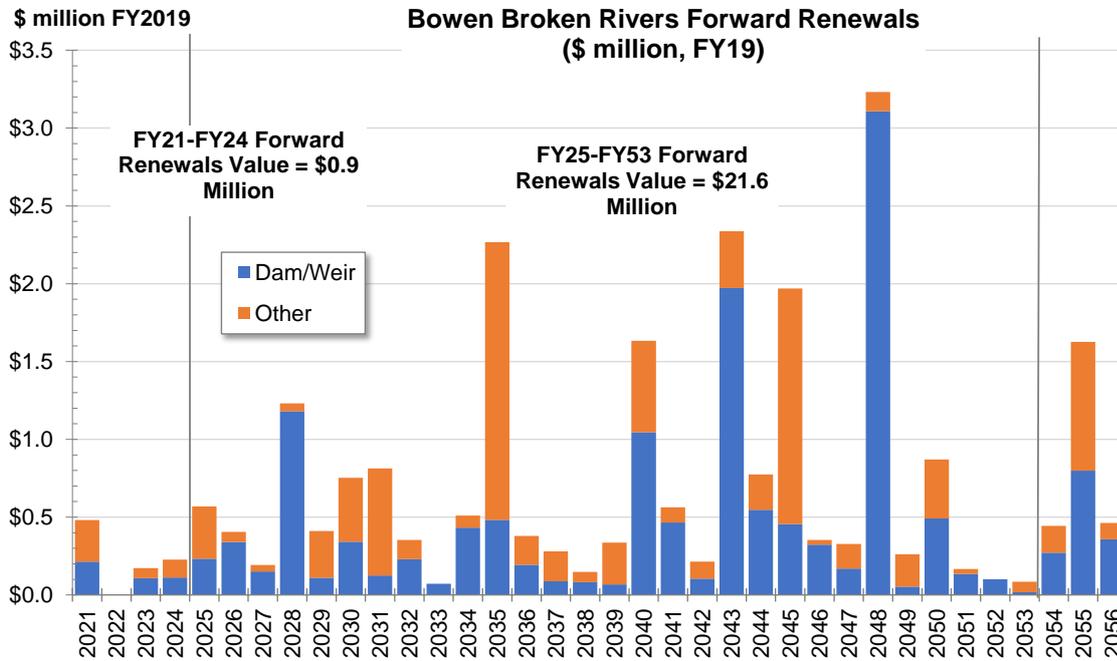
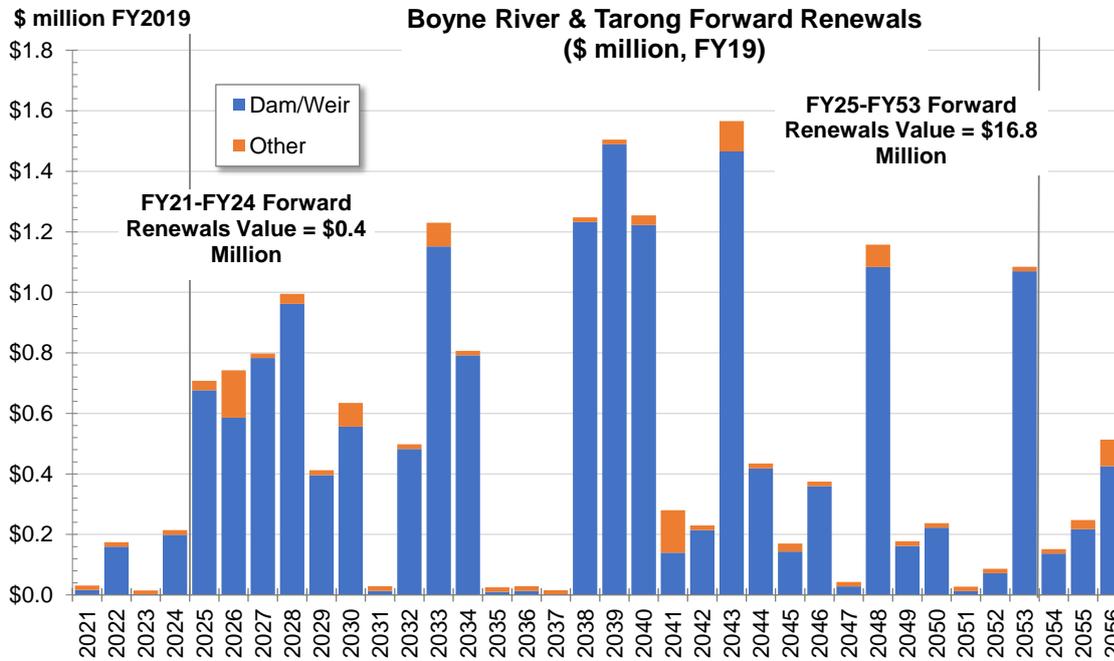
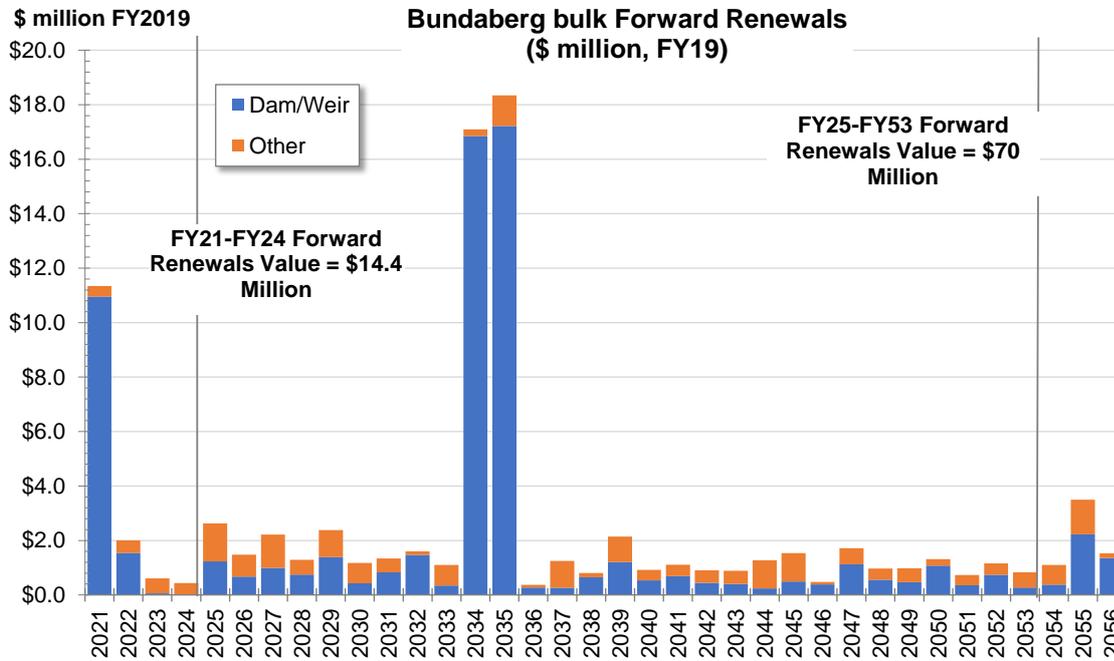
Figure 1 presents Sunwater's revised forward renewals submission.
Figure 2 presents Sunwater's revised forward renewals submission adjusted for the impact of applying a 10% life extension.
Figure 3 (where provided) presents an additional adjustment for refurbishment issues identified in select bulk water schemes.
Table 1 presents a tabulated annual comparison of the submitted and adjusted forward renewals submission.
