Rural Irrigation Capital Expenditure Review

Sunwater

Client: Queensland Competition Authority

AECOM Australia Pty Ltd

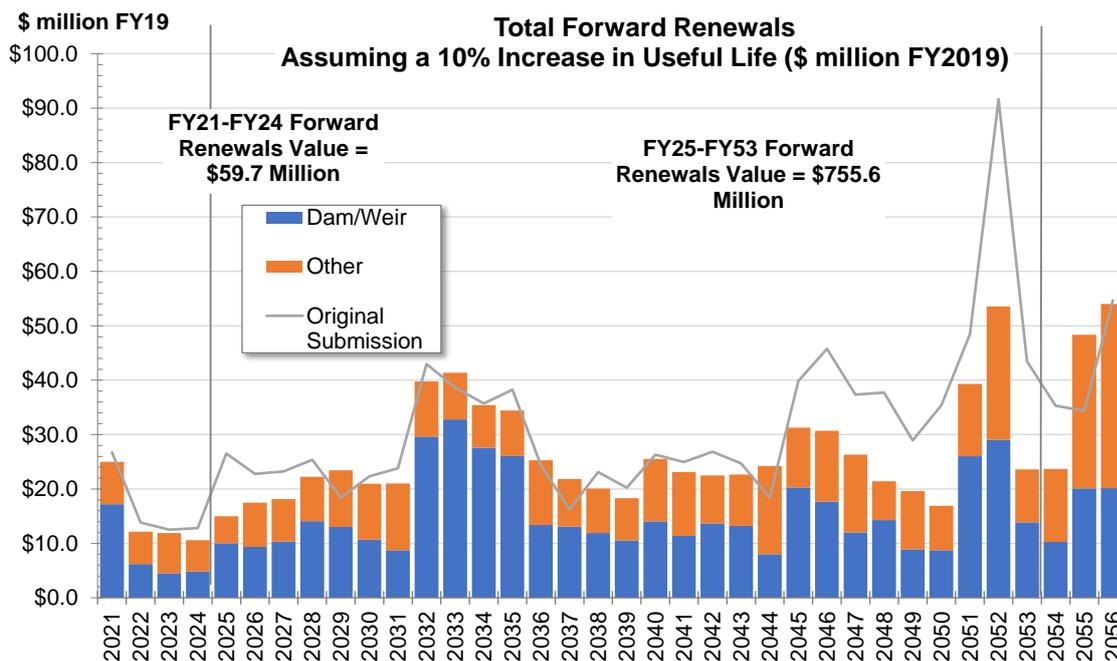
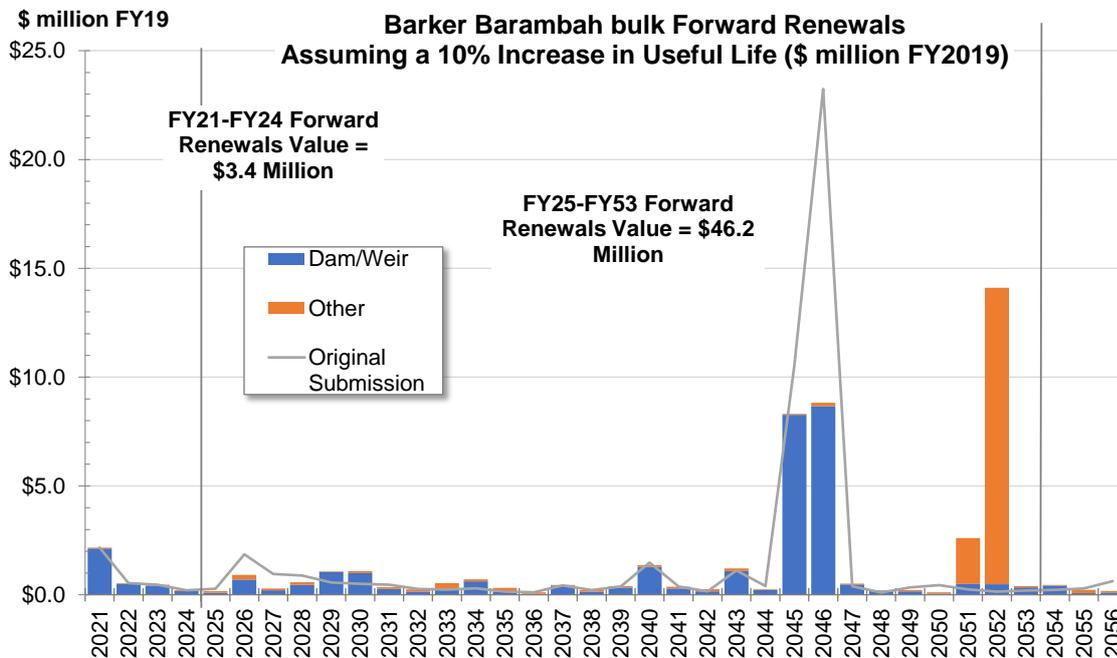
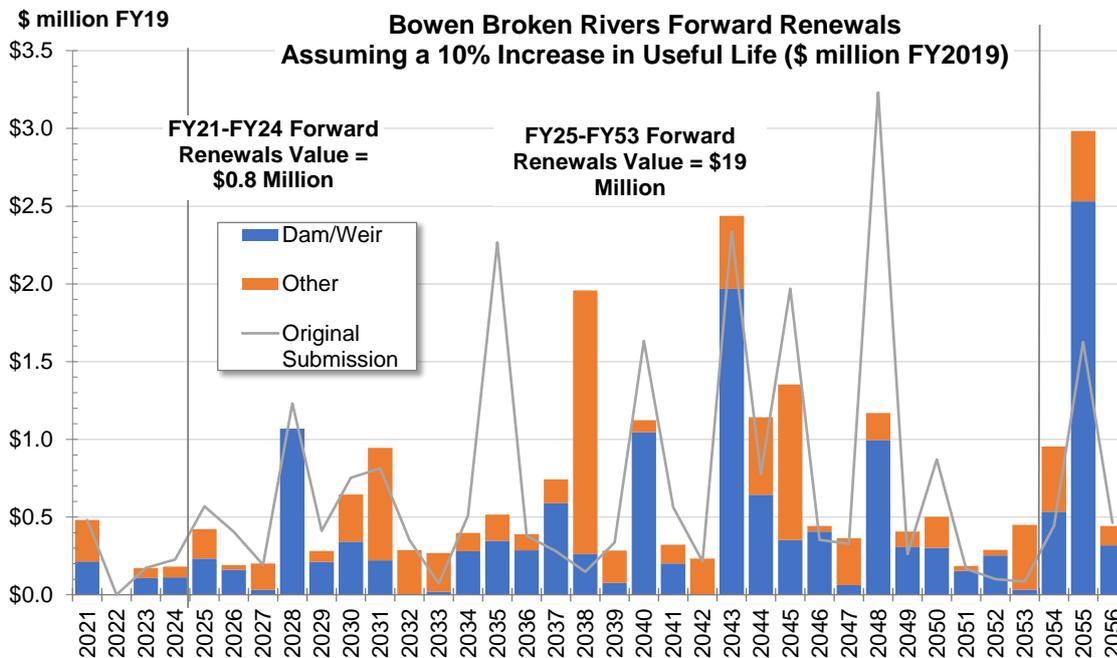
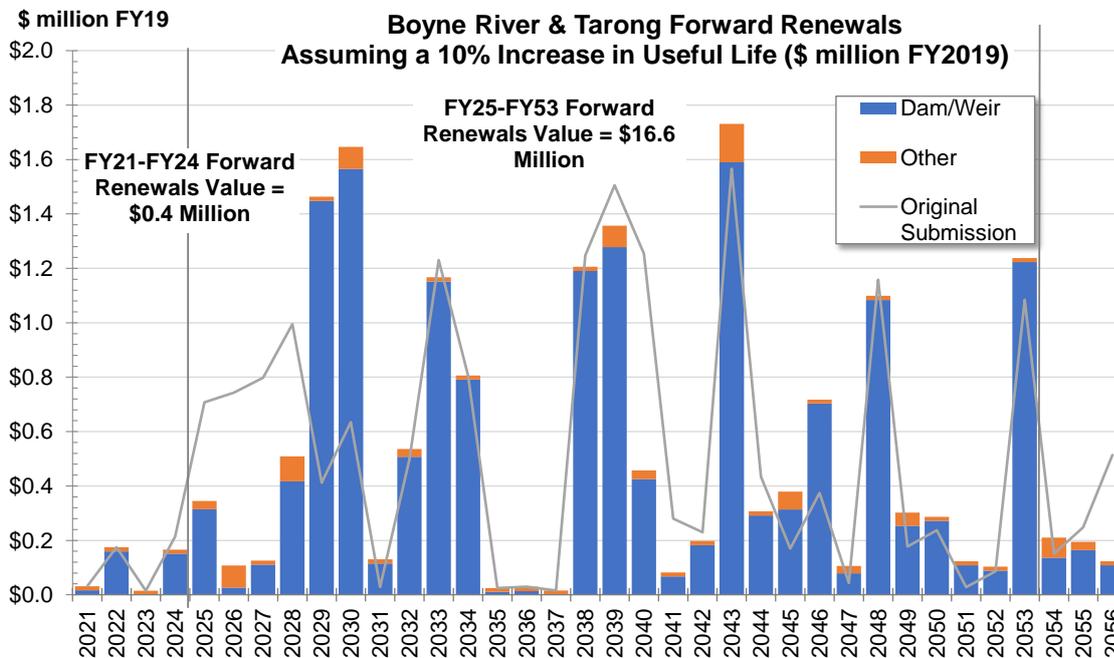
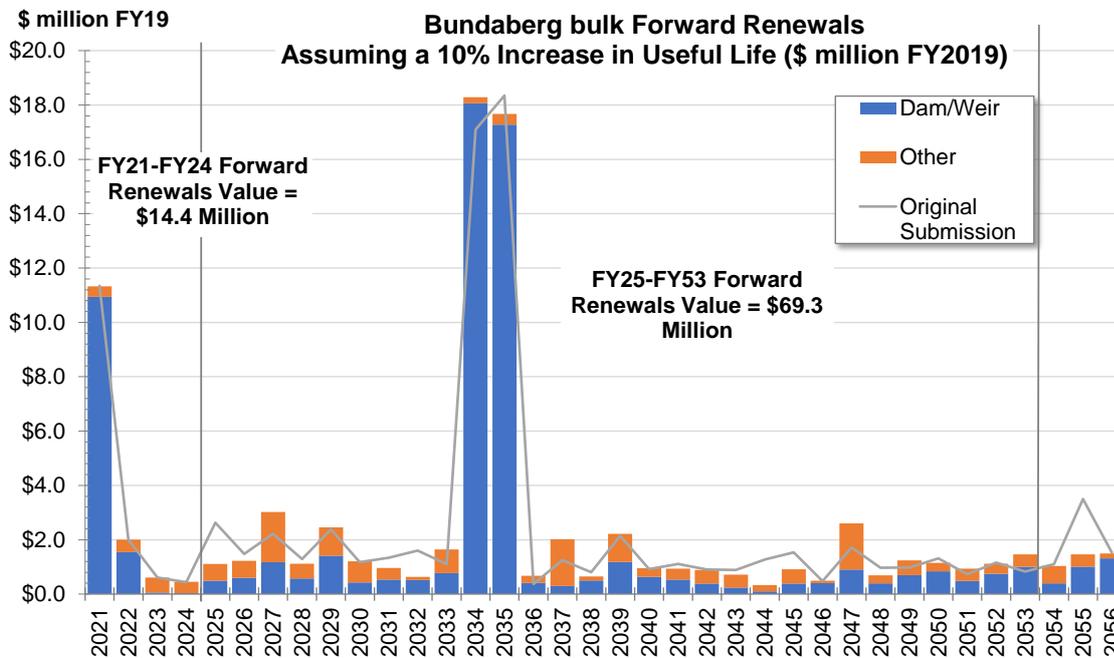
Figure 1 presents Sunwater's revised forward renewals submission.
Figure 2 presents Sunwater's revised forward renewals submission adjusted for the impact of applying a 10% life extension.
Figure 3 (where provided) presents an additional adjustment for refurbishment issues identified in select bulk water schemes.
Table 1 presents a tabulated annual comparison of the submitted and adjusted forward renewals submission.

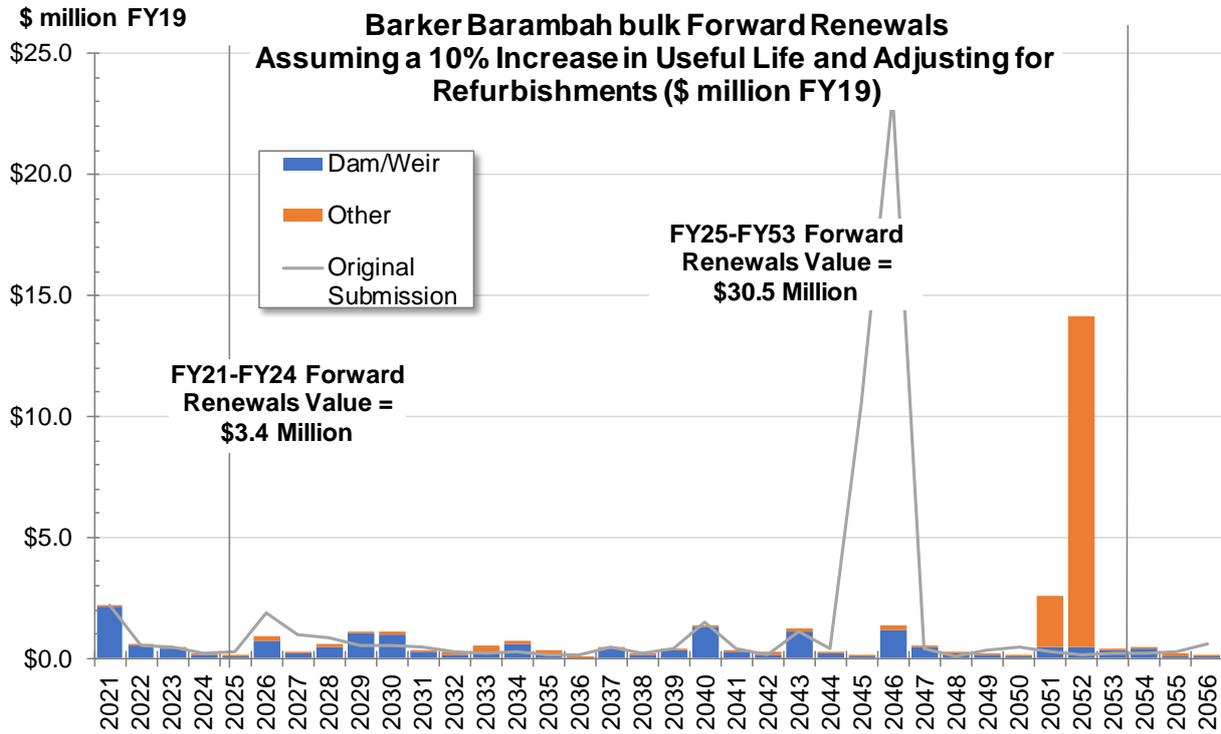
Figure 1 presents Sunwater's revised forward renewals submission.
Figure 2 presents Sunwater's revised forward renewals submission adjusted for the impact of applying a 10% life extension.
Figure 3 (where provided) presents an additional adjustment for refurbishment issues identified in select bulk water schemes.
Table 1 presents a tabulated annual comparison of the submitted and adjusted forward renewals submission.

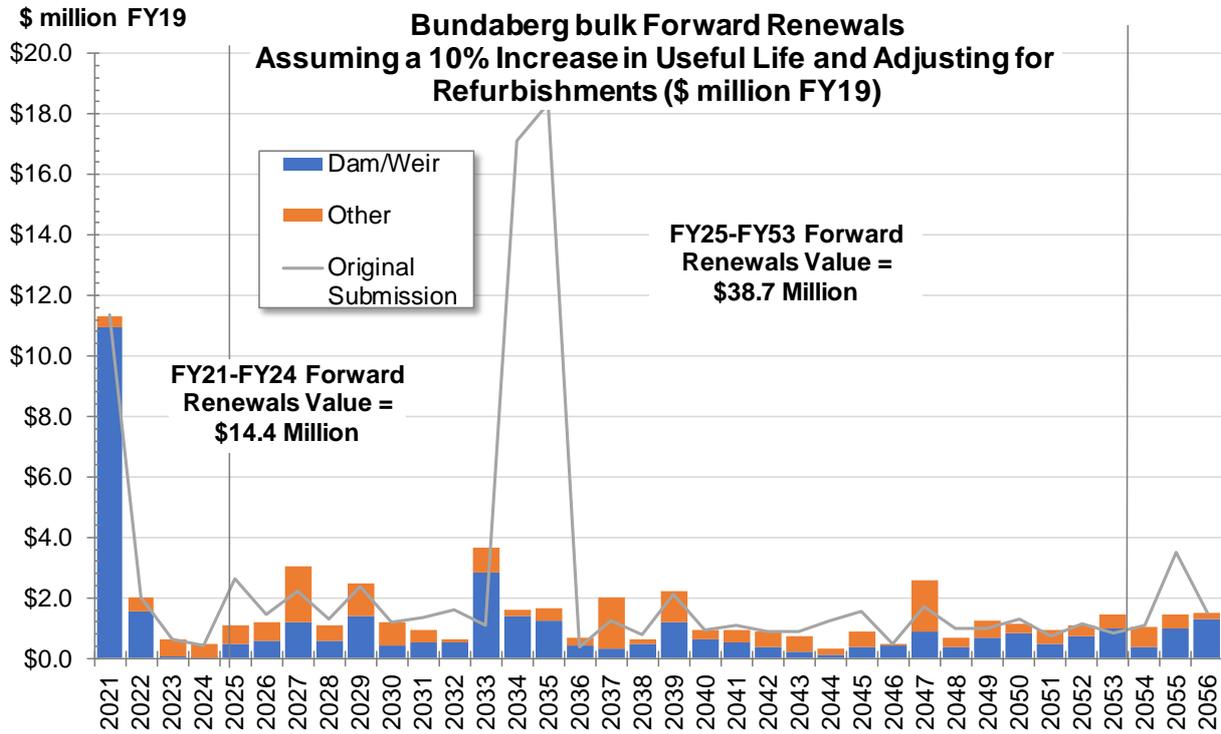
Figure 1 presents Sunwater's revised forward renewals submission.
Figure 2 presents Sunwater's revised forward renewals submission adjusted for the impact of applying a 10% life extension.
Figure 3 (where provided) presents an additional adjustment for refurbishment issues identified in select bulk water schemes.
Table 1 presents a tabulated annual comparison of the submitted and adjusted forward renewals submission.

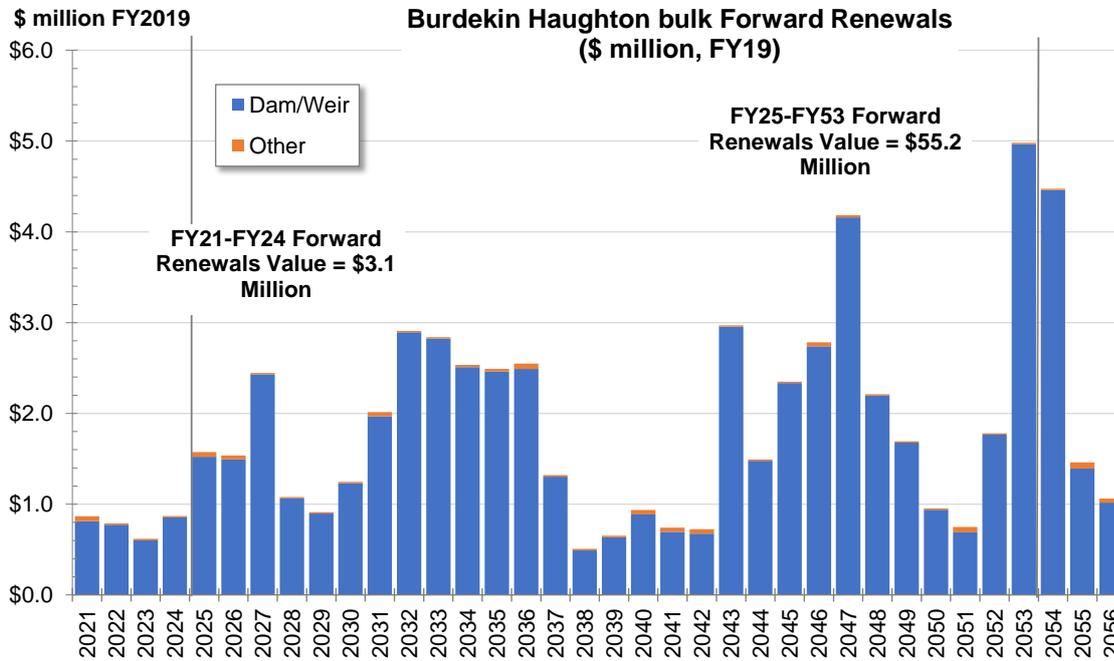
Figure 1 presents Sunwater's revised forward renewals submission.
Figure 2 presents Sunwater's revised forward renewals submission adjusted for the impact of applying a 10% life extension.
Figure 3 (where provided) presents an additional adjustment for refurbishment issues identified in select bulk water schemes.
Table 1 presents a tabulated annual comparison of the submitted and adjusted forward renewals submission.

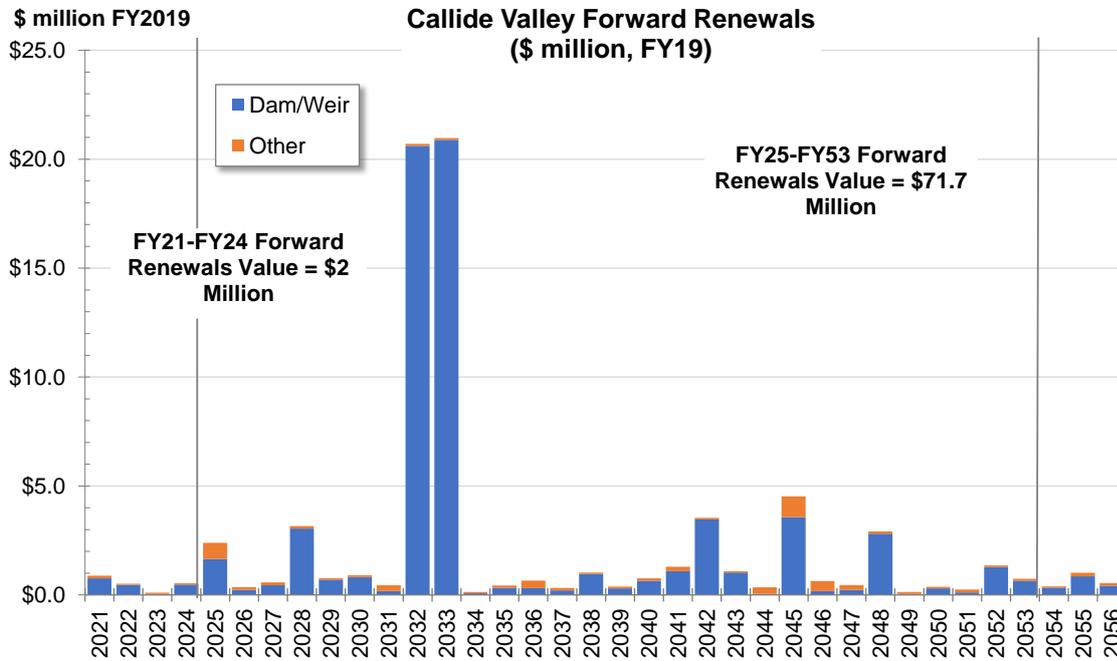
Figure 1 presents Sunwater's revised forward renewals submission.
Figure 2 presents Sunwater's revised forward renewals submission adjusted for the impact of applying a 10% life extension.
Figure 3 (where provided) presents an additional adjustment for refurbishment issues identified in select bulk water schemes.
Table 1 presents a tabulated annual comparison of the submitted and adjusted forward renewals submission.

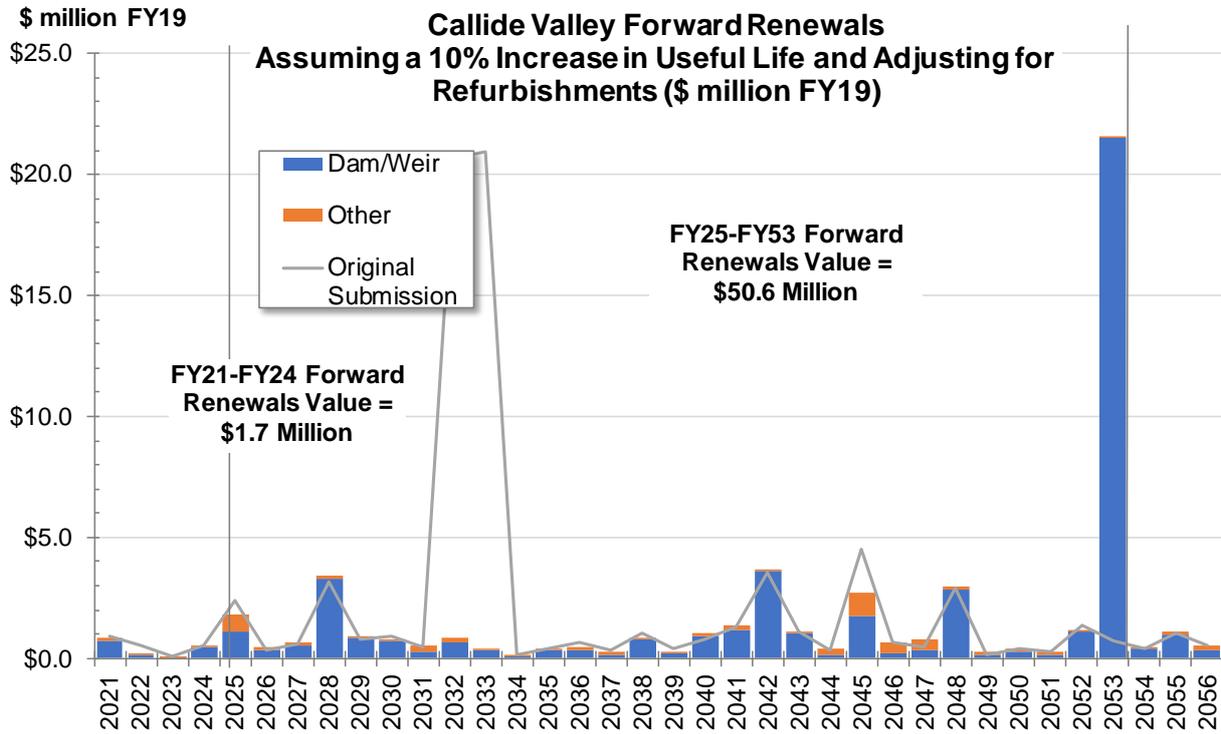
Figure 1 presents Sunwater's revised forward renewals submission.
Figure 2 presents Sunwater's revised forward renewals submission adjusted for the impact of applying a 10% life extension.
Figure 3 (where provided) presents an additional adjustment for refurbishment issues identified in select bulk water schemes.
Table 1 presents a tabulated annual comparison of the submitted and adjusted forward renewals submission.

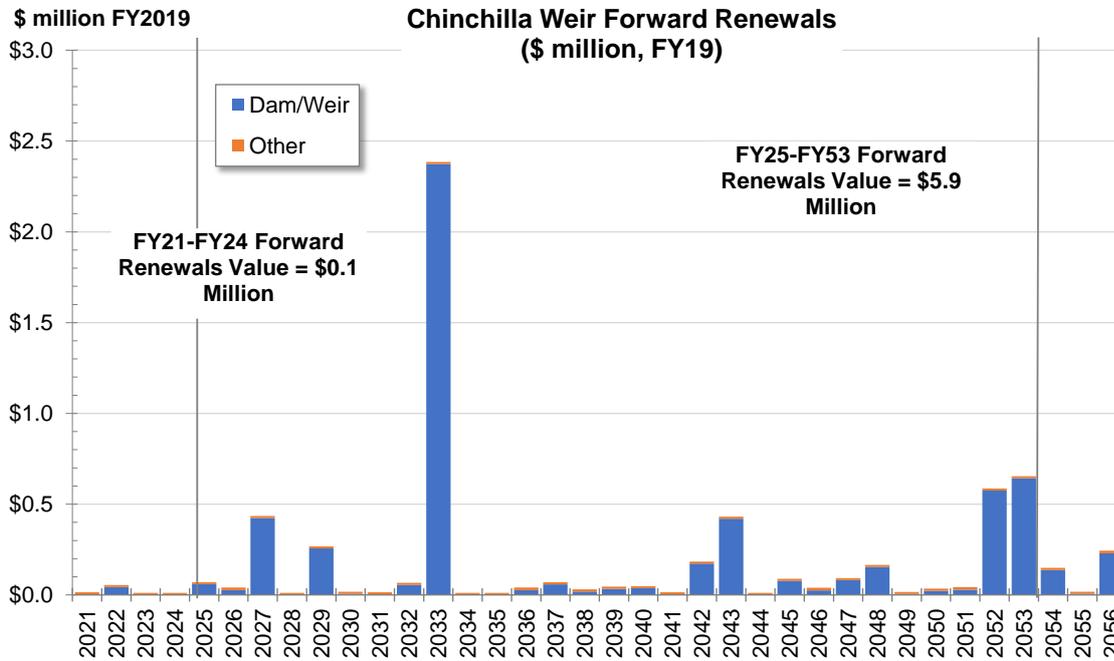
Figure 1 presents Sunwater's revised forward renewals submission.
Figure 2 presents Sunwater's revised forward renewals submission adjusted for the impact of applying a 10% life extension.
Figure 3 (where provided) presents an additional adjustment for refurbishment issues identified in select bulk water schemes.
Table 1 presents a tabulated annual comparison of the submitted and adjusted forward renewals submission.

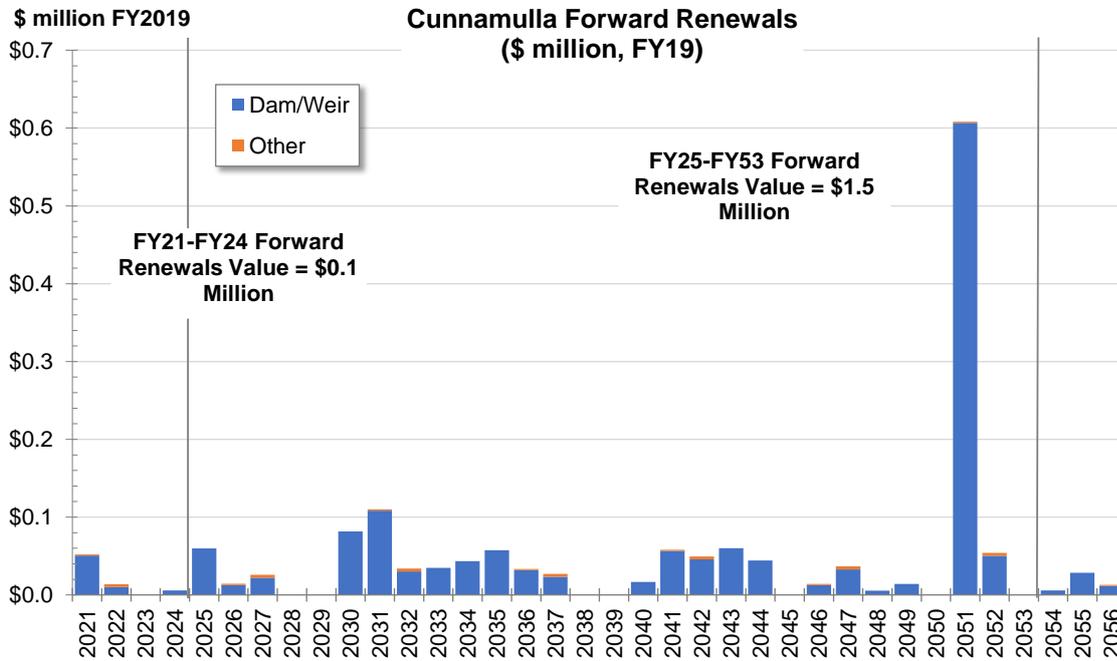
Figure 1 presents Sunwater's revised forward renewals submission.
Figure 2 presents Sunwater's revised forward renewals submission adjusted for the impact of applying a 10% life extension.
Figure 3 (where provided) presents an additional adjustment for refurbishment issues identified in select bulk water schemes.
Table 1 presents a tabulated annual comparison of the submitted and adjusted forward renewals submission.

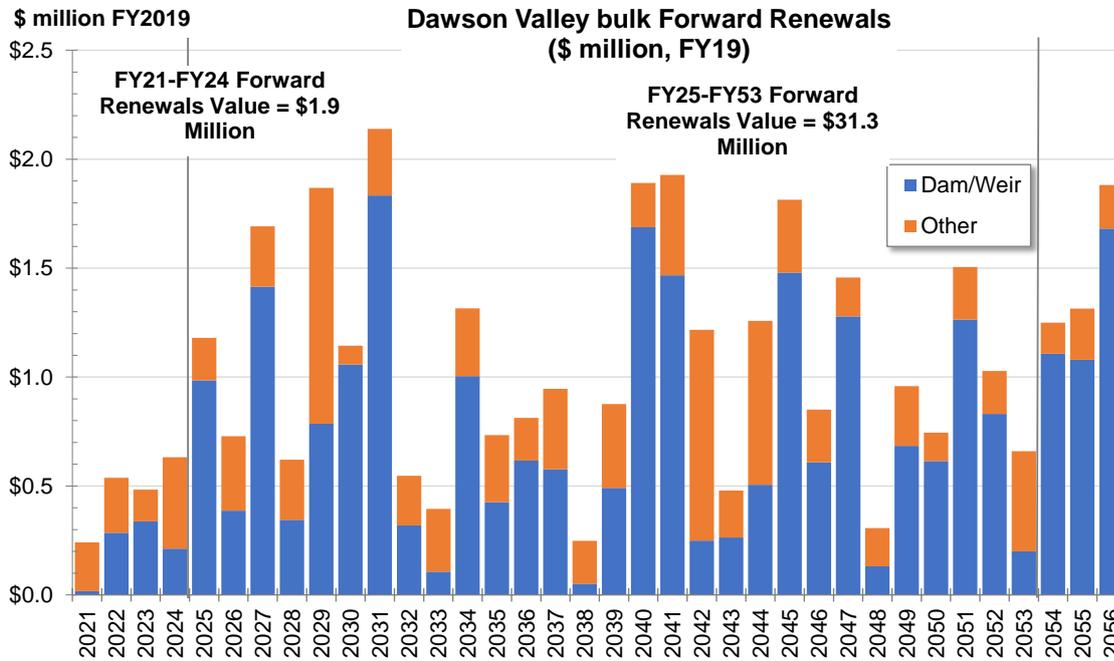
Figure 1 presents Sunwater's revised forward renewals submission.
Figure 2 presents Sunwater's revised forward renewals submission adjusted for the impact of applying a 10% life extension.
Figure 3 (where provided) presents an additional adjustment for refurbishment issues identified in select bulk water schemes.
Table 1 presents a tabulated annual comparison of the submitted and adjusted forward renewals submission.

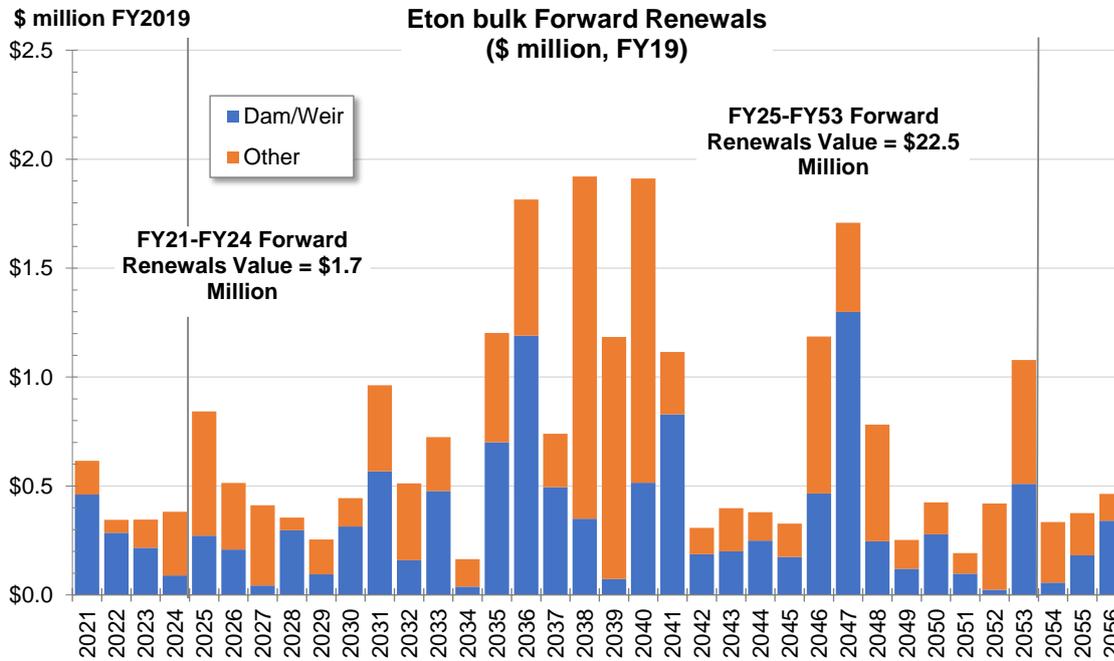
Figure 1 presents Sunwater's revised forward renewals submission.
Figure 2 presents Sunwater's revised forward renewals submission adjusted for the impact of applying a 10% life extension.
Figure 3 (where provided) presents an additional adjustment for refurbishment issues identified in select bulk water schemes.
Table 1 presents a tabulated annual comparison of the submitted and adjusted forward renewals submission.

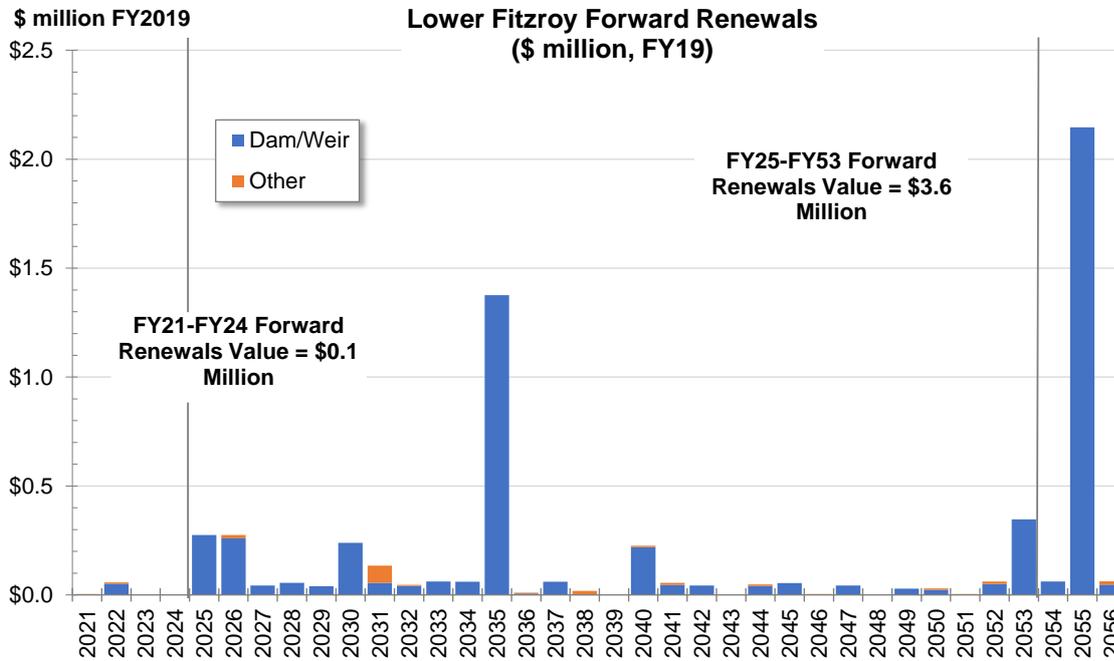
Figure 1 presents Sunwater's revised forward renewals submission.
Figure 2 presents Sunwater's revised forward renewals submission adjusted for the impact of applying a 10% life extension.
Figure 3 (where provided) presents an additional adjustment for refurbishment issues identified in select bulk water schemes.
Table 1 presents a tabulated annual comparison of the submitted and adjusted forward renewals submission.

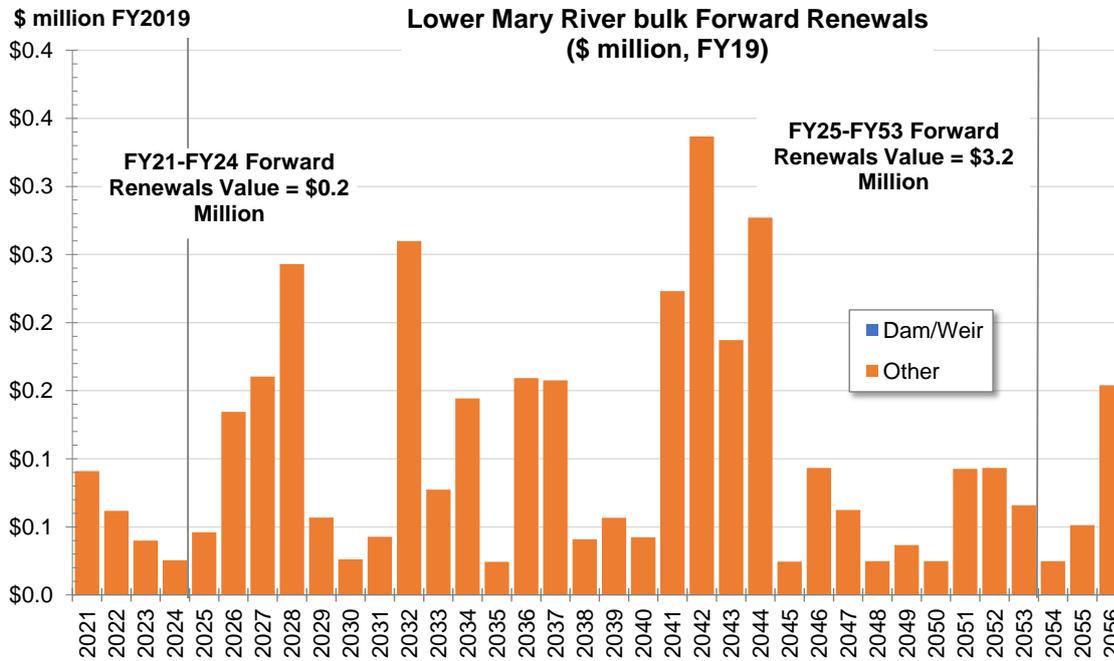
Figure 1 presents Sunwater's revised forward renewals submission.
Figure 2 presents Sunwater's revised forward renewals submission adjusted for the impact of applying a 10% life extension.
Figure 3 (where provided) presents an additional adjustment for refurbishment issues identified in select bulk water schemes.
Table 1 presents a tabulated annual comparison of the submitted and adjusted forward renewals submission.

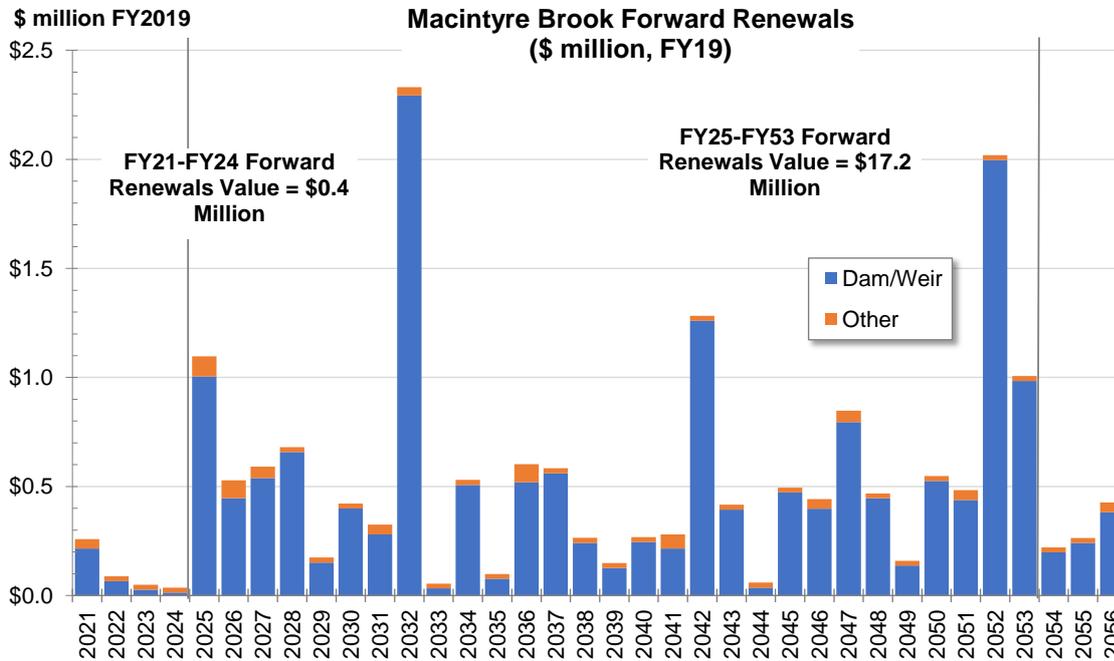
Figure 1 presents Sunwater's revised forward renewals submission.
Figure 2 presents Sunwater's revised forward renewals submission adjusted for the impact of applying a 10% life extension.
Figure 3 (where provided) presents an additional adjustment for refurbishment issues identified in select bulk water schemes.
Table 1 presents a tabulated annual comparison of the submitted and adjusted forward renewals submission.

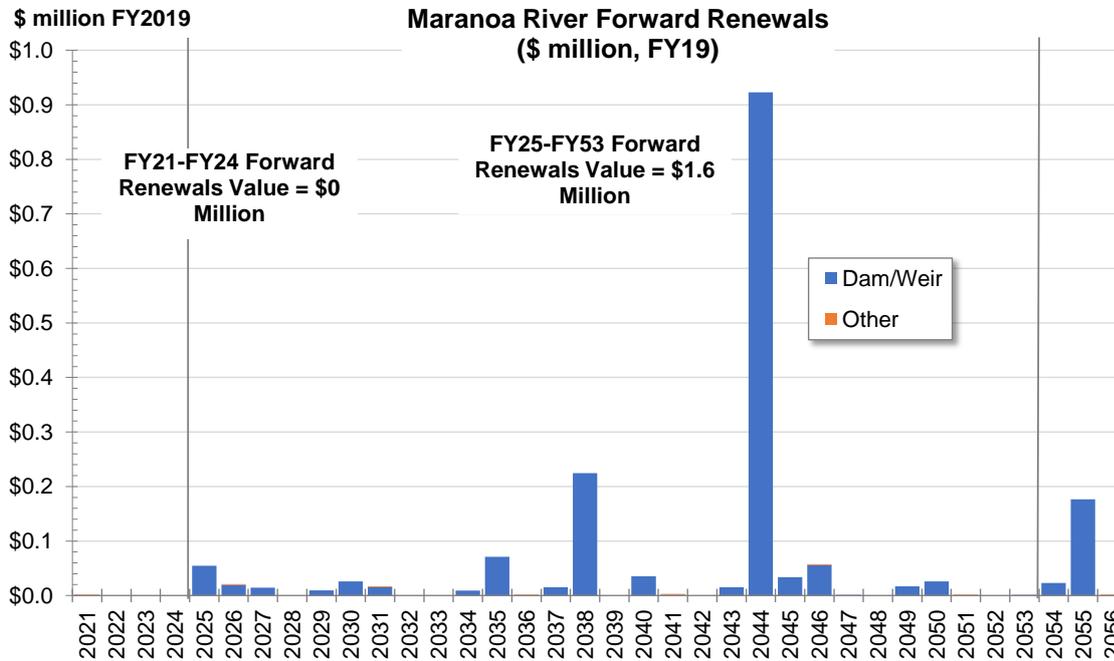
Figure 1 presents Sunwater's revised forward renewals submission.
Figure 2 presents Sunwater's revised forward renewals submission adjusted for the impact of applying a 10% life extension.
Figure 3 (where provided) presents an additional adjustment for refurbishment issues identified in select bulk water schemes.
Table 1 presents a tabulated annual comparison of the submitted and adjusted forward renewals submission.

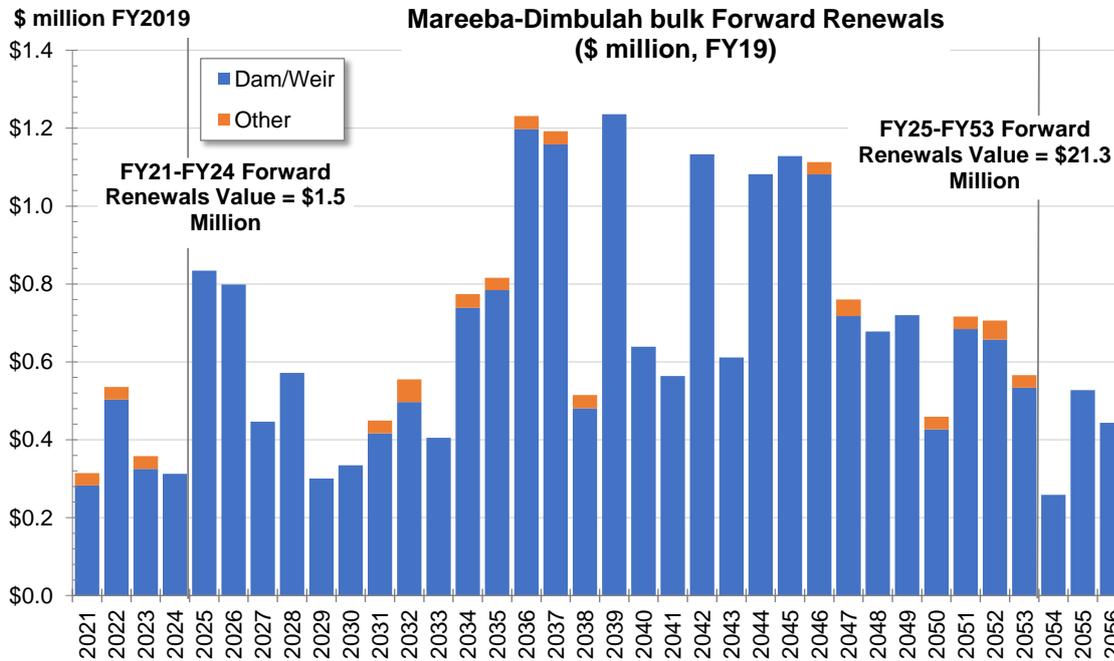
Figure 1 presents Sunwater's revised forward renewals submission.
Figure 2 presents Sunwater's revised forward renewals submission adjusted for the impact of applying a 10% life extension.
Figure 3 (where provided) presents an additional adjustment for refurbishment issues identified in select bulk water schemes.
Table 1 presents a tabulated annual comparison of the submitted and adjusted forward renewals submission.

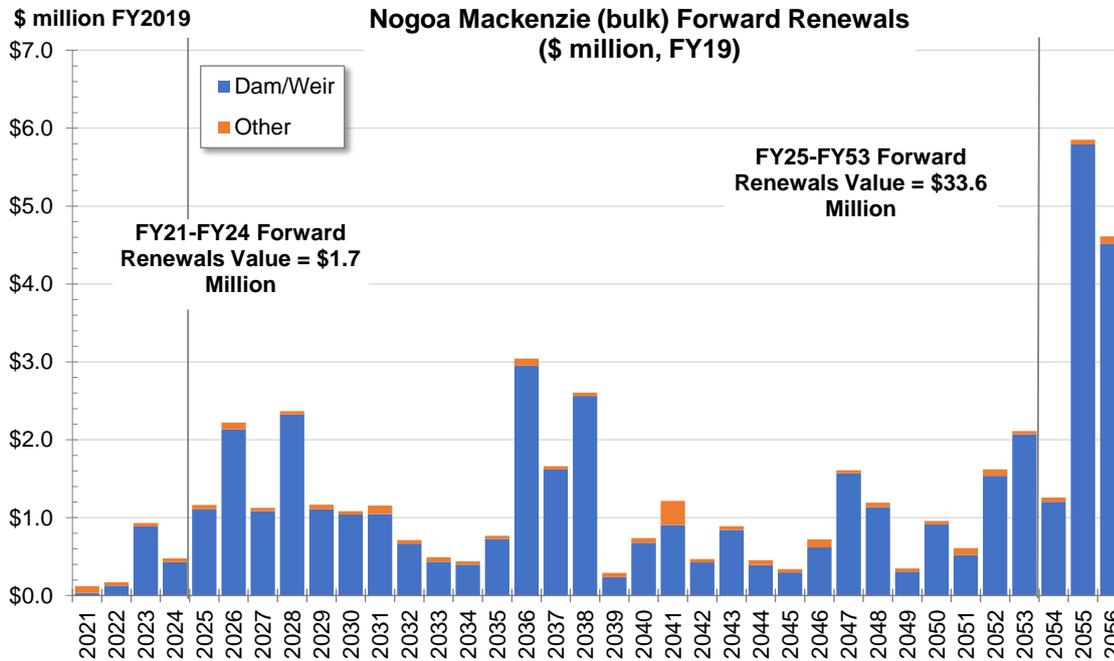
Figure 1 presents Sunwater's revised forward renewals submission.
Figure 2 presents Sunwater's revised forward renewals submission adjusted for the impact of applying a 10% life extension.
Figure 3 (where provided) presents an additional adjustment for refurbishment issues identified in select bulk water schemes.
Table 1 presents a tabulated annual comparison of the submitted and adjusted forward renewals submission.

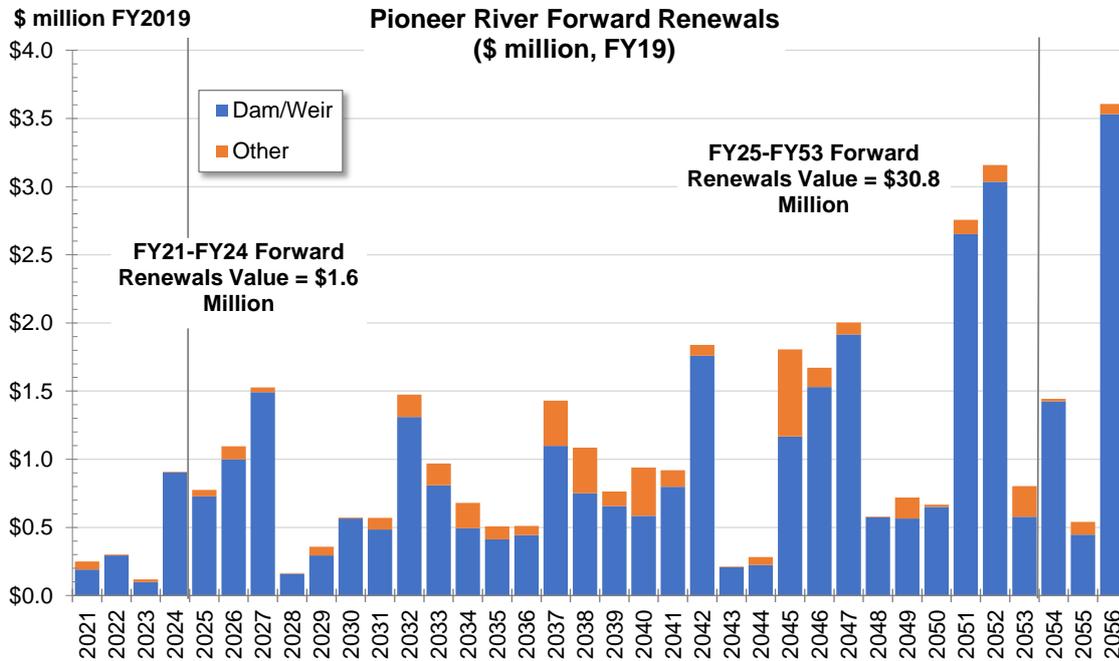
Figure 1 presents Sunwater's revised forward renewals submission.
Figure 2 presents Sunwater's revised forward renewals submission adjusted for the impact of applying a 10% life extension.
Figure 3 (where provided) presents an additional adjustment for refurbishment issues identified in select bulk water schemes.
Table 1 presents a tabulated annual comparison of the submitted and adjusted forward renewals submission.

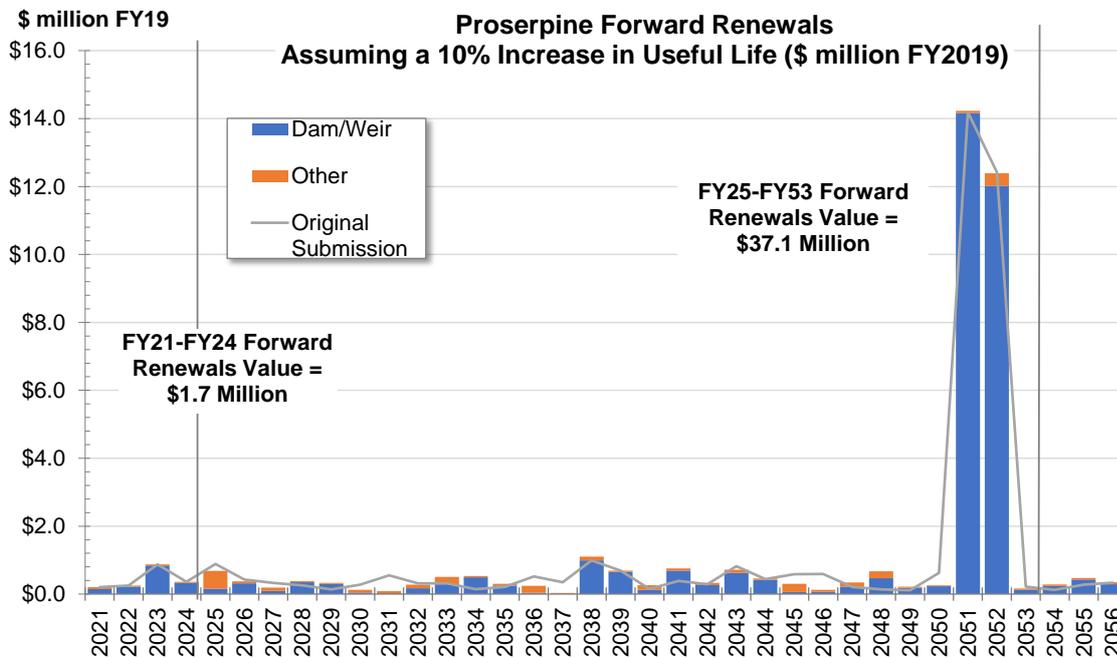
Figure 1 presents Sunwater's revised forward renewals submission.
Figure 2 presents Sunwater's revised forward renewals submission adjusted for the impact of applying a 10% life extension.
Figure 3 (where provided) presents an additional adjustment for refurbishment issues identified in select bulk water schemes.
Table 1 presents a tabulated annual comparison of the submitted and adjusted forward renewals submission.

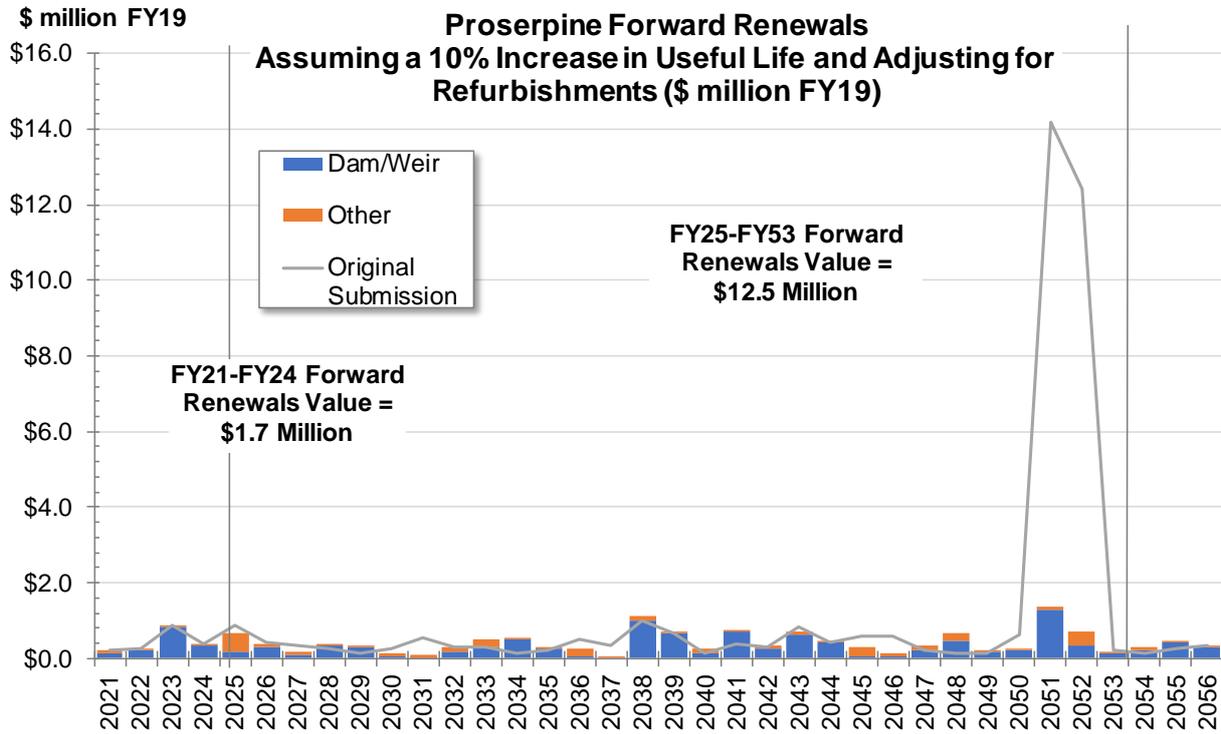
Figure 1 presents Sunwater's revised forward renewals submission.
Figure 2 presents Sunwater's revised forward renewals submission adjusted for the impact of applying a 10% life extension.
Figure 3 (where provided) presents an additional adjustment for refurbishment issues identified in select bulk water schemes.
Table 1 presents a tabulated annual comparison of the submitted and adjusted forward renewals submission.

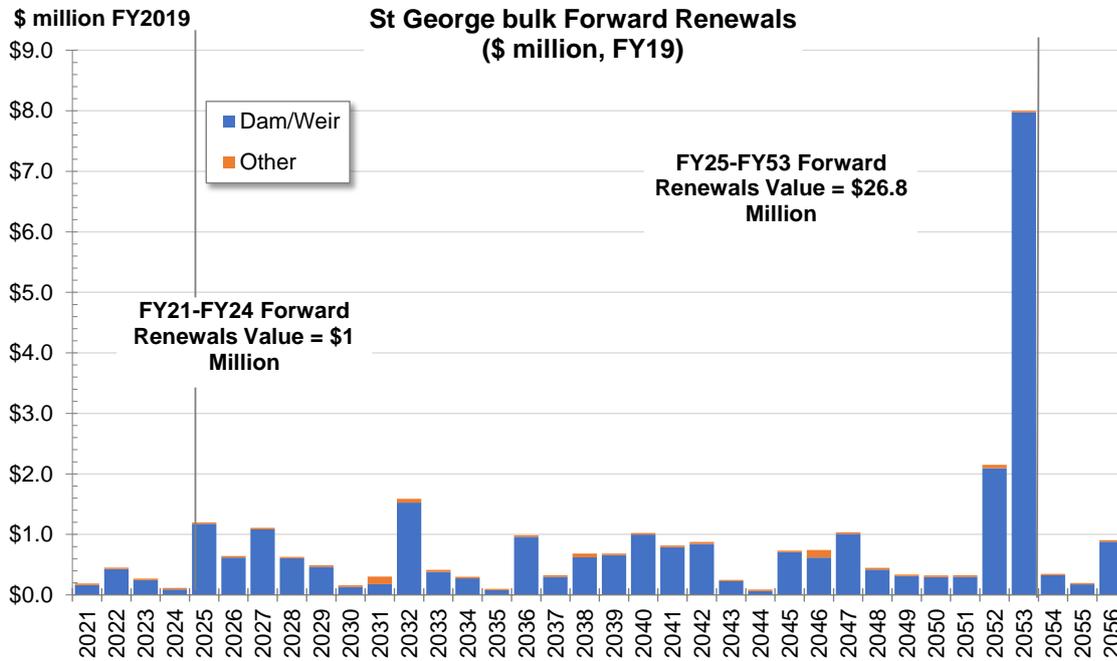
Figure 1 presents Sunwater's revised forward renewals submission.
Figure 2 presents Sunwater's revised forward renewals submission adjusted for the impact of applying a 10% life extension.
Figure 3 (where provided) presents an additional adjustment for refurbishment issues identified in select bulk water schemes.
Table 1 presents a tabulated annual comparison of the submitted and adjusted forward renewals submission.

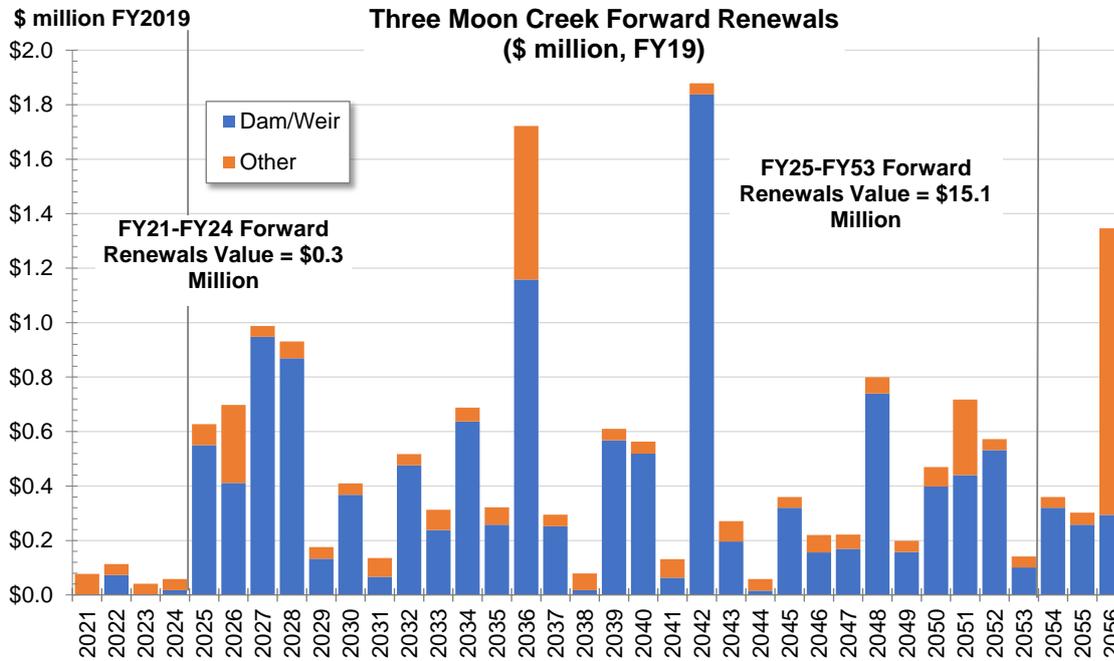
Figure 1 presents Sunwater's revised forward renewals submission.
Figure 2 presents Sunwater's revised forward renewals submission adjusted for the impact of applying a 10% life extension.
Figure 3 (where provided) presents an additional adjustment for refurbishment issues identified in select bulk water schemes.
Table 1 presents a tabulated annual comparison of the submitted and adjusted forward renewals submission.

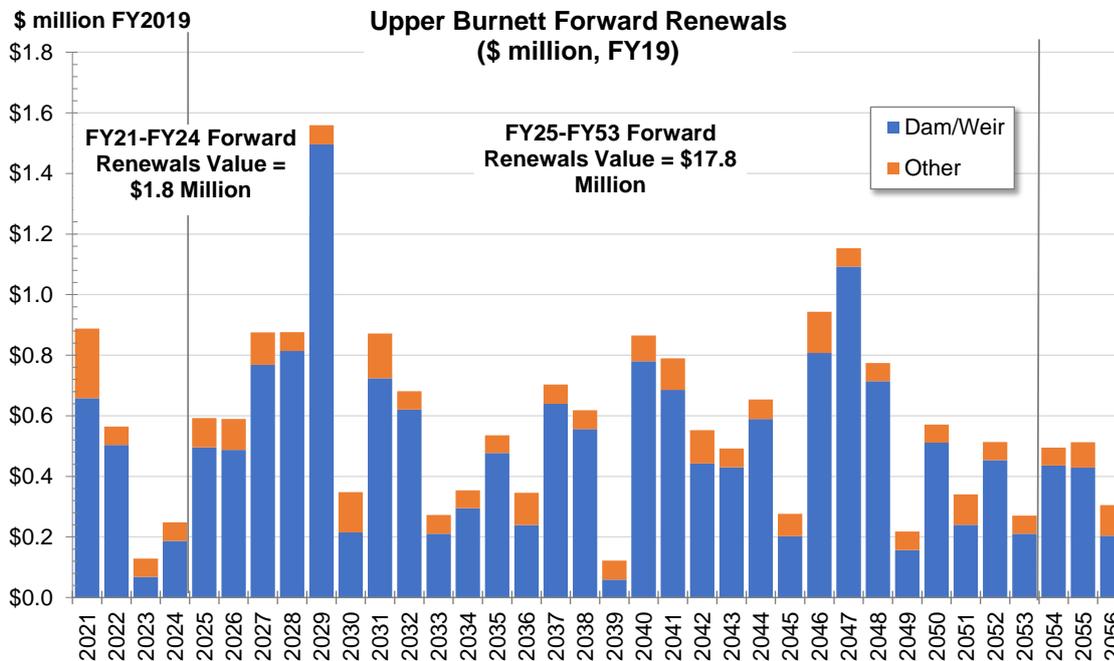
Figure 1 presents Sunwater's revised forward renewals submission.
Figure 2 presents Sunwater's revised forward renewals submission adjusted for the impact of applying a 10% life extension.
Figure 3 (where provided) presents an additional adjustment for refurbishment issues identified in select bulk water schemes.
Table 1 presents a tabulated annual comparison of the submitted and adjusted forward renewals submission.
