Rural Irrigation Capital Expenditure Review

Sunwater

Client: Queensland Competition Authority

AECOM Australia Pty Ltd

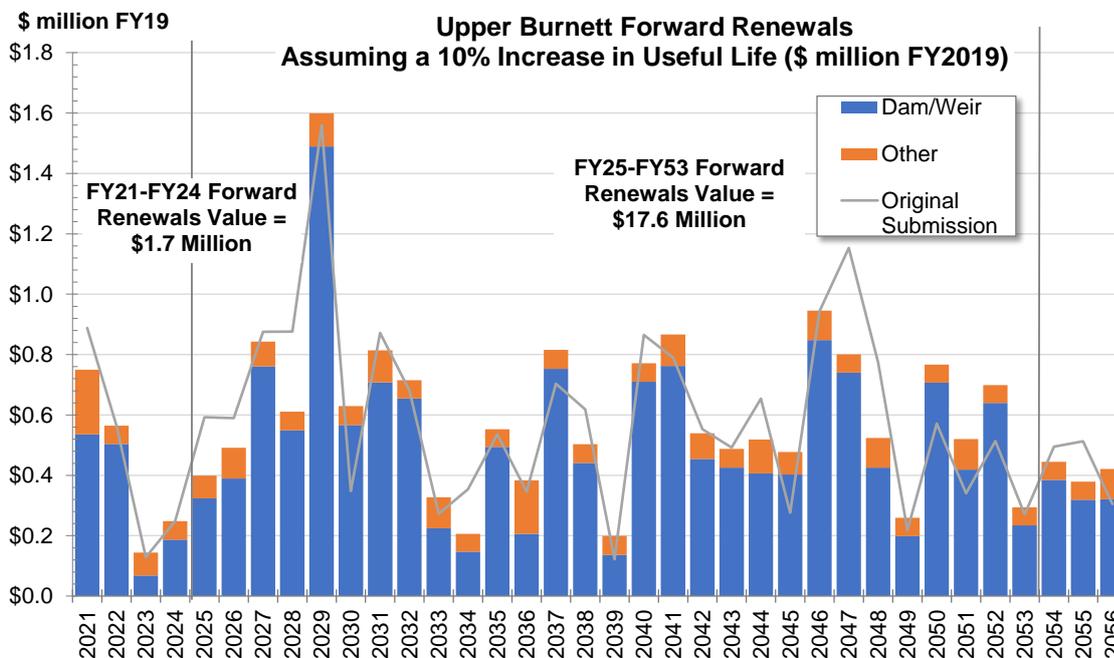
Figure 1 presents Sunwater's revised forward renewals submission.
Figure 2 presents Sunwater's revised forward renewals submission adjusted for the impact of applying a 10% life extension.
Figure 3 (where provided) presents an additional adjustment for refurbishment issues identified in select bulk water schemes.
Table 1 presents a tabulated annual comparison of the submitted and adjusted forward renewals submission.

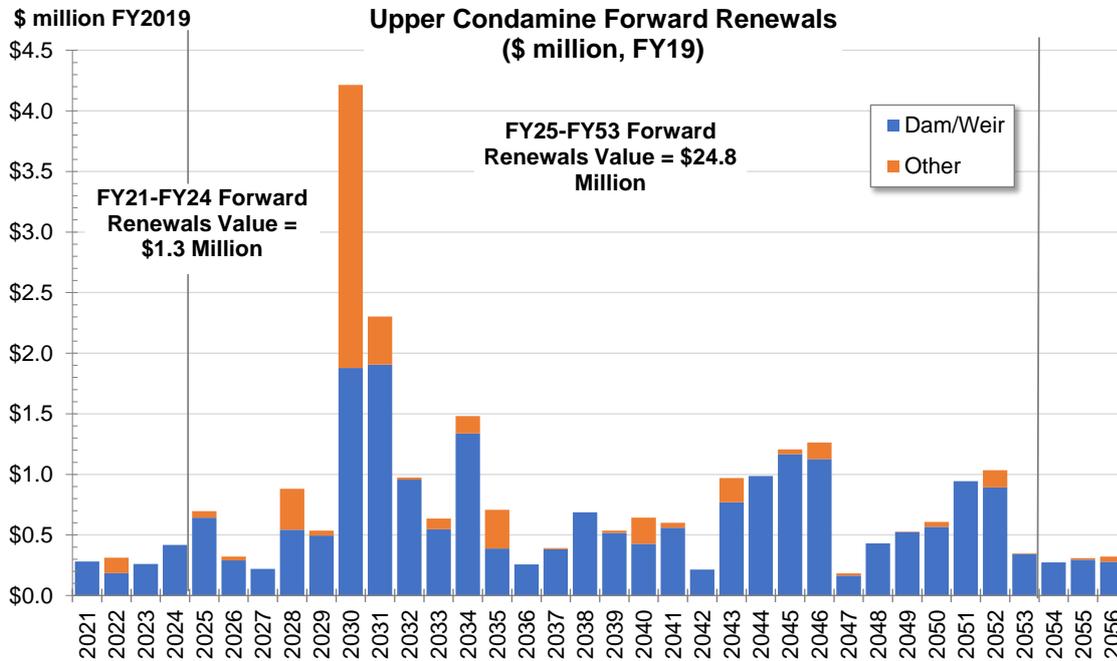
Figure 1 presents Sunwater's revised forward renewals submission.
Figure 2 presents Sunwater's revised forward renewals submission adjusted for the impact of applying a 10% life extension.
Figure 3 (where provided) presents an additional adjustment for refurbishment issues identified in select bulk water schemes.
Table 1 presents a tabulated annual comparison of the submitted and adjusted forward renewals submission.

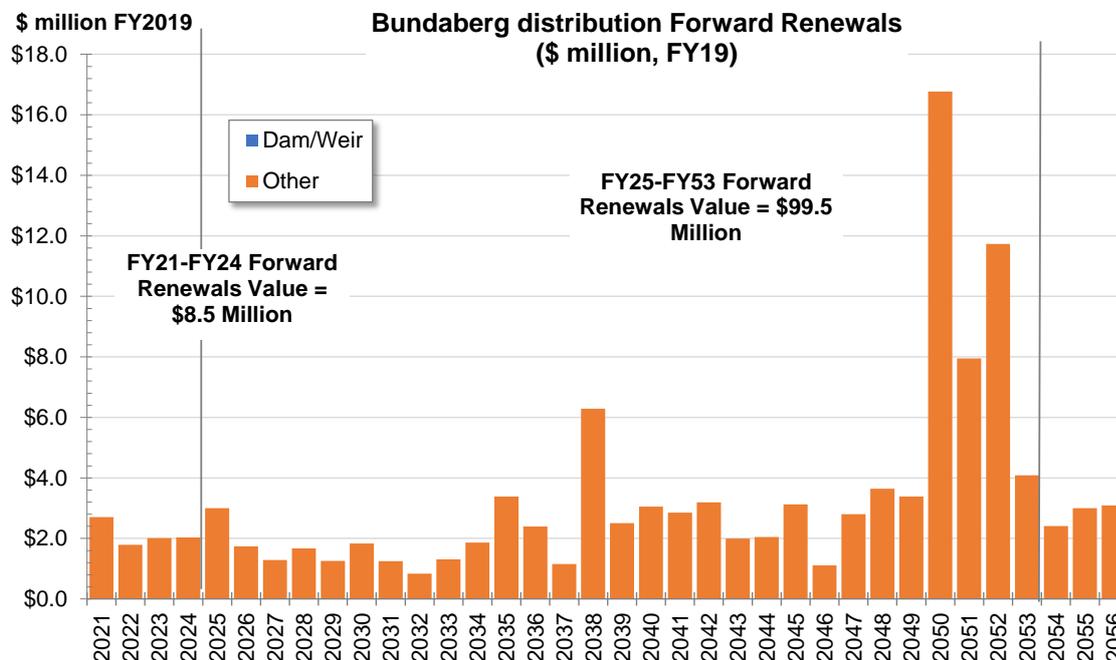
Figure 1 presents Sunwater's revised forward renewals submission.
Figure 2 presents Sunwater's revised forward renewals submission adjusted for the impact of applying a 10% life extension.
Figure 3 (where provided) presents an additional adjustment for refurbishment issues identified in select bulk water schemes.
Table 1 presents a tabulated annual comparison of the submitted and adjusted forward renewals submission.

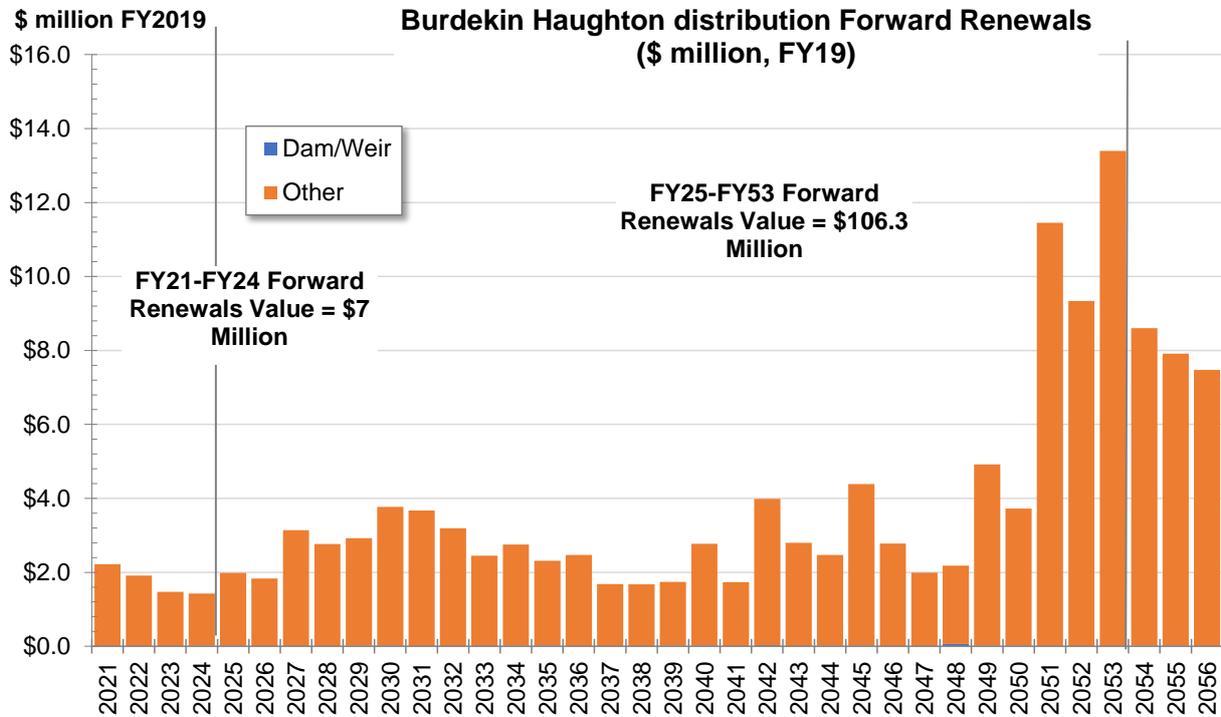
Figure 1 presents Sunwater's revised forward renewals submission.
Figure 2 presents Sunwater's revised forward renewals submission adjusted for the impact of applying a 10% life extension.
Figure 3 (where provided) presents an additional adjustment for refurbishment issues identified in select bulk water schemes.
Table 1 presents a tabulated annual comparison of the submitted and adjusted forward renewals submission.

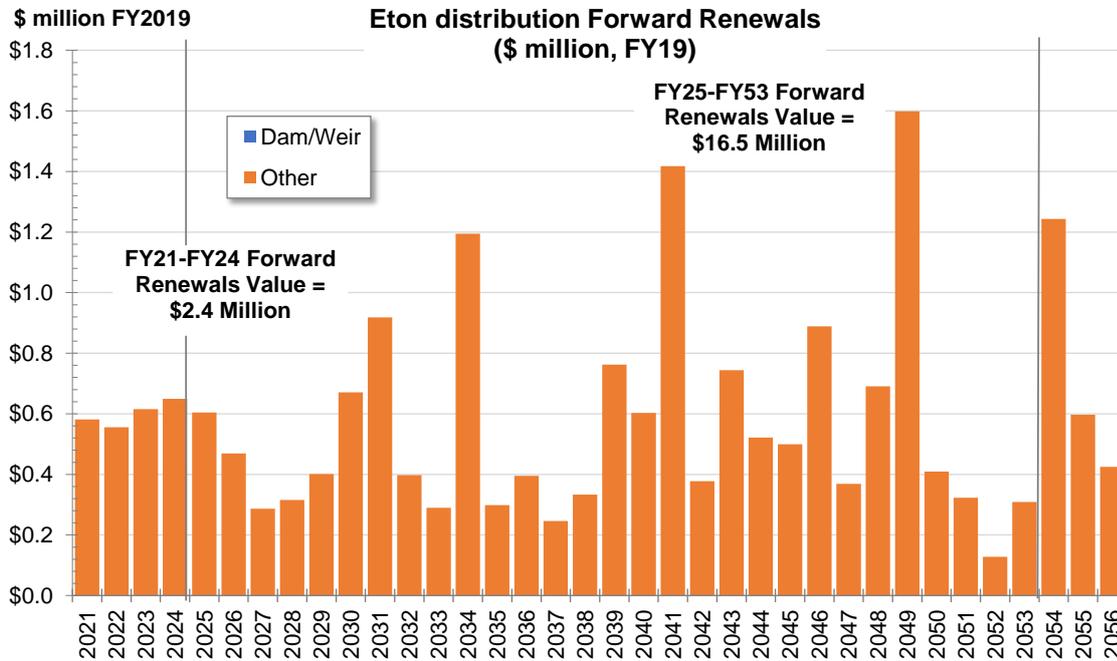
Figure 1 presents Sunwater's revised forward renewals submission.
Figure 2 presents Sunwater's revised forward renewals submission adjusted for the impact of applying a 10% life extension.
Figure 3 (where provided) presents an additional adjustment for refurbishment issues identified in select bulk water schemes.
Table 1 presents a tabulated annual comparison of the submitted and adjusted forward renewals submission.
